JORDAN

Petra

Incorrect restoration and shortcomings

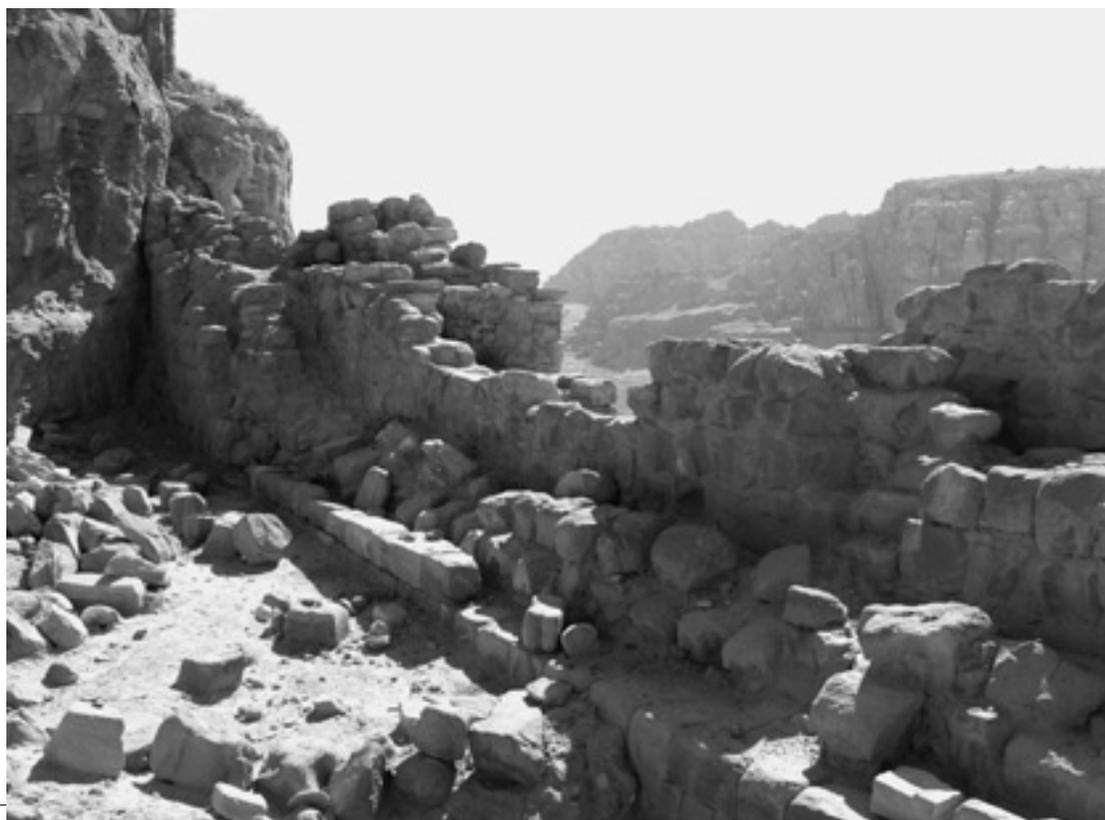
Palace Tomb 765, measurement results ►

| | 85,5% conserved shape |
| | 53,3 % weathering rate |
| | 47,4 % weathering |
| | 2,5 % alveolar / tafoni weathering |
| | 116,9 m weathered limonit |
| | 57,7 m cracks |
| | 3,5 % broken area |
| | 7,7 % stonewalled part |

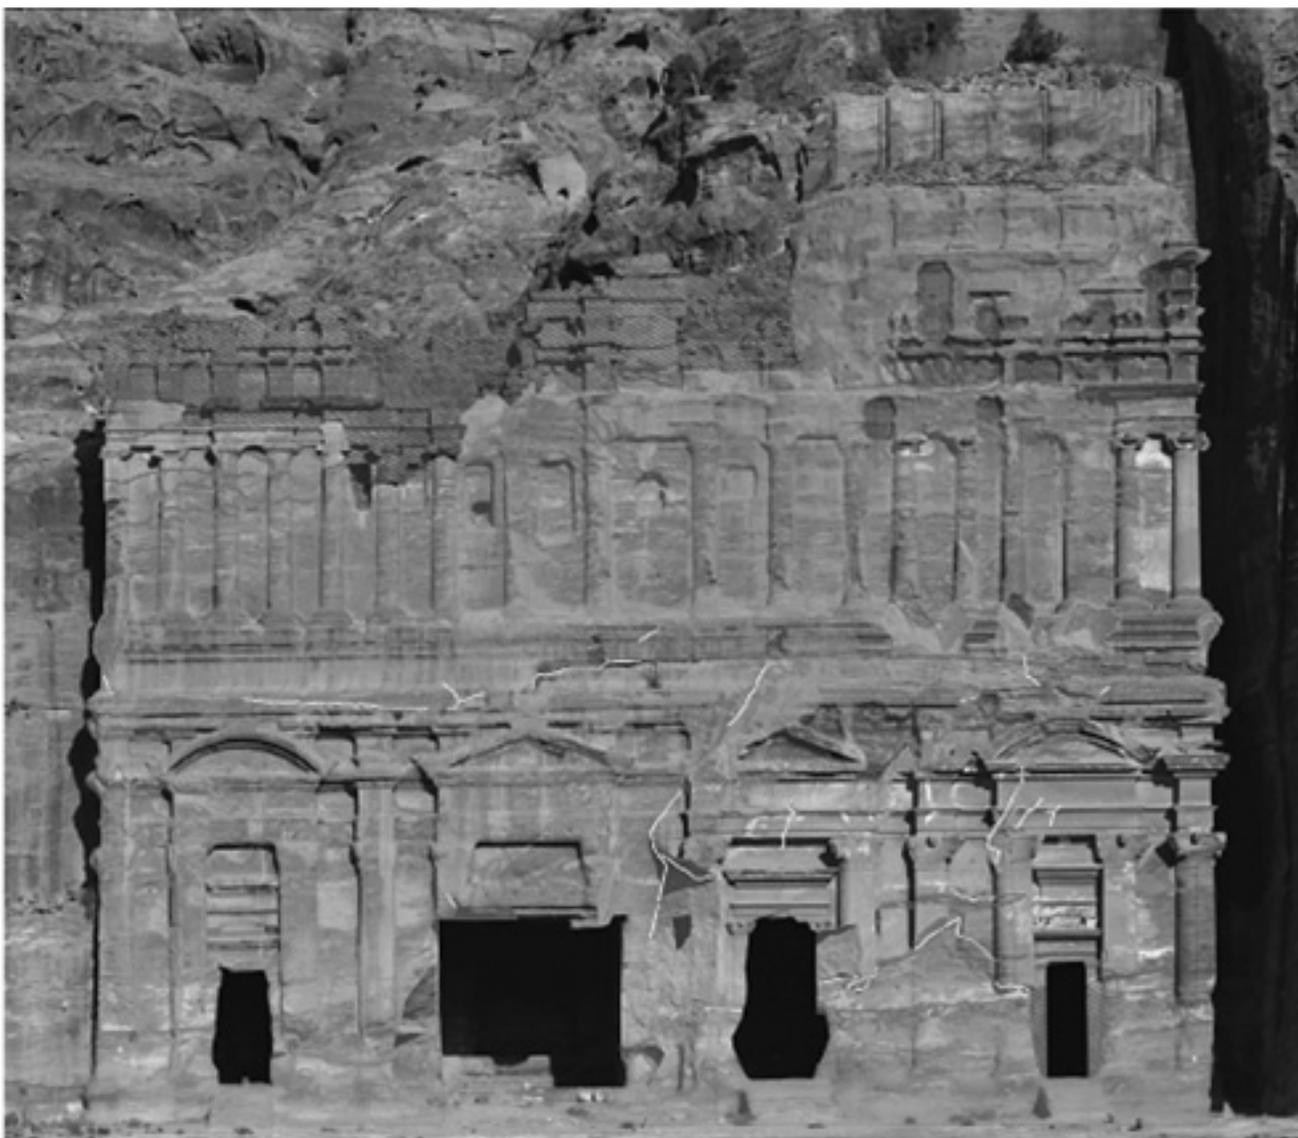
Apart from these buildings, there are also certain sections of the rock-cut façades which were made of ashlar masonry. According to recent investigations, 14% of all structural elements of these façades are either completely or partly made of cut stone.² In most cases these areas are seriously at risk of falling off. Not only is the natural stone severely weathered, but also the remains of the once rich decoration. During a survey of 211 tomb façades, traces of plaster, colour and stucco could be found on nearly 24% of these façades. Apart from the once coloured and plainly stuccoed rock façades the few remains of the original lavish stucco decoration at Qasr al-Bint and the finely stuccoed back walls of caves on the eastern wall of el-Habis also show signs of gradual loss.

Palace Tomb: Elements, which have been masoned, not cut from the rock

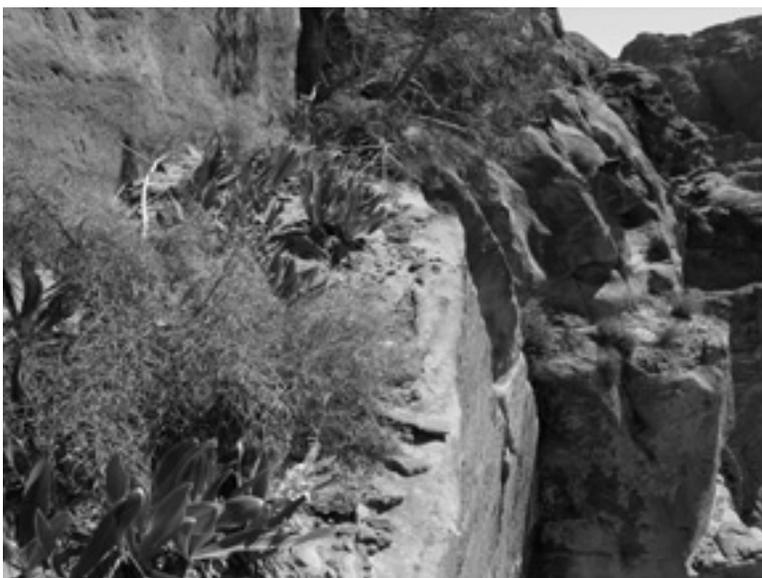
Corinthian Tomb, verdure

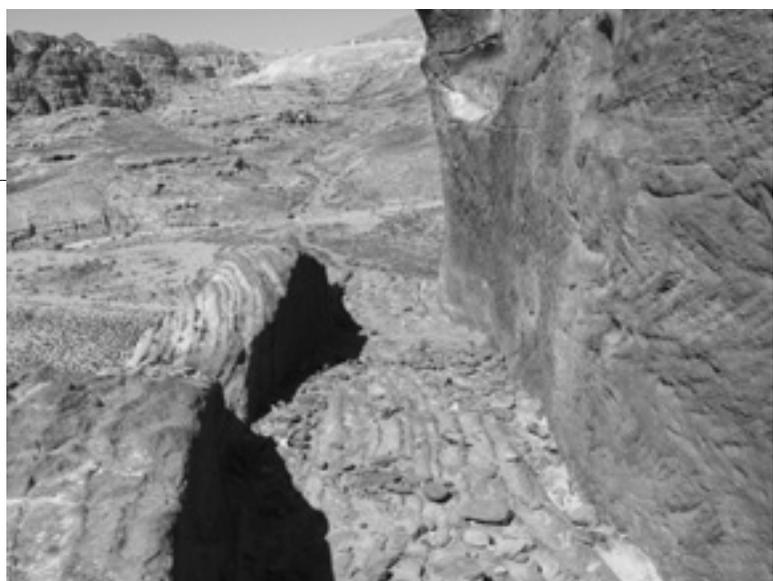
The builders of Petra, the Nabataeans, were very aware of the destructive force of the water. For this reason the majority of structures were equipped with drainage systems. Nowadays, most of them have either filled up or are partly destroyed, which in many places leads to damage to the façades.⁵

Corinthian Tomb, drainage

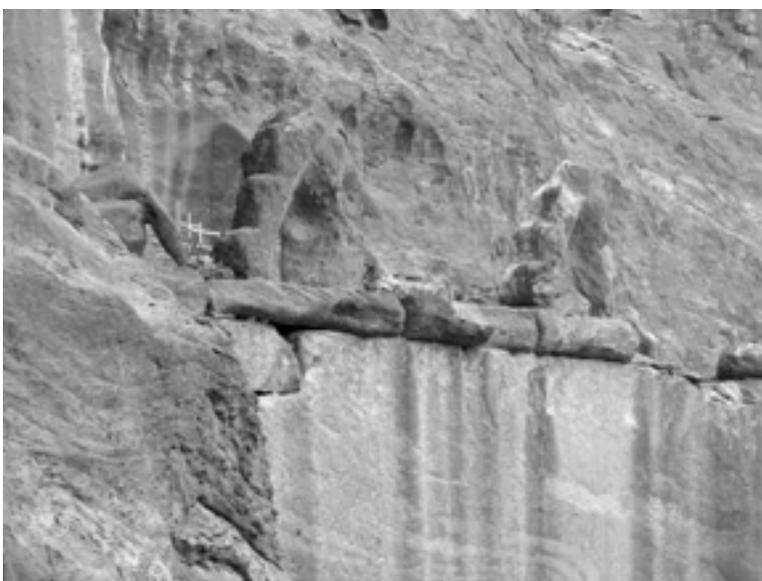
Tomb 824, endangered architectural elements

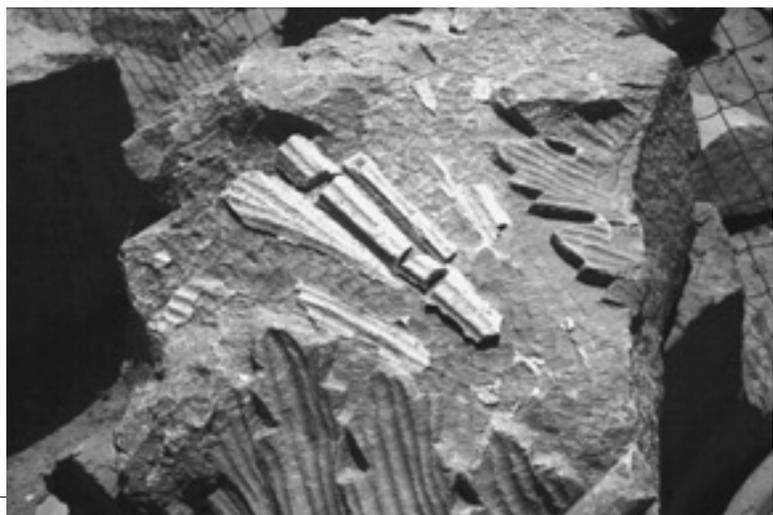
Weathered stucco decoration from the capital of the Great Temple

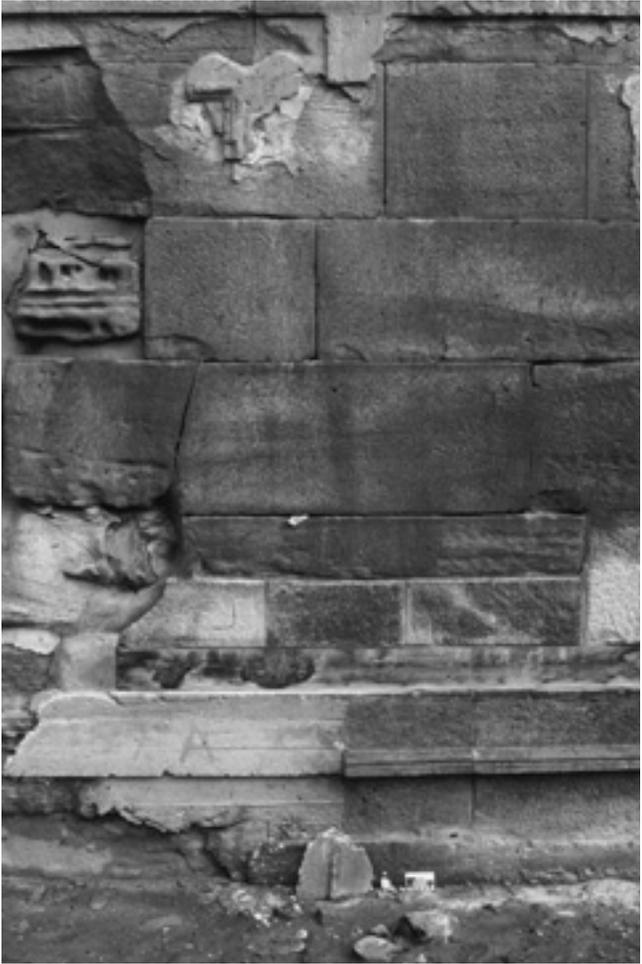
Qasr al Bint, condition of stucco decoration

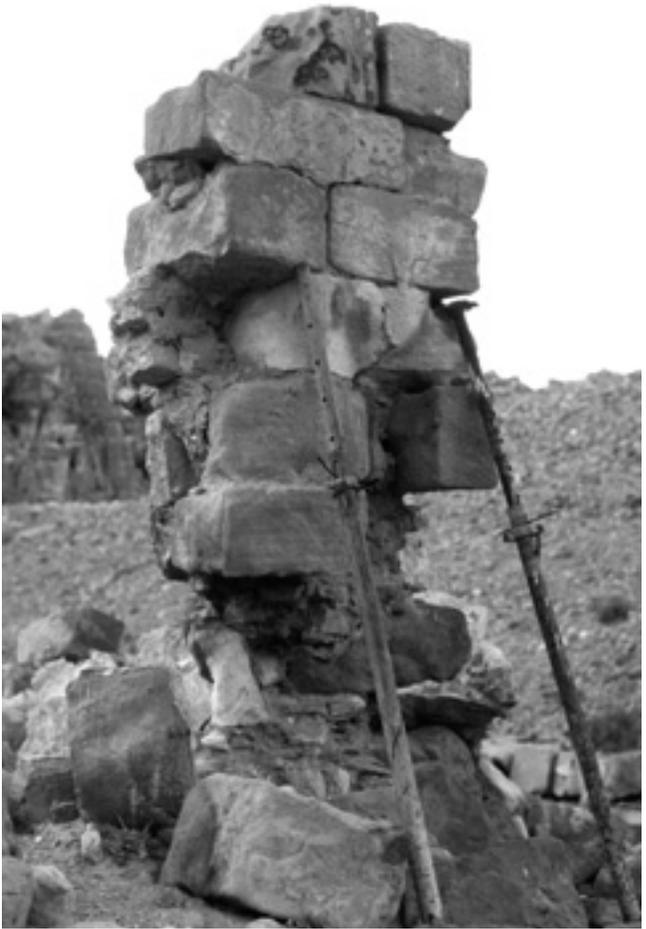
King's Palace, masoned corner

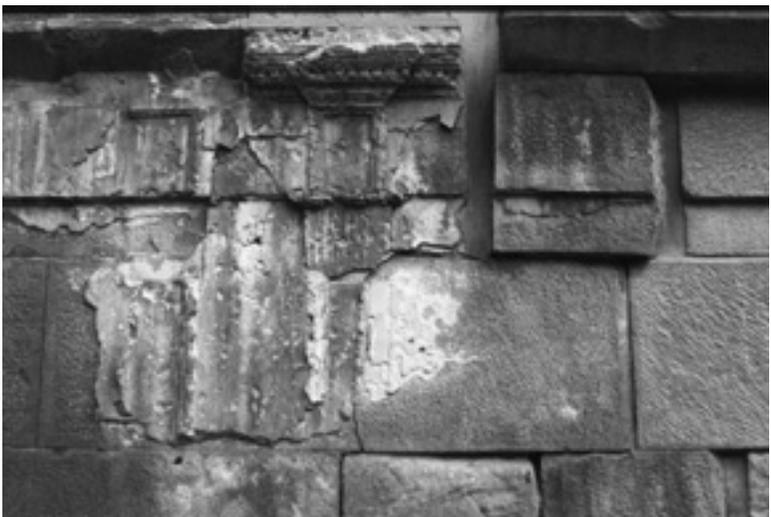
containing cement was used. This very hard and dense building material leads to an acceleration of the weathering processes of the original material and has resulted in further damage. Until now, there is no stone workshop for the large number of decorative elements, such as ornamented and partly stuccoed and painted capitals, friezes and waste fragments. Many of these pieces remain largely unprotected against weathering.

Temenos Gate, cement mortar

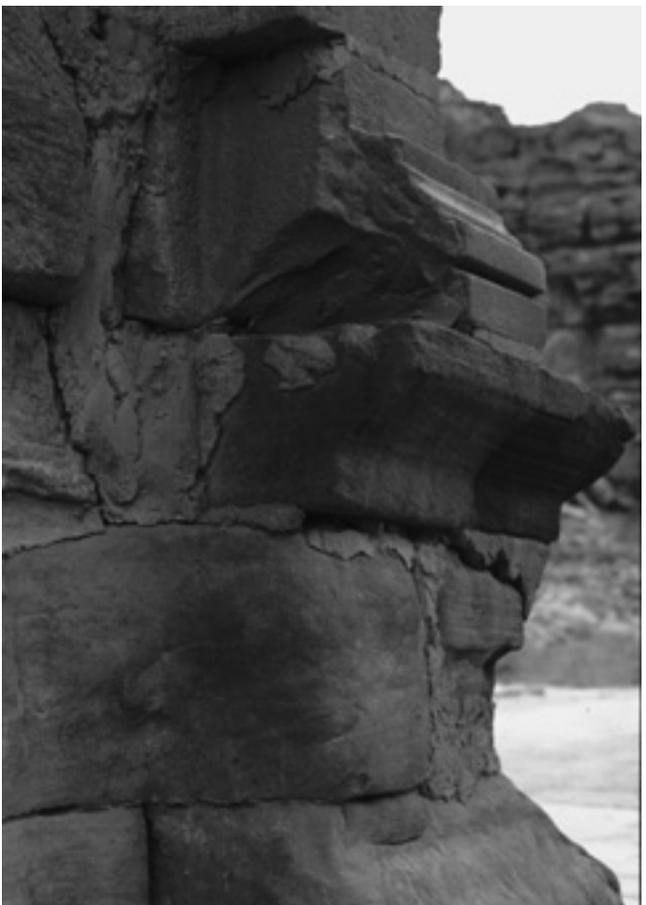
Qasr al Bint, recent rupture on stucco decoration
