ICOMOS Sri Lanka

**Preliminary Survey of Tsunami-affected Monuments
and Sites in the Maritime Region of Sri Lanka**

PART THREE
The Western Maritime Region:
from the Gin Ganga to the Kalu Ganga

March 2005

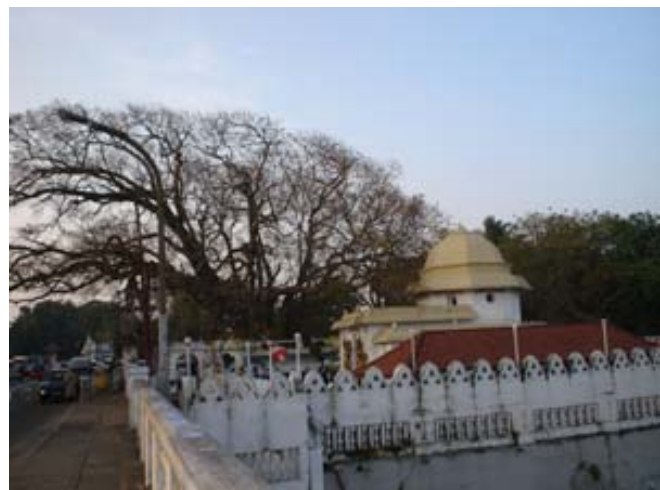
Name – KALUTARA BODHIYA
Type – RELIGIOUS - CULTURAL - HISTORICAL
Address – Kalutara Bodhiya, Kalutara
DS Division - Kalutara
GN Division – Kalutara South
GPS Coordinates - 06⁰ N 35.218
- 079⁰ E 57.576
Distance from the Sea – 400 m
Extent of Damage – No damage.
Estimated Cost for Conservation
- Rs. 000 million

ELEMENT	MATERIAL	EXTENT OF DAMAGE
ROOF	Asbestos, Calicut tiles, timber frame	No damage
WALLS	Bricks, Concrete	No damage
DOORS	Timber	No damage
WINDOWS	Timber, glass	No damage
FLOOR	Cement rendered	No damage
FOUNDATION	Rubble	No damage
SITE	Cement rendered, shrubs	No damage
OTHER

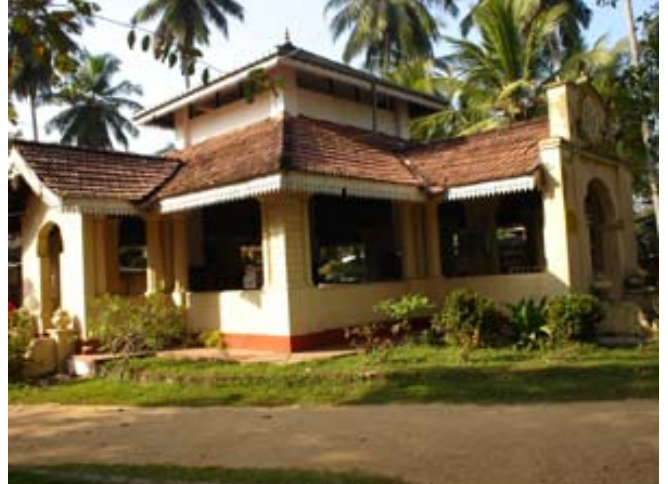
Extent of Damage – No damage.

ELEMENT	MATERIAL	EXTENT OF DAMAGE
ROOF	Calicut tiles, timber frame	No damage
WALLS	Cabock	No damage
DOORS	Timber	No damage
WINDOWS	Timber, glass	No damage
FLOOR	Cement rendered	No damage
FOUNDATION	Rubble	No damage
SITE	Trees, sandy soil	No damage
OTHER

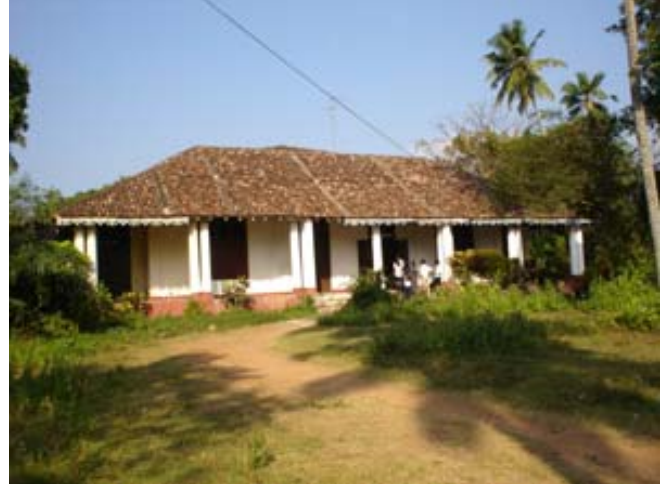
Name – JEM VILLA
Type – HISTORICAL - RESIDENTIAL
Address – No.870, Galle Road, Katukurunda, Kalutara
DS Division - Kalutara
GN Division – Katukurunda
GPS Coordinates - 06⁰ N 33.784
- 079⁰ E 58.062
Distance from the Sea – 550 m
Extent of Damage – No damage.
Estimated Cost for Conservation
- Rs. 000 million

ELEMENT	MATERIAL	EXTENT OF DAMAGE
ROOF	Half round tiles, timber frame	No damage
WALLS	Bricks	No damage
DOORS	Timber	No damage
WINDOWS	Timber, glass	No damage
FLOOR	Terracotta	No damage
FOUNDATION	Brick	No damage
SITE	Coconut cultivation	No damage
OTHER

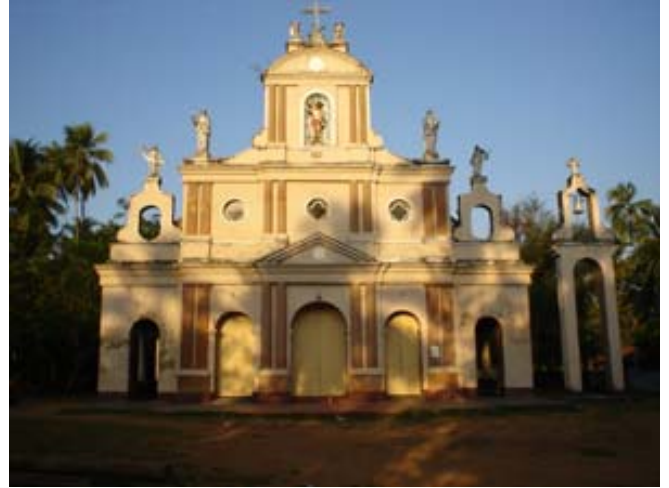
Name – St. SEBASTIAN CHURCH
Type – RELIGIOUS - HISTORICAL
Address – Kalamulla, Kalutara
DS Division - Kalutara
GN Division - Kalamulla
GPS Coordinates - 06⁰ N 33.516
- 079⁰ E 57.955
Distance from the Sea – 400m
Extent of Damage – No damage.
Estimated Cost for Conservation
- Rs. 000 million

ELEMENT	MATERIAL	EXTENT OF DAMAGE
ROOF	Calicut tiles, timber frame	No damage
WALLS	Cabock, bricks	No damage
DOORS	Timber	No damage
WINDOWS	Timber, glass	No damage
FLOOR	Cement rendered	No damage
FOUNDATION	Bricks	No damage
SITE	Sandy	No damage
OTHER

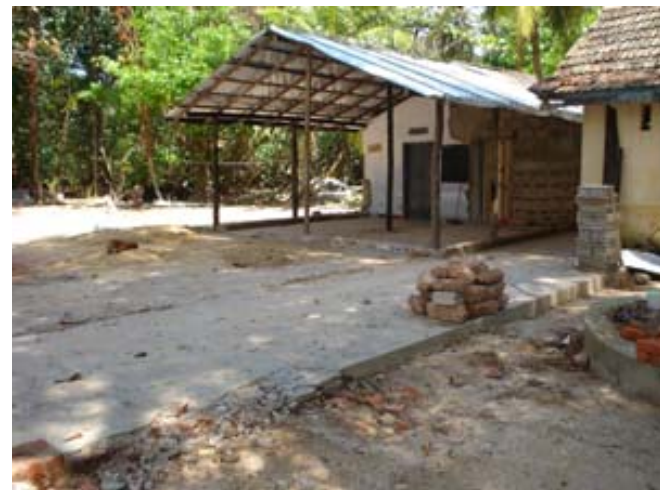
Extent of Damage – The *dharmasalava* and two bhikku *kuti*'s have been completely destroyed.

ELEMENT	MATERIAL	EXTENT OF DAMAGE
ROOF	Calicut tiles, timber frame	Completely destroyed
WALLS	Cabock	Completely destroyed
DOORS	Timber	Completely destroyed
WINDOWS	Timber	Completely destroyed
FLOOR	Cement rendered	Completely destroyed
FOUNDATION	Cabock	No damage
SITE	Sandy with coconut trees.	Washed away
OTHER

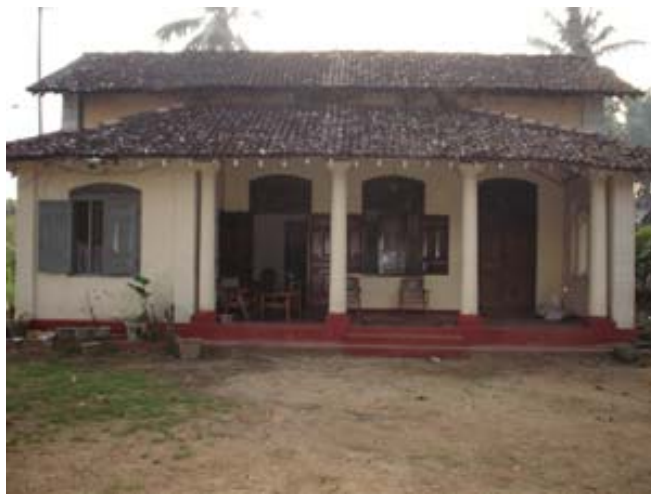
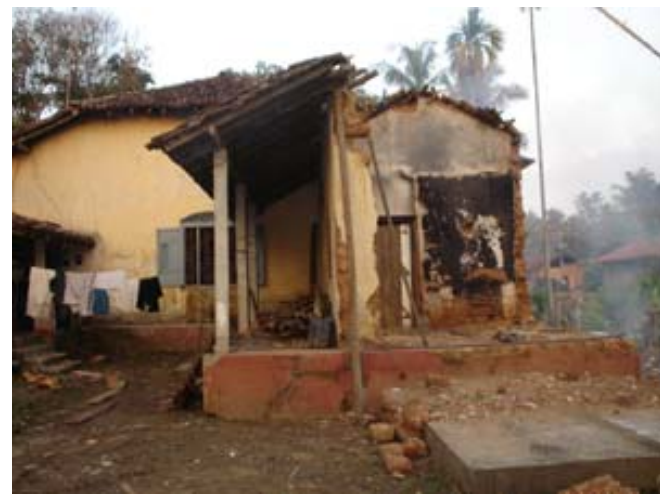
Name – CHALI VILLA
Type – HISTORICAL - RESIDENTIAL
Address – Chali Villa, Payagala North, Payagala
DS Division - Beruwala
GN Division – Payagala North
GPS Coordinates - 06⁰ N 31.797
- 079⁰ E 58.656
Distance from the Sea – 300 m
Extent of Damage – Rear portion is completely destroyed.
Estimated Cost for Conservation
- Rs. 0.5 million

ELEMENT	MATERIAL	EXTENT OF DAMAGE
ROOF	Calicut tiles, timber frame	Rear roof has collapsed.
WALLS	Cabock	Rear section has collapsed.
DOORS	Decorated timber	Damaged
WINDOWS	Decorated timber	Damaged
FLOOR	Cement rendered	Damaged
FOUNDATION	Cabock	No damage
SITE	Sandy soil with coconut trees.	Washed away
OTHER	Storied house.	No damage

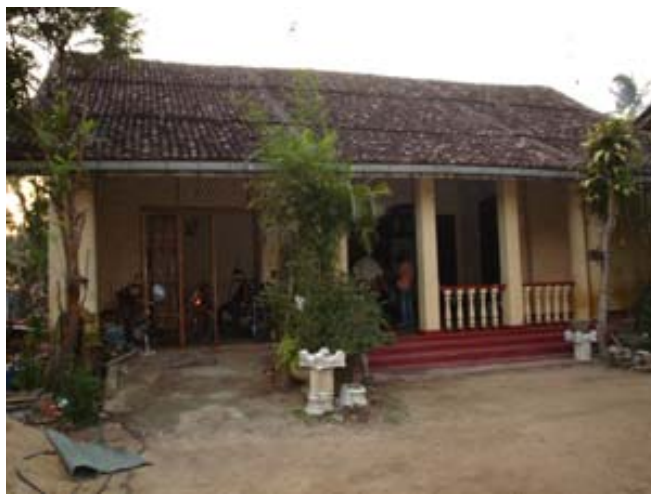
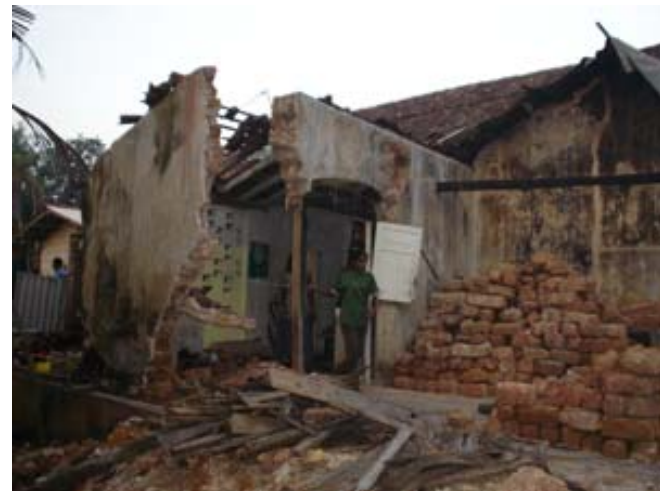
Extent of Damage – **Rear portion is completely destroyed.**

ELEMENT	MATERIAL	EXTENT OF DAMAGE
ROOF	Calicut tiles, timber frame	Rear roof has collapsed.
WALLS	Cabock	Rear section has collapsed.
DOORS	Decorated timber	Damaged
WINDOWS	Decorated timber	Damaged
FLOOR	Cement rendered, terracotta tiles	Damaged
FOUNDATION	Cabock	Damaged
SITE	Sandy soil with coconut trees.	Washed away
OTHER

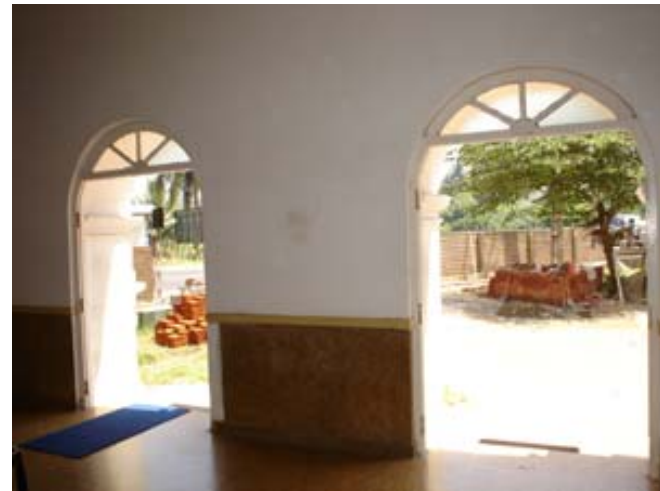
Extent of Damage – Front doors have been damaged.

Parapet wall has been destroyed. The store has been damaged.

ELEMENT	MATERIAL	EXTENT OF DAMAGE
ROOF	Calicut tiles, timber frame	No damage
WALLS	Cabock	No damage
DOORS	Timber	Damaged
WINDOWS	Glazed, timber	No damage
FLOOR	Terrazzo	No damage
FOUNDATION	Cabock	No damage
SITE	Trees	No damage
OTHER		Store has been destroyed.

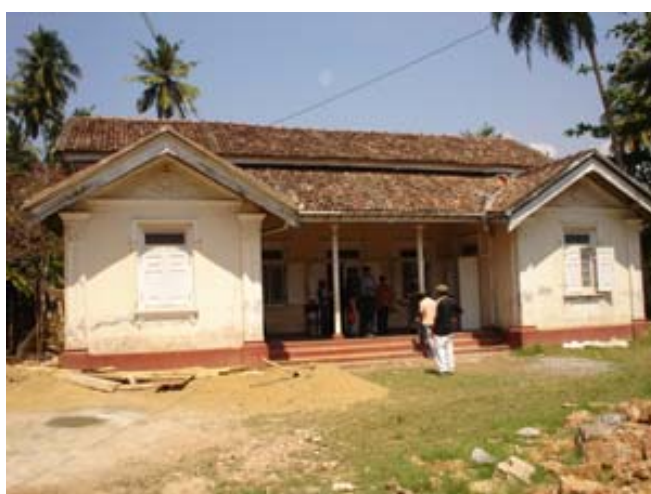
Name – SITHY MIDNAWWARA
Type – HISTORICAL- RESIDENTIAL
Address – No. 58/1, Thudawa Road, Maggona
DS Division - Beruwala
GN Division- Maggona West
GPS Coordinates - 06⁰ N 30.171
- 079⁰ E 58.723
Distance from the Sea – 300 m
Extent of Damage – Parapet wall has been destroyed.
Estimated Cost for Conservation
- Rs. 0.2 million

ELEMENT	MATERIAL	EXTENT OF DAMAGE
ROOF	Half round tiles, timber frame	No damage
WALLS	Cabock	No damage
DOORS	Timber	Damaged
WINDOWS	Timber	No damage
FLOOR	Terracotta, cement rendered	No damage
FOUNDATION	Cabock	No damage
SITE	Turf	No damage
OTHER		Parapet wall has been damaged.

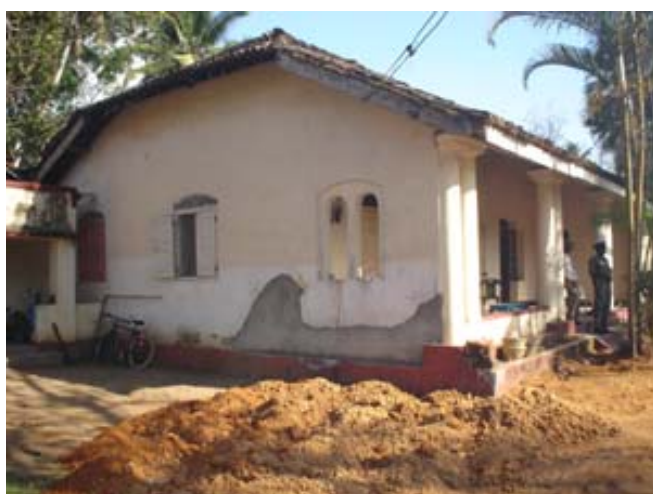
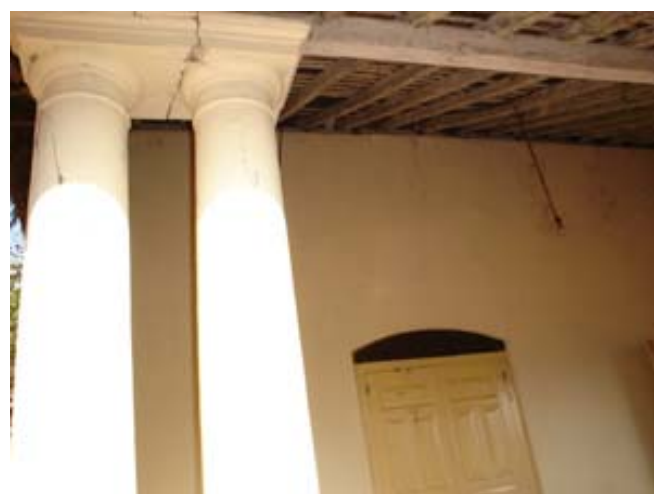
Extent of Damage – Doors have been damaged. Walls are cracked. Plaster has fallen off. Parapet wall is destroyed.

ELEMENT	MATERIAL	EXTENT OF DAMAGE
ROOF	Half round tiles, timber frame	No damage
WALLS	Cabock	Cracked
DOORS	Timber	Damaged
WINDOWS	Timber	No damage
FLOOR	Terracotta, cement rendered	No damage
FOUNDATION	Cabock	No damage
SITE	Coconut cultivation	Washed away.
OTHER		Parapet wall has been damaged.

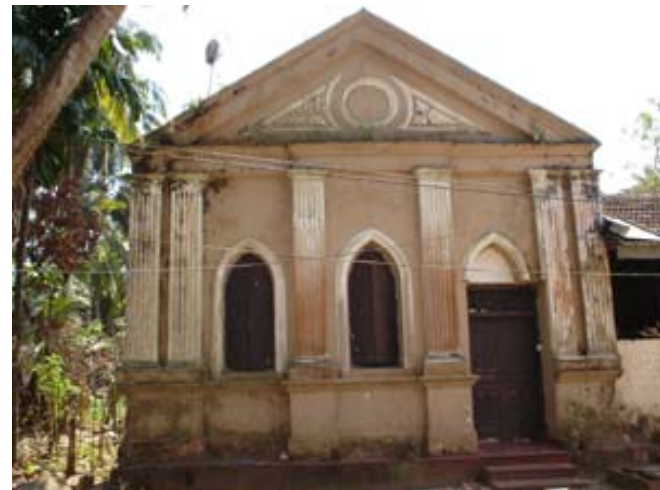
ELEMENT	MATERIAL	EXTENT OF DAMAGE
ROOF	Calicut tiles, timber frame	No damage
WALLS	Brick	Plaster is damaged. Walls are cracked.
DOORS	Timber	Damaged
WINDOWS	Timber, coloured glass	Damaged
FLOOR	Cement rendered	No damage
FOUNDATION	Rubble	No damage
SITE	Coconut cultivation	No damage
OTHER		Parapet wall is destroyed.

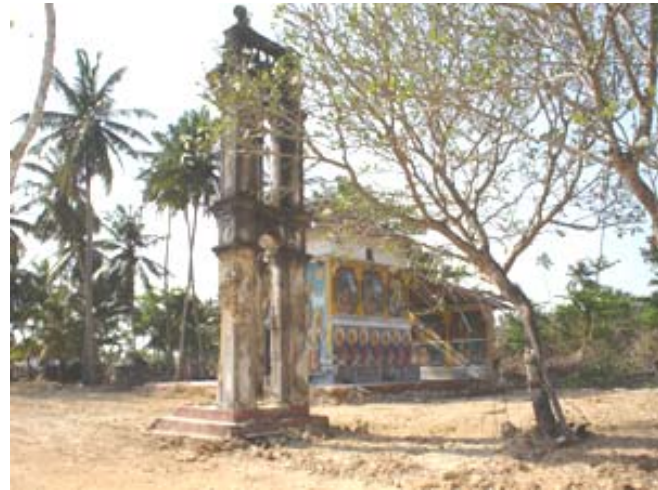
ELEMENT	MATERIAL	EXTENT OF DAMAGE
ROOF	Half round tiles, Calicut tiles, timber frame	Completely destroyed
WALLS	Cabock	Completely destroyed
DOORS	Timber	Completely destroyed
WINDOWS	Timber	Completely destroyed
FLOOR	Cement rendered	Completely destroyed
FOUNDATION	Rubble	Completely destroyed
SITE	Coconut cultivation	Completely washed away.
OTHER

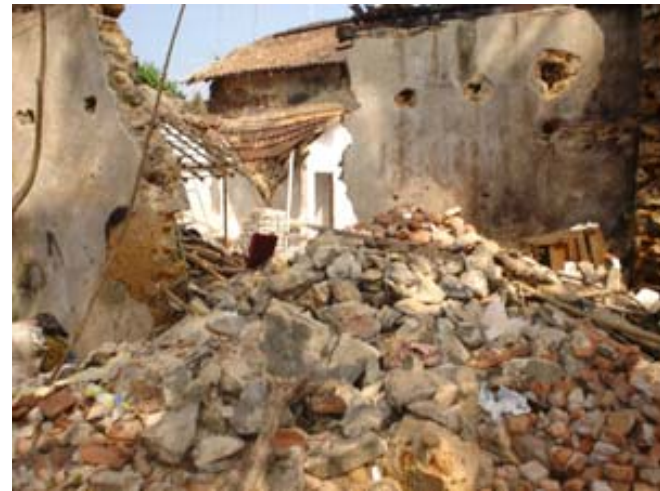
ELEMENT	MATERIAL	EXTENT OF DAMAGE
ROOF	Half round tiles, Calicut tiles timber frame	Rear section is completely destroyed.
WALLS	Cabock Rubble	Rear section is completely destroyed.
DOORS	Timber	Damaged
WINDOWS	Timber	Damaged
FLOOR	Cement rendered	Damaged
FOUNDATION	Rubble	No damage
SITE		
OTHER

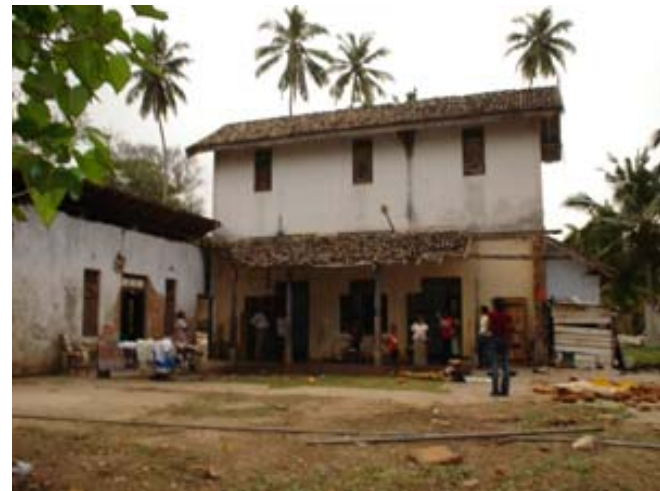
ELEMENT	MATERIAL	EXTENT OF DAMAGE
ROOF	Half round tiles, timber frame	Rear portion is completely destroyed.
WALLS	Bricks	Rear portion is completely destroyed. Others are cracked. Plaster is damaged.
DOORS	Timber	Rear portion is completely destroyed.
WINDOWS	Timber	Rear portion is completely destroyed.
FLOOR	Cement rendered	Rear portion is completely destroyed.
FOUNDATION	Rubble	No damage
SITE	Coconut cultivation	No damage
OTHER

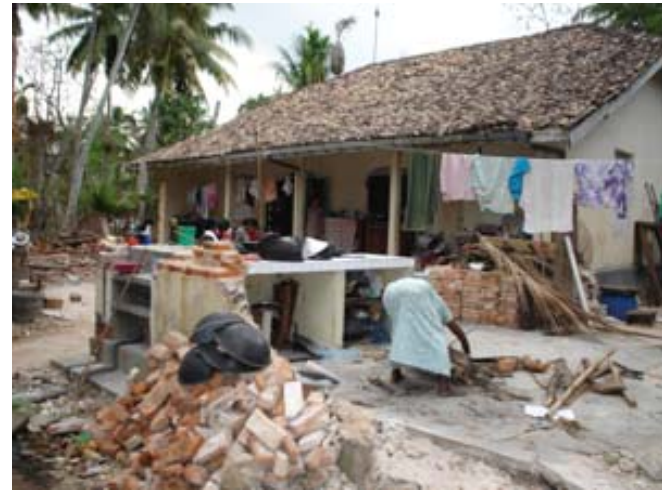
ELEMENT	MATERIAL	EXTENT OF DAMAGE
ROOF	Calicut tiles, timber frame	Rear portion is completely destroyed.
WALLS	Bricks	Rear portion is completely destroyed. Others are cracked. Plaster is damaged. Walls are cracked
DOORS	Timber	Rear portion is completely destroyed. Others are damaged.
WINDOWS	Timber	Rear portion is completely destroyed.
FLOOR	Cement rendered	Rear portion is completely destroyed.
FOUNDATION	Rubble	No damage
SITE	Coconut cultivation	No damage
OTHER

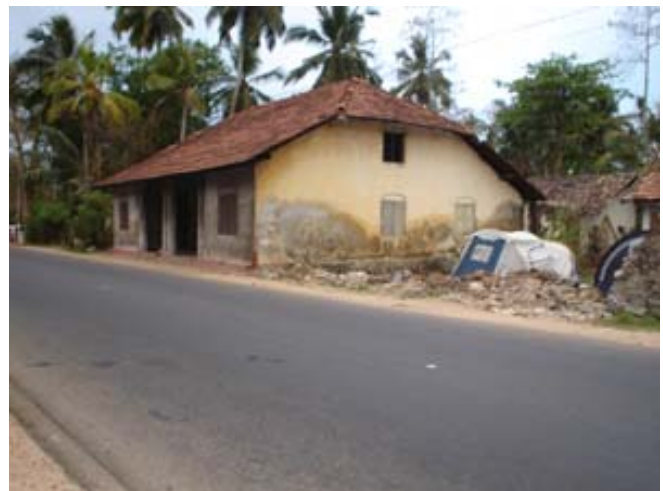
ELEMENT	MATERIAL	EXTENT OF DAMAGE
ROOF	Calicut tiles, timber frame	Rear portion is destroyed.
WALLS	Rubble, cabock, coral stone	Rear portion is destroyed. Cracks, plaster damaged.
DOORS	Timber	Rear portion is destroyed. Damaged
WINDOWS	Timber	Rear portion is destroyed. Damaged
FLOOR	Cement rendered	Rear portion is destroyed. No damage
FOUNDATION	Rubble	No damage
SITE	Sandy	No damage
OTHER

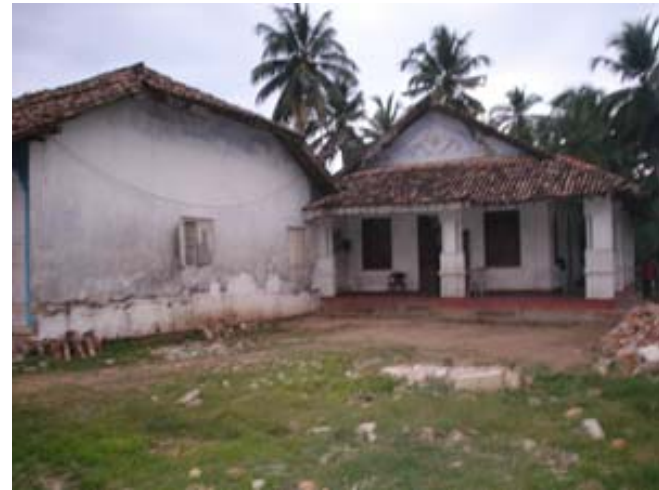
ELEMENT	MATERIAL	EXTENT OF DAMAGE
ROOF	Half round tiles, timber frame	Rear portion is destroyed.
WALLS	Rubble, cabock, coral stone	Rear portion is destroyed. Cracked, plaster is damaged.
DOORS	Timber	Rear portion is destroyed. Damaged
WINDOWS	Timber	Rear portion is destroyed. Damaged
FLOOR	Cement rendered	Rear portion is destroyed. Damaged
FOUNDATION	Rubble	No damage
SITE	Sand	No damage
OTHER

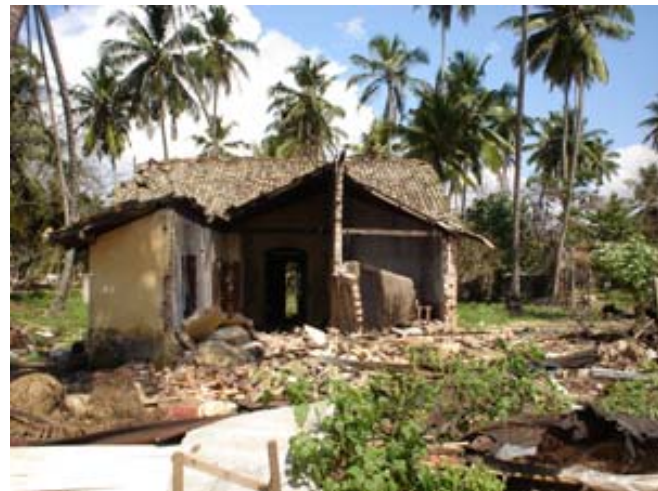
ELEMENT	MATERIAL	EXTENT OF DAMAGE
ROOF	Half round tiles, timber frame	Rear portion is destroyed.
WALLS	Cabock, bricks	Rear portion is destroyed. Cracked, plaster is damaged.
DOORS	Timber	Rear portion is destroyed. Damaged
WINDOWS	Timber	Rear portion is destroyed. Damaged
FLOOR	Cement rendered	Rear portion is destroyed. Damaged
FOUNDATION	Rubble	No damage
SITE	Coconut cultivation	No damage
OTHER

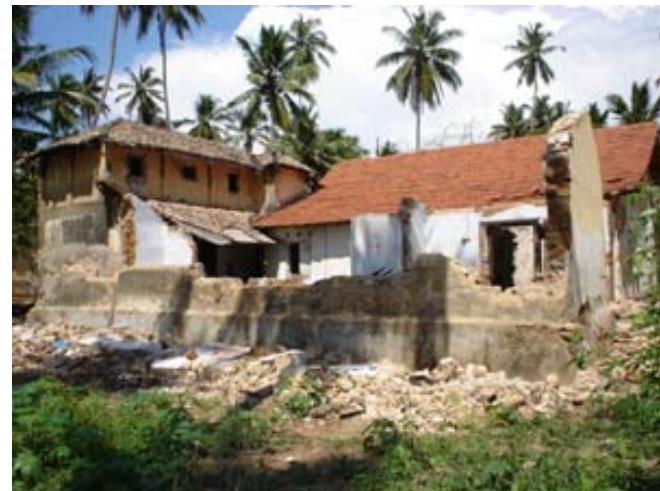
ELEMENT	MATERIAL	EXTENT OF DAMAGE
ROOF	Half round tiles, timber frame	Rear portion is destroyed.
WALLS	Cabock, Brick	Rear portion is destroyed. Cracked, plaster is damaged.
DOORS	Timber	Rear portion is destroyed. Damaged
WINDOWS	Timber	Rear portion is destroyed. Damaged
FLOOR	Cement rendered	Rear portion is destroyed. Damaged
FOUNDATION	Rubble	No damage
SITE	Coconut cultivation	No damage
OTHER

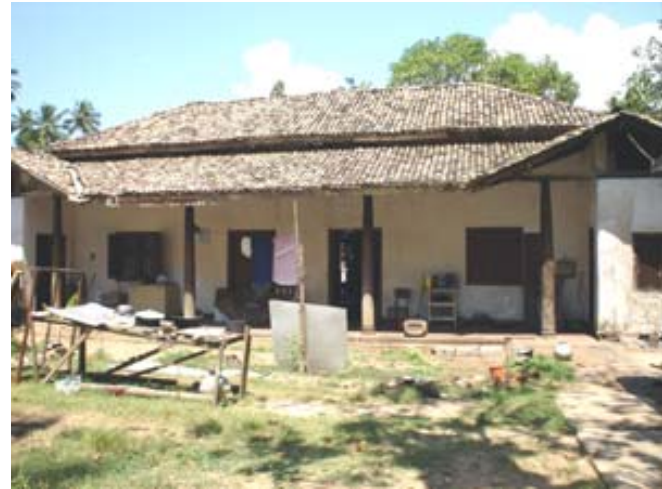
ELEMENT	MATERIAL	EXTENT OF DAMAGE
ROOF	Half round tiles, timber frame	Kitchen and a room are destroyed.
WALLS	Cabock, Corel Stone , Rubble	Kitchen and a room destroyed. Cracked, plaster is damaged.
DOORS	Timber	Kitchen and a room destroyed. Damaged
WINDOWS	Timber	Kitchen and a room destroyed. Damaged
FLOOR	Stone paved, cement rendered	Kitchen and a room destroyed. No damage
FOUNDATION	Rubble	No damage
SITE	Trees	No damage
OTHER		Parapet wall is destroyed.

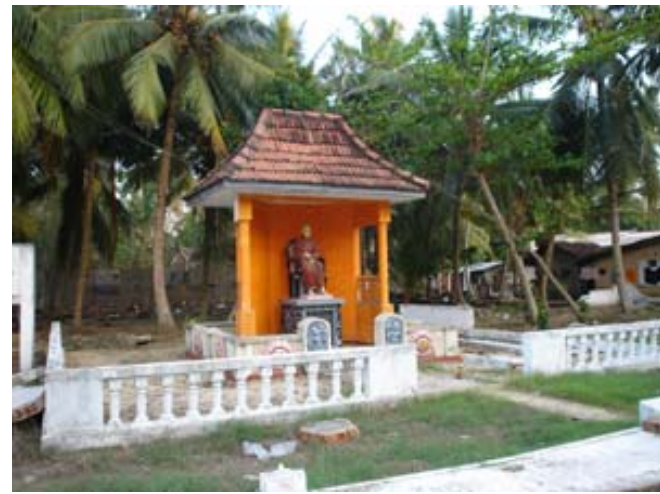
ELEMENT	MATERIAL	EXTENT OF DAMAGE
ROOF	Calicut tiles, half round tiles, timber frame	No damage
WALLS	Cabock, limestone	No damage
DOORS	Timber	No damage
WINDOWS	Timber, glass	No damage
FLOOR	Cement rendered	No damage
FOUNDATION	Rubble	No damage
SITE	Trees	No damage
OTHER		Parapet wall of the Nayaka statue is damaged.

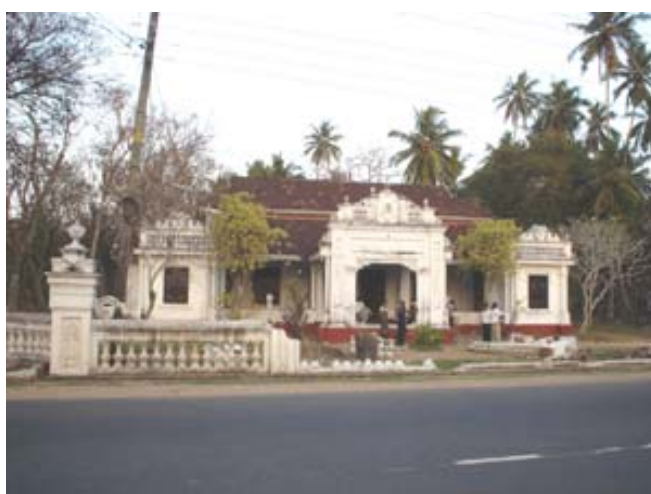
ELEMENT	MATERIAL	EXTENT OF DAMAGE
ROOF	Calicut tiles, timber frame	No damage
WALLS	Bricks, Rubble	No damage
DOORS	Decorated timber	No damage
WINDOWS	Decorated timber	No damage
FLOOR	Cement rendered	No damage
FOUNDATION	Rubble	No damage
SITE	Trees	Washed away
OTHER		Parapet wall is damaged.

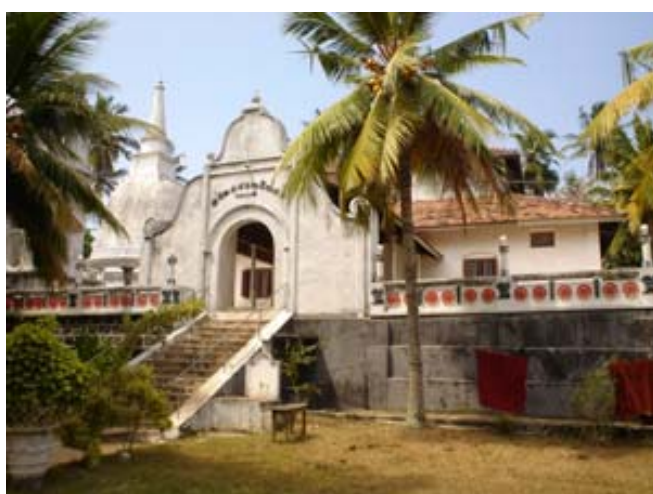
ELEMENT	MATERIAL	EXTENT OF DAMAGE
ROOF	Half round tiles, timber frame	No damage
WALLS	Bricks	No damage
DOORS	Timber	No damage
WINDOWS	Timber	No damage
FLOOR	Cement rendered	No damage
FOUNDATION	Rubble	No damage
SITE	Trees	No damage
OTHER		Parapet wall is completely destroyed.

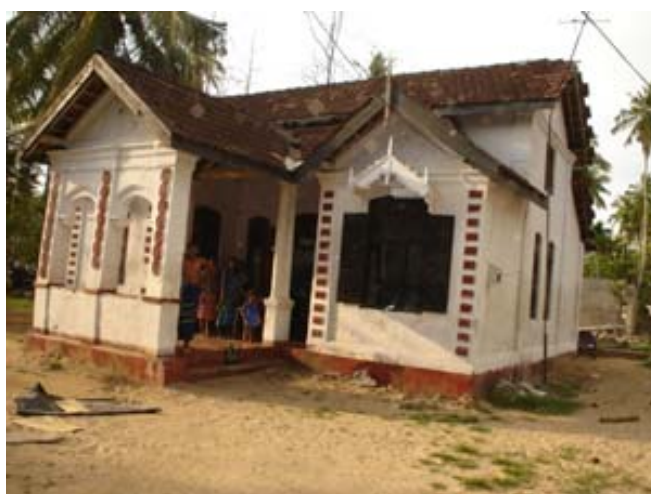
ELEMENT	MATERIAL	EXTENT OF DAMAGE
ROOF	Calicut tiles, timber frame	No damage
WALLS	Cabock, rubble	Cracked
DOORS	Timber	Damaged
WINDOWS	Timber	No damage
FLOOR	Cement rendered	No damage
FOUNDATION	Rubble	No damage
SITE	Sand	No damage
OTHER		New kitchen is completely destroyed.

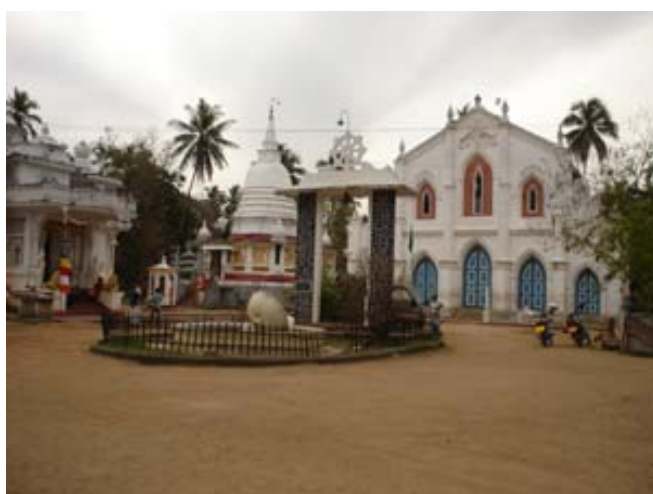
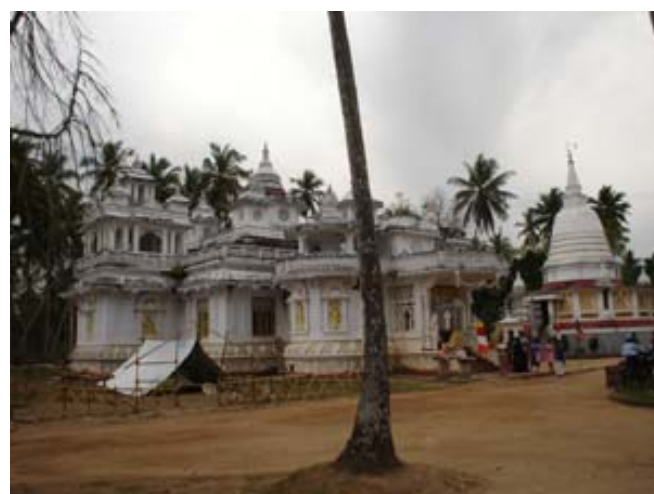
ELEMENT	MATERIAL	EXTENT OF DAMAGE
ROOF	Calicut tiles, timber frame	No damage
WALLS	Corel stone	No damage
DOORS	Timber	Damaged
WINDOWS	Timber	No damage
FLOOR	Cement rendered	No damage
FOUNDATION	Rubble	No damage
SITE	Coconut cultivation	No damage
OTHER		Parapet wall is completely destroyed.

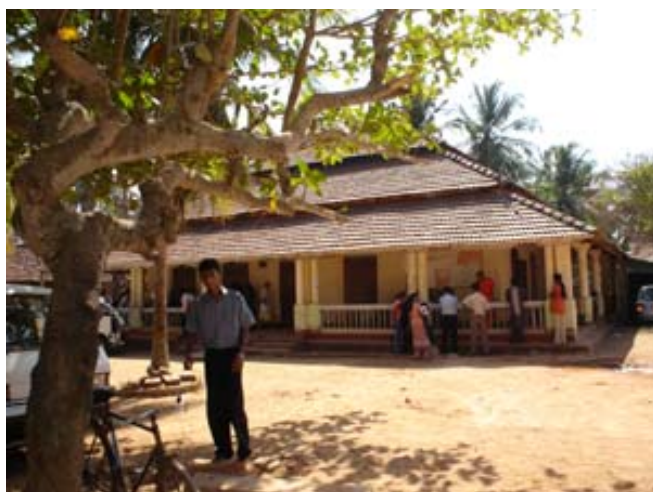
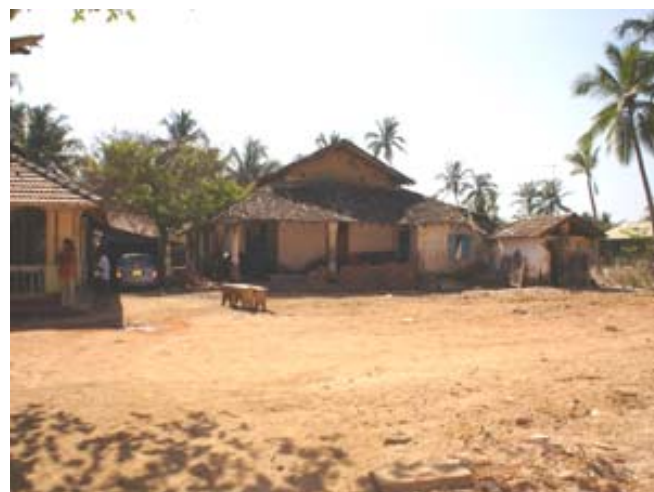
ELEMENT	MATERIAL	EXTENT OF DAMAGE
ROOF	Half round tiles, calicut tiles, timber frame	Some buildings are completely destroyed. Some are damaged.
WALLS	Cabock	Some buildings are completely destroyed. Some are damaged.
DOORS	Timber	Some buildings are completely destroyed. Some are damaged.
WINDOWS	Timber	Some buildings are completely destroyed.
FLOOR	Cement rendered	Some buildings are completely destroyed.
FOUNDATION	Cabock	Some buildings are completely destroyed.
SITE	Coconut cultivation	Washed away.
OTHER		Parapet wall is completely destroyed.

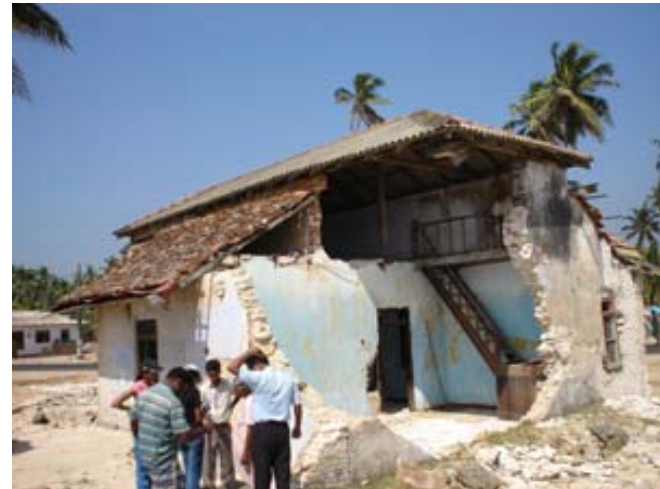
ELEMENT	MATERIAL	EXTENT OF DAMAGE
ROOF	Calicut tiles, asbestos, timber frame	Rear is completely destroyed.
WALLS	Rubble, bricks lime mortar	Rear is completely destroyed.
DOORS	Decorated timber	Completely destroyed
WINDOWS	Decorated timber	Completely destroyed
FLOOR	Cement rendered	Completely destroyed
FOUNDATION	Rubble	Damaged
SITE		
OTHER

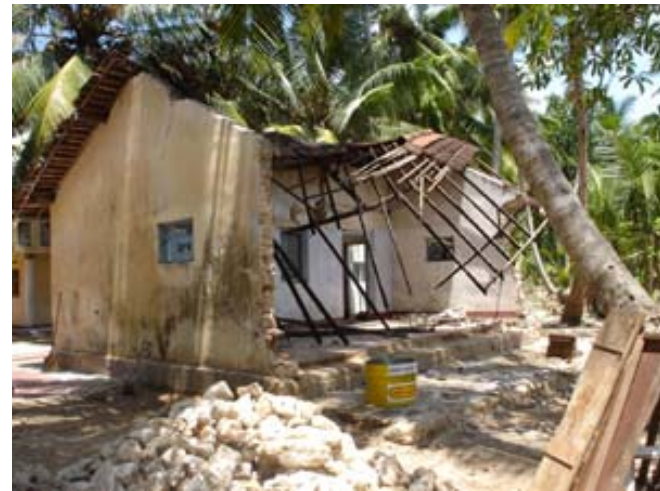
ELEMENT	MATERIAL	EXTENT OF DAMAGE
ROOF	Calicut tiles, timber frame	<i>Dharmasalava</i> and <i>danasalava</i> are completely destroyed.
WALLS	Bricks	<i>Dharmasalava</i> and <i>danasalava</i> are completely destroyed. Walls in the other buildings are cracked. The <i>Stupa prakara</i> is completely destroyed.
DOORS	Timber	Completely destroyed and some are damaged.
WINDOWS	Timber	Completely destroyed and some are damaged.
FLOOR	Cement rendered	Completely destroyed. The floor of the <i>stupa maluwa</i> is washed away.
FOUNDATION	Rubble	Damaged
SITE	Coconut cultivation	Washed away
OTHER		Parapet wall is destroyed.

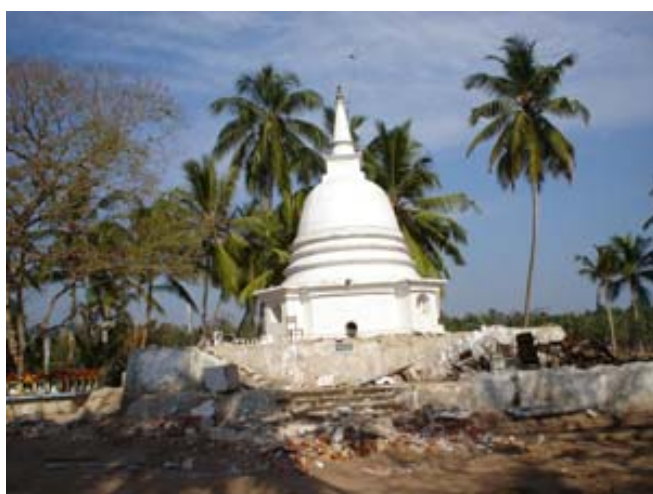
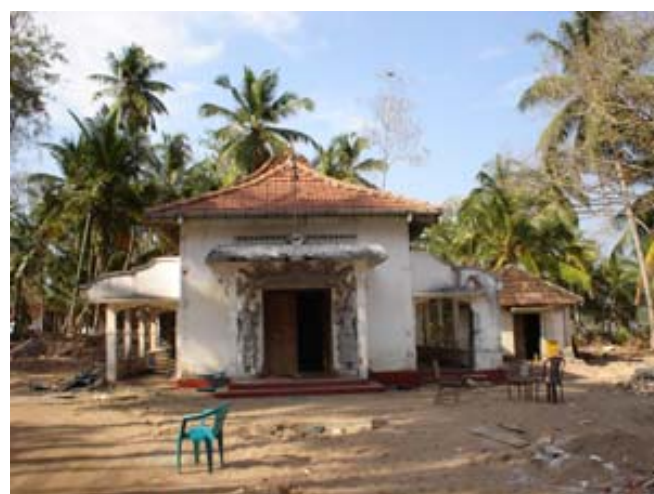
ELEMENT	MATERIAL	EXTENT OF DAMAGE
ROOF	Calicut tiles Timber frame	Refectory and preaching hall are completely destroyed.
WALLS	Corel Stones	Refectory, preaching hall, <i>pilimage</i> and <i>prakara</i> of the <i>stupa</i> are completely destroyed. Walls in the other buildings are cracked.
DOORS	Timber	Completely destroyed and some are damaged.
WINDOWS	Timber	Completely destroyed and some are damaged.
FLOOR	Cement rendered	Completely destroyed. Floor of the <i>stupa maluwa</i> is washed away.
FOUNDATION	Rubble	Damaged
SITE	Coconut cultivation	Washed away
OTHER		Parapet wall is destroyed.

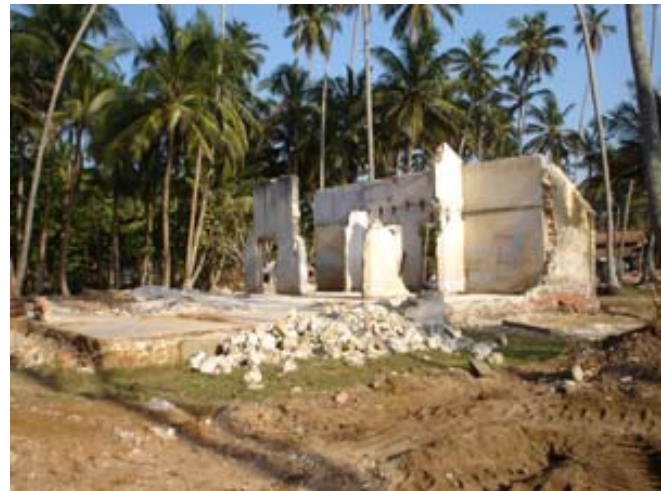
ELEMENT	MATERIAL	EXTENT OF DAMAGE
ROOF		Completely destroyed
WALLS	Corel stones	Completely destroyed
DOORS		Completely destroyed
WINDOWS		Completely destroyed
FLOOR	Cement rendered	Completely destroyed
FOUNDATION	Rubble	Completely destroyed
SITE	Coconut cultivation	Washed away
OTHER		Parapet wall is destroyed.

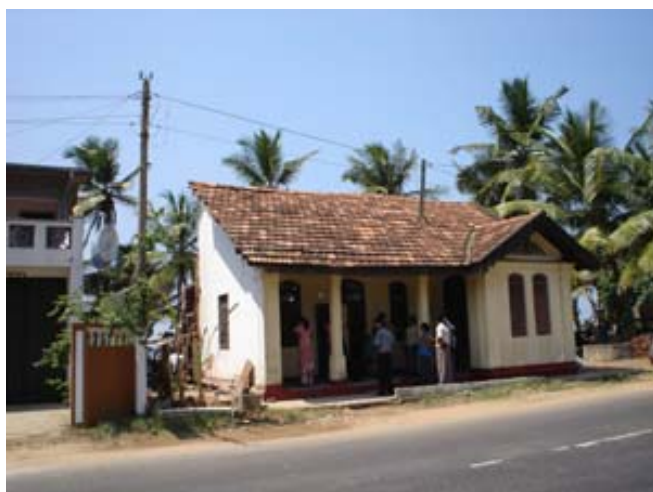
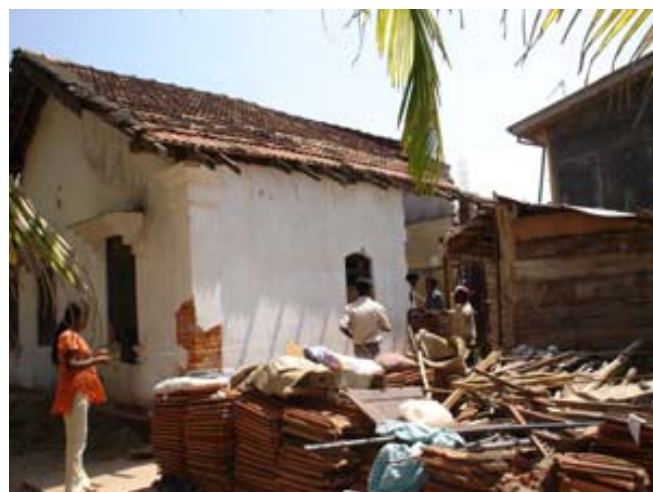
ELEMENT	MATERIAL	EXTENT OF DAMAGE
ROOF	Calicut tiles, timber frame	Except in two rooms the rest is completely destroyed.
WALLS	Bricks	Except in two rooms the rest is completely destroyed.
DOORS	Timber	Except in two rooms the rest is completely destroyed.
WINDOWS	Timber	Except in two rooms the rest is completely destroyed.
FLOOR	Cement rendered, timber deck	Except in two rooms the rest is completely destroyed.
FOUNDATION	Rubble	Except in two rooms the rest is completely destroyed.
SITE	Coconut cultivation	Washed away
OTHER

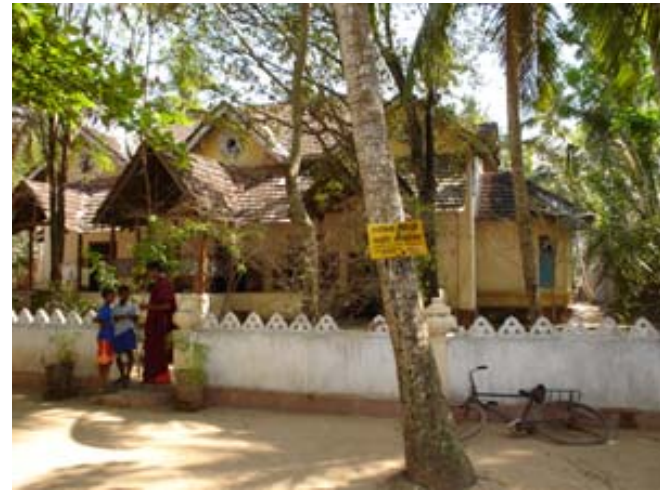
ELEMENT	MATERIAL	EXTENT OF DAMAGE
ROOF	Calicut tiles, timber frame	No damage
WALLS	Rubble, lime mortar	Cracked
DOORS	Timber	No damage
WINDOWS	Timber	No damage
FLOOR	Tiled	No damage
FOUNDATION	Rubble	No damage
SITE	Coconut cultivation	No damage
OTHER		The painted timber ceiling panels were washed away.

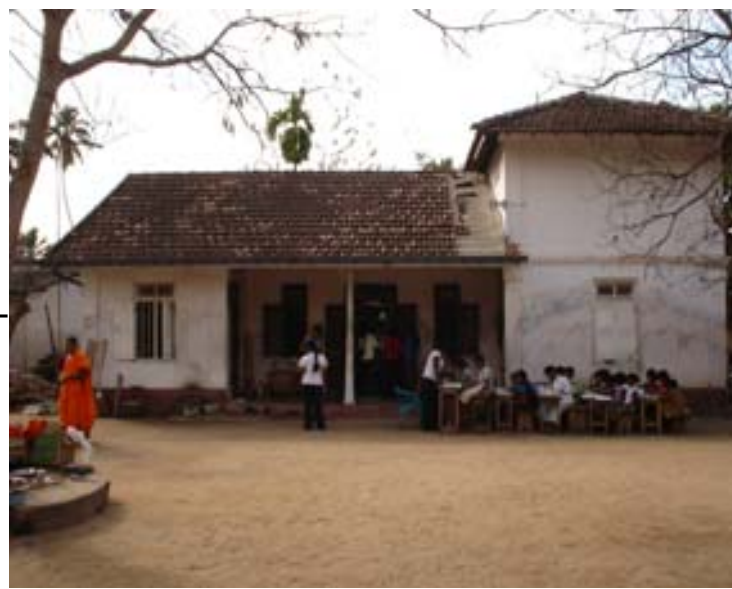
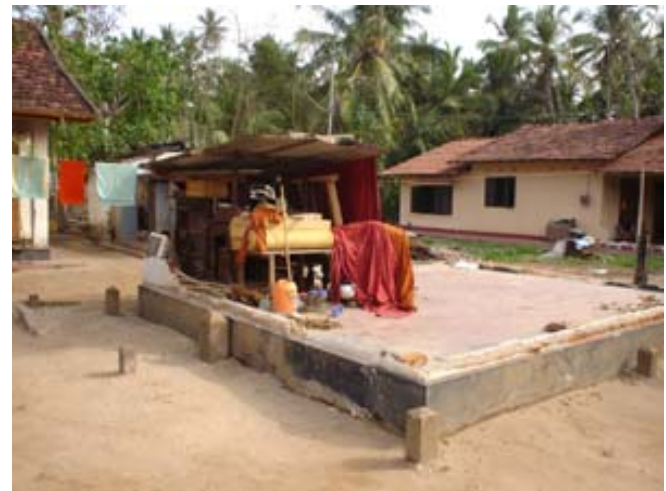
ELEMENT	MATERIAL	EXTENT OF DAMAGE
ROOF	Calicut tiles, timber frame	<i>Poyage</i> , refectory and <i>deva mandiraya</i> are completely destroyed.
WALLS	Corel stone, bricks	<i>Poyage</i> , Refectory and <i>deva mandiraya</i> are completely destroyed.
DOORS	Timber	<i>Poyage</i> , Refectory and <i>deva mandiraya</i> are completely destroyed.
WINDOWS	Timber	<i>Poyage</i> , Refectory and <i>deva mandiraya</i> are completely destroyed.
FLOOR	Cement rendered	Destroyed.
FOUNDATION	Corel stone, rubble	Damaged.
SITE	Coconut cultivation	Washed away.
OTHER

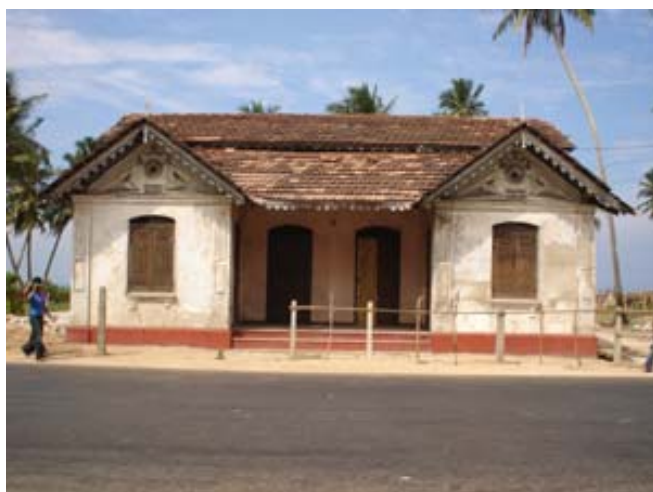
ELEMENT	MATERIAL	EXTENT OF DAMAGE
ROOF	Calicut tiles, timber frame	Partly damaged.
WALLS	Corel stone	Walls in the back have been completely destroyed.
DOORS	Timber	Damaged
WINDOWS	Timber	Damaged
FLOOR	Cement rendered	Damaged
FOUNDATION	Corel stone, rubble	No damage
SITE	Coconut cultivation	No damage
OTHER

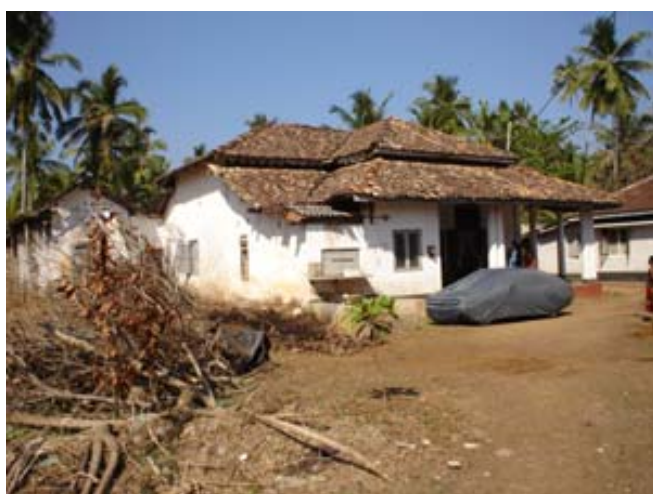
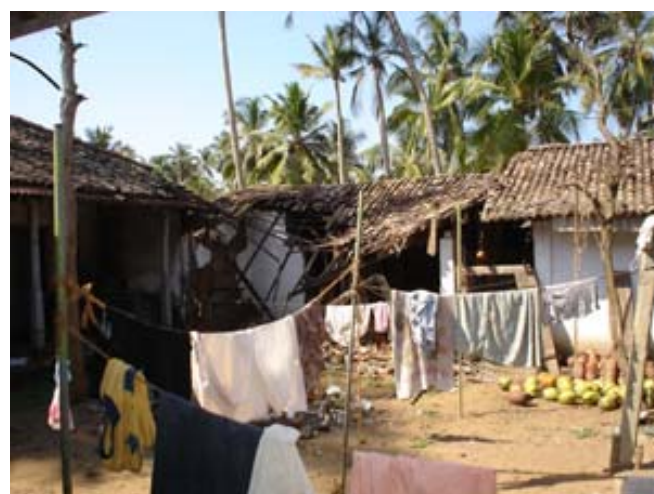
ELEMENT	MATERIAL	EXTENT OF DAMAGE
ROOF	Half round tiles, timber frame	Rear room has been damaged.
WALLS	Rubble, lime mortar	No damage
DOORS	Timber, glass	No damage
WINDOWS	Timber, glass	No damage
FLOOR	Cement rendered	No damage
FOUNDATION	Rubble	No damage
SITE	Coconut cultivation	No damage
OTHER

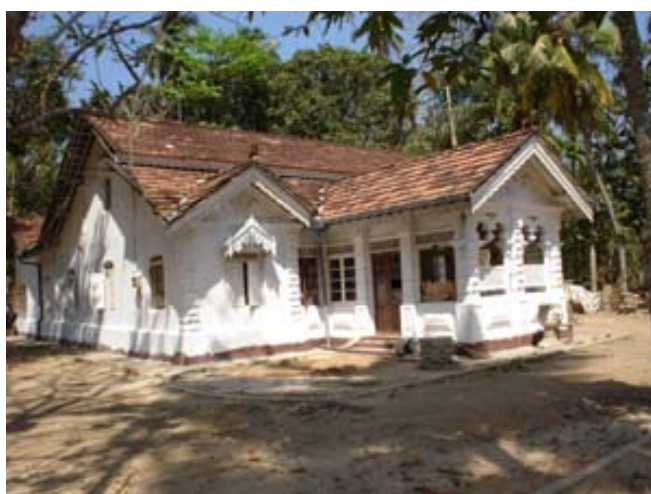
ELEMENT	MATERIAL	EXTENT OF DAMAGE
ROOF	Calicut tiles, timber frame	No damage
WALLS	Bricks	Cracked
DOORS	Timber, glass	No damage
WINDOWS	Timber, glass	No damage
FLOOR	Terracotta	No damage
FOUNDATION	Rubble	No damage
SITE	Trees, coconut cultivation	No damage
OTHER		Timber staircase is damaged. Parapet wall is damaged.

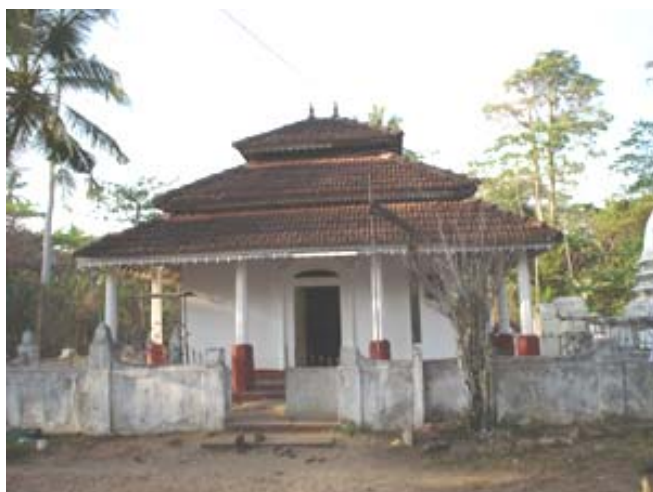
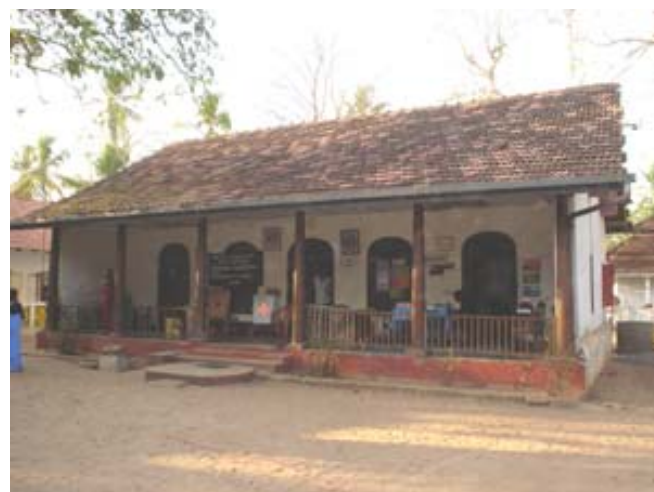
ELEMENT	MATERIAL	EXTENT OF DAMAGE
ROOF	Half round tiles, timber frame	Not affected.
WALLS	Corel stone	Cracked. <i>Prakara bemma</i> has been damaged.
DOORS	Timber	Damaged
WINDOWS	Timber	Not affected.
FLOOR	Cement rendered	Not affected.
FOUNDATION	Corel stone, rubble	Not affected.
SITE	Coconut cultivation	Not affected.
OTHER		Parapet wall has been destroyed. All the toilets and wells are destroyed. The <i>stupa</i> is badly cracked.

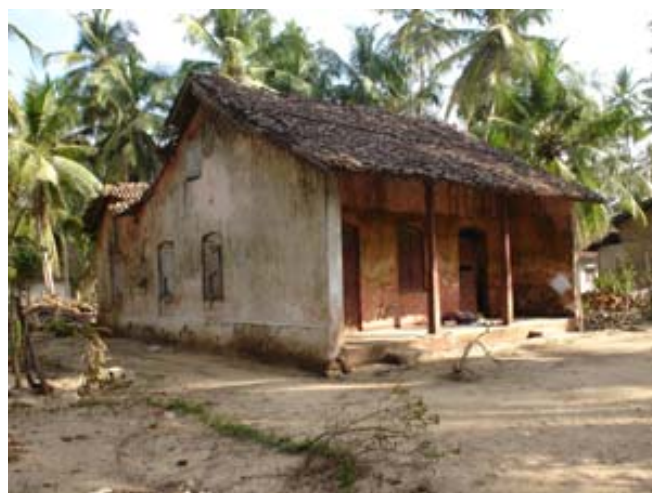
ELEMENT	MATERIAL	EXTENT OF DAMAGE
ROOF	Half round tiles, timber frame	Partly damaged.
WALLS	Corel stone	Plaster is damaged.
DOORS	Timber	Damaged
WINDOWS	Timber	Damaged
FLOOR	Cement rendered	Not affected.
FOUNDATION	Corel stone, rubble	Not affected.
SITE	Coconut cultivation	Washed away
OTHER

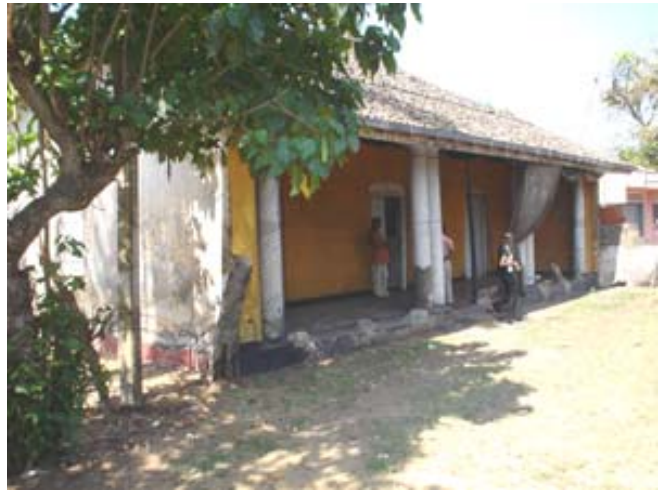
ELEMENT	MATERIAL	EXTENT OF DAMAGE
ROOF	Half round tiles, timber frame	No damage
WALLS	Corel stone, lime mortar	Rear walls are damaged.
DOORS	Timber	No damage
WINDOWS	Timber	No damage
FLOOR	Cement rendered	No damage
FOUNDATION	Rubble	No damage
SITE	Coconut cultivation	No damage
OTHER		Parapet wall is destroyed.

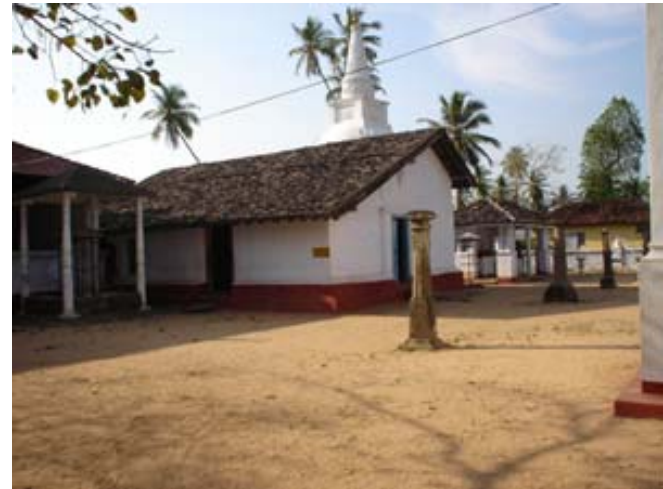
ELEMENT	MATERIAL	EXTENT OF DAMAGE
ROOF	Half round tiles, Calicut tiles, timber frame	No damage
WALLS	Corel stones	No damage
DOORS	Timber	No damage
WINDOWS	Timber	No damage
FLOOR	Cement rendered	No damage
FOUNDATION	Rubble	No damage
SITE	Coconut cultivation	No damage
OTHER		Parapet wall is destroyed.
