## MID 19TH CENTURY COMMERCIAL BUILDING BY JAMES BOGARDUS

### PART ONE: BRICK AND TIMBER CONSTRUCTION

## PART TWO : CAST IRON CONSTRUCTION

### PART THREE : INTEGRATION

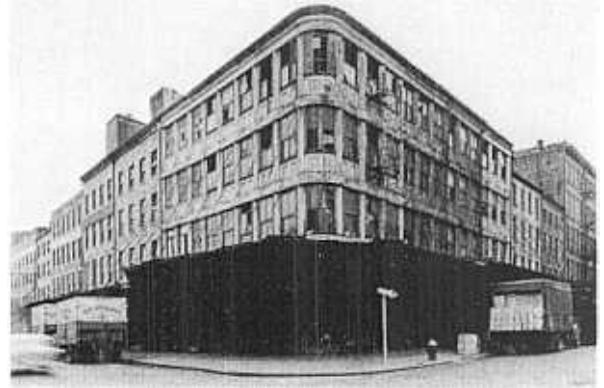
Fig. 5 a-b. — H.A.B.S. View with shed & flanking stores. (Photo: Country H.A.B.S.)

ray Street and two other brick-fronted stores at 264 and 266 Washington Street using the corner site as a coal yard (fig. 5). Thus, when it was decided to build on this corner lot, the architect was limited in his opportunities.

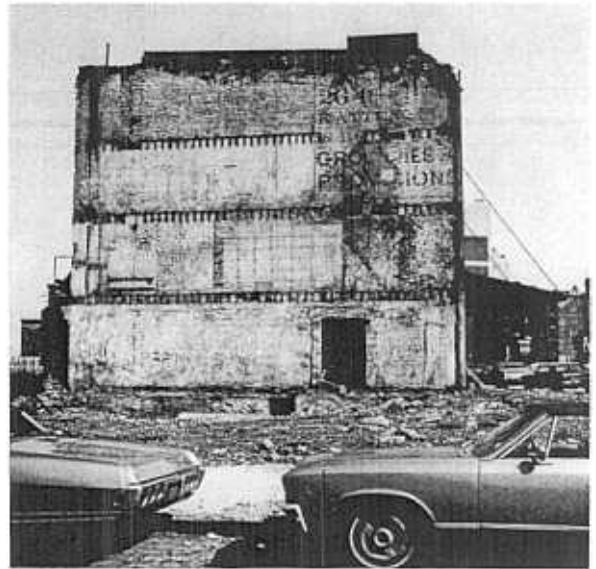
Fig. 6. — Encroachment View at 264. (Photo: Author.)

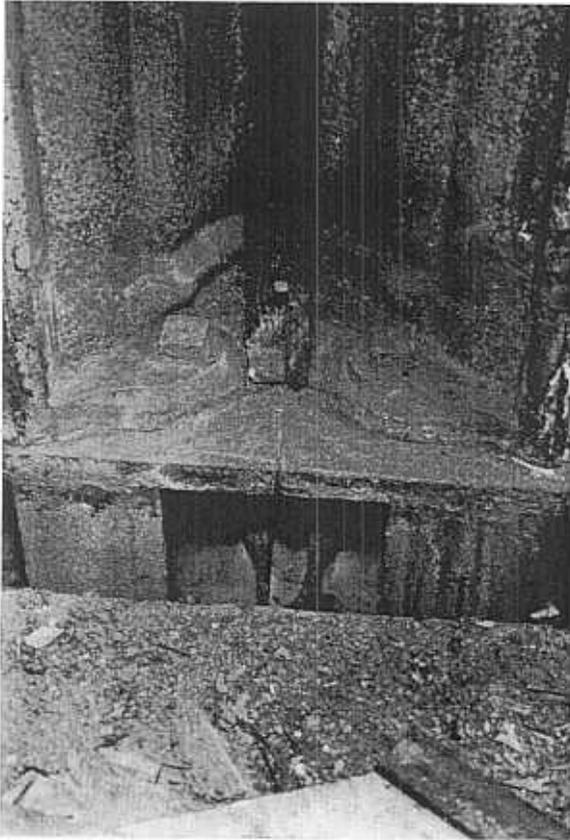
Fig. 11. — Photo of column base and bolted beams. (Photo: Courtesy H.A.B.S.)

The columns were so designed as to straddle two adjoining beams to which they could be attached by two bolts passing vertically through both parts and fixed with a nut (fig. 11). The beams in turn which were machine planed so as to make certain that the columns rested evenly also contained openings laterally so that a bolt passing through from one to the next would fasten the beams together (fig. 12). A second column would then be placed at the same level at the juncture of the beam already in use and the adjoining one. This was secured in the same manner described above. Between the columns was set a 36-inch-long spandrel panel which was supported by the use of two rivets an inch and a quarter long on each side driven into the columns about a third of the way from top and bottom of the panel. This procedure was then repeated at the next higher level to create a bay system which could be extended vertically and laterally until the building was topped off by the cornice. Thus by a simple and logical system consisting of a few different

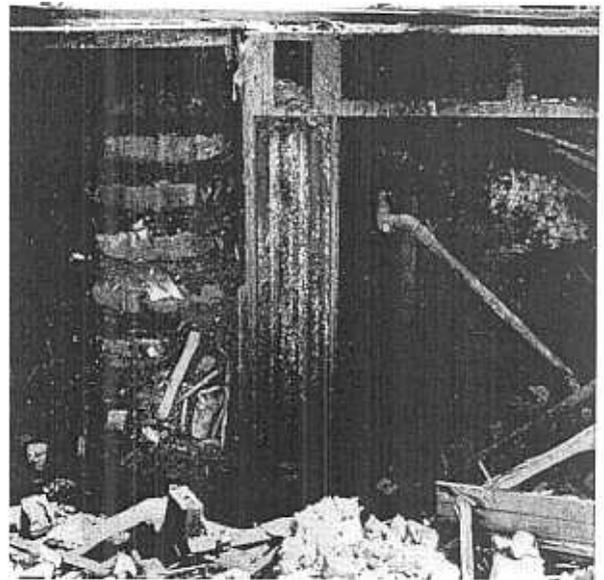
Fig. 13. — Photo of Basement level with granite stairs and column resting on granite pad. (Photo: Author.)

structural base (fig. 13, 14). It was discovered that columns like those used above were also employed below. These were shorter in height being about five feet six inches and three-quarters of an inch in thickness as compared to the 12 foot columns employed at the ground level (see fig. 3). These basement columns rested on a granite slab or pad which in turn rested on a layer of brick pavers. These sturdy columns carried beams similar to those already described.

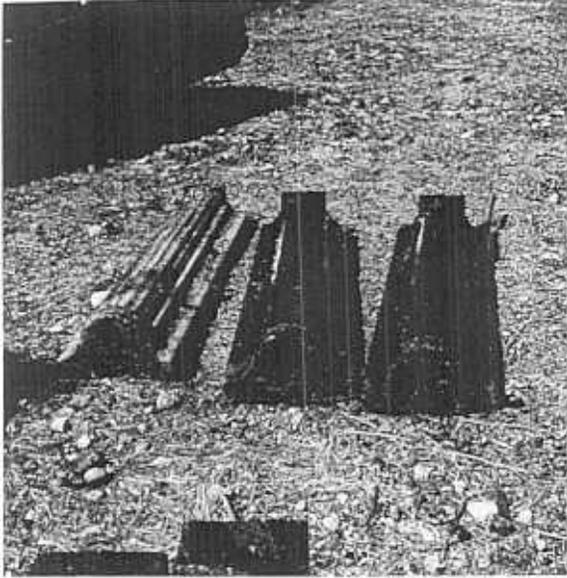
Fig. 15. — Basement columns. (Photo: Author.)

Perhaps even more interesting was the discovery that in no way were the iron columns attached to the granite pads or blocks. The columns were neither bolted, clamped nor cemented. Those columns which were in good enough condition to be recovered were simply lifted off their pads by a "cat" after the debris had been cleared and the facts established (fig. 15).

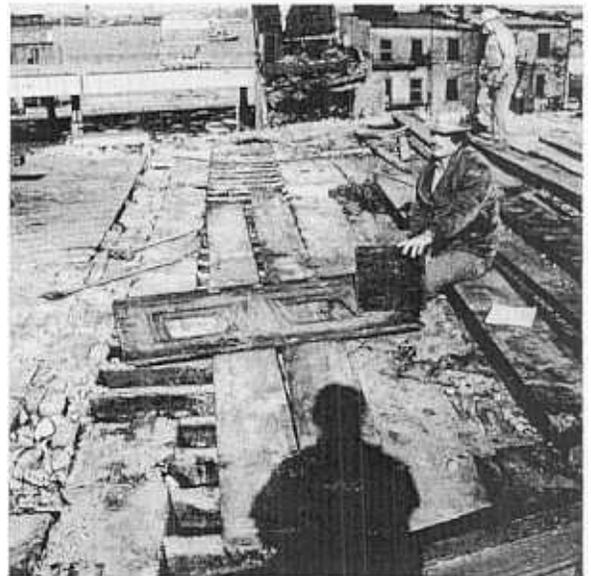
Fig. 18. — Composition of spandrel panel plates. (Photo: Author.)

The dismantling operation also shed much light on another aspect of cast iron construction mentioned by *The Evening Post* when it reported on the ornamental opportunities possible. An examination of one of the spandrel panels indicated that the two recessed squares

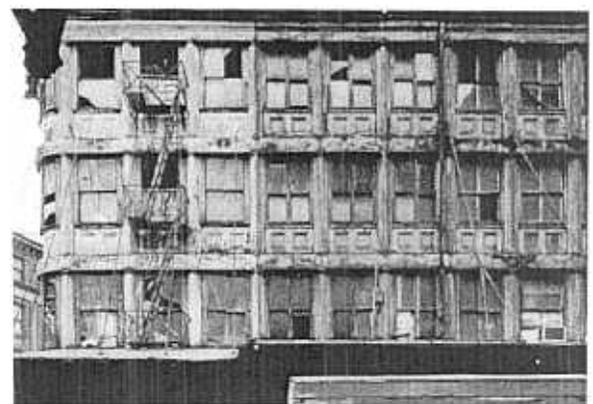
Fig. 21. — Beam ornaments at 2nd & 3rd tiers. (Photo: Country H.A.B.S.)

The Ackerman view also displays another form of decoration which also occurs at the Laing Stores, although its presence was not noticed until a close study was made possible by the removal of the shed (fig. 21). The reference is to the ornaments covering the juncture of the iron beams at every storey excluding the cornice. These were not purely decorative as they help to prevent water from seeping into these joints and rusting the bolts. But close inspection will indicate that while the first three storeys carry somewhat identical ornaments they are not precisely the same. Those on the upper

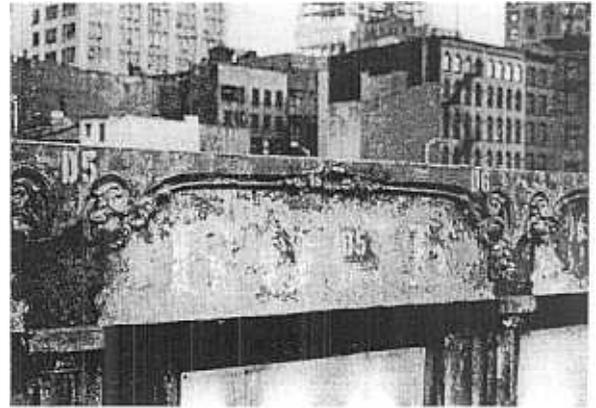
Fig. 23. — Beam ornament at 1st tier. (Photo : Author.)

two floors are shorter and separated whereas the ornaments on the lower storey are longer and continuous. Fortunately, a few pieces of both ornaments were salvaged during disassembly (fig. 22, 23). When compared they proved not only to be different in length but considerably different in style. The pieces atop the ground floor level were 72 inches long with a classical head at the beam juncture inspired by sculpture of the V century B.C. (fig. 24). The heads on the pieces above were chosen from a later Hellenistic period related to the Pergamon Altar (fig. 27). One is serene and untroubled with no show of emotion while the other has an agonized expression with deep set eyes and beetled brow. The entire piece is but 52 inches. In this instance the arrangement of the decor changes. In the Laing Store the second floor beams carried the longer members and the beams above, excepting the cornice, were covered with the shorter (fig. 26). So that with the limited vocabulary in panel and on beam it was possible to introduce a combination which in its day suggested to the beholder a variety despite the presence of a family resemblance.

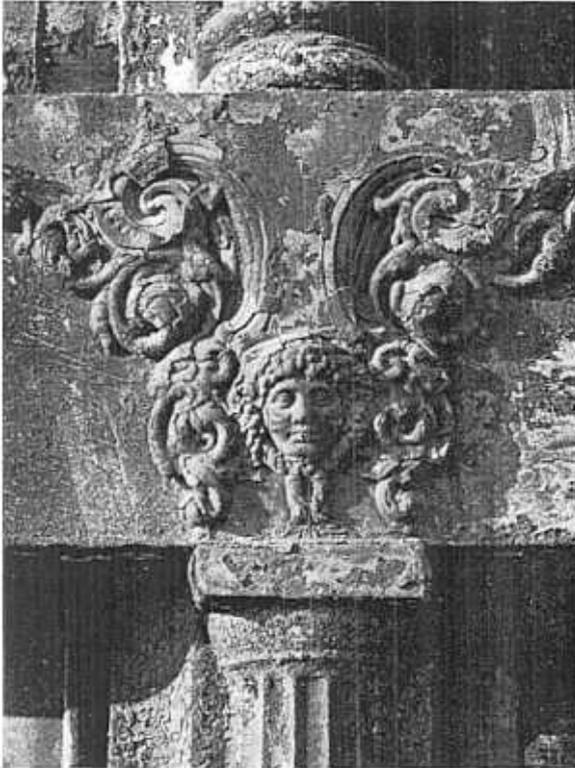
Fig. 24. — Head on ornament atop ground floor level. (Photo Cervin Robinson.)

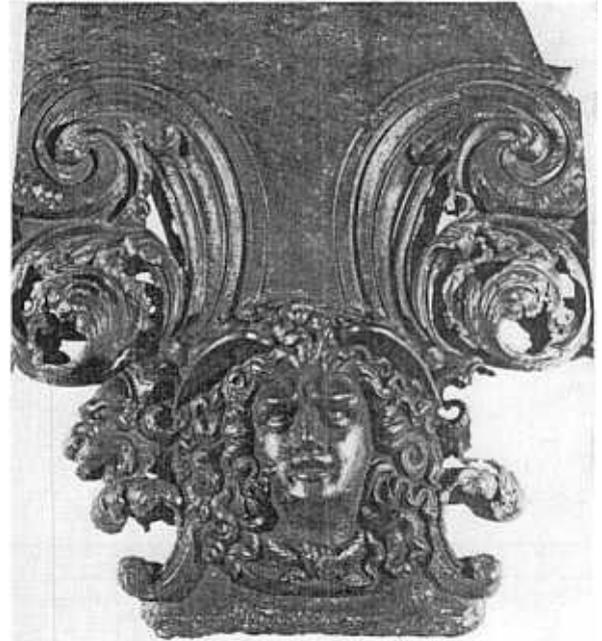
Fig. 25. — Head on ornament at 2nd & 3rd floor levels. (Photo P.S.U. Photo Service.)

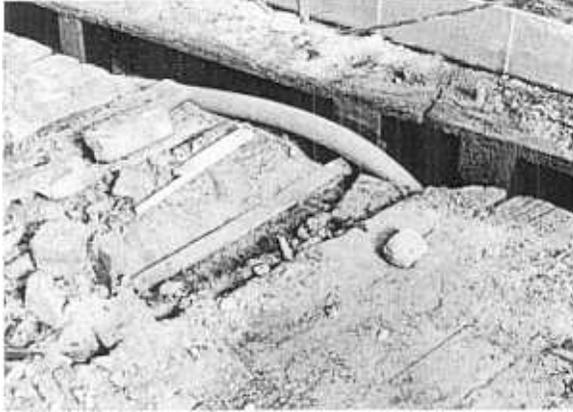
32

Fig. 32, 33, 34. — View of strap iron usage.  
(Photo 32: Author. Photo 33-34: John Grintza.)

is then twisted so that it lies flat on a brick party wall and is finally bent vertically to allow the brick and cement to cover it. As can be seen the iron front which faces Washington Street is quite separate from the flooring so that the only element holding the facade to the interior at this point is the strap iron.
