## "As much as necessary, as little as possible"

### Notes on the Protection and Restoration of Medieval and Renaissance Stained Glass\*

*Ulf Dietrich Korn*

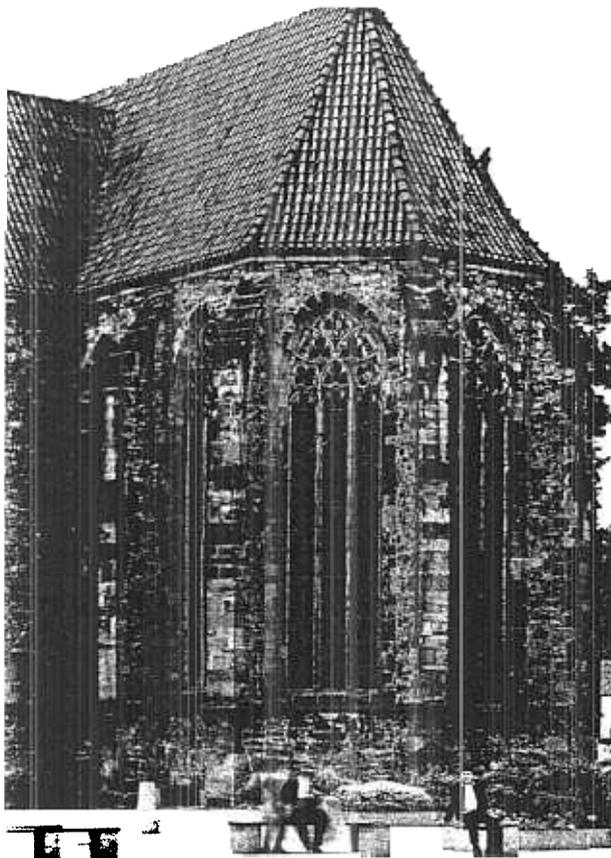
**Fig. 1**

*Herford, Neustadter Johanniskirche. Chancel window with isothermal protective glazing, 1969. The diamond pattern takes into account the delicate exterior of the chancel but covers the splendid external line-effect of the leading in the medieval panels.*

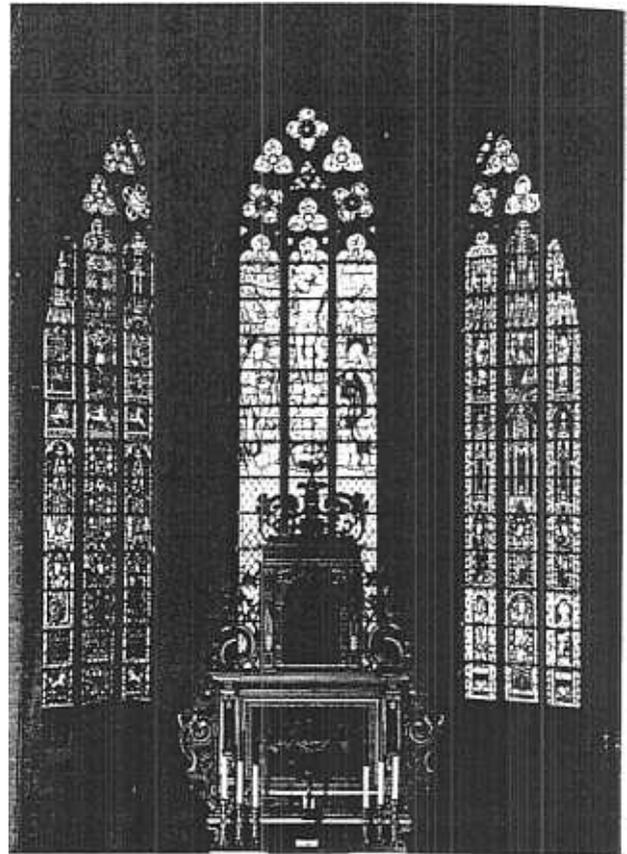
**Fig. 2**

*Herford Neustadter Johanniskirche. The side windows of the chancel, from the 3rd quarter of the 14th century, conceal the totally varied distribution of protective glazing. The diamonds can hardly be seen even in the early 16th century bright middle window.*

There is another disadvantage of isothermal protective glazing which must not be concealed: the inward displacement, by some centimeters, of the original panels necessarily reduces the impression of the mullions and of the wall depth. Normally, in the dim light inside churches, the mullion and tracery-work appears dark beside the much brighter glass paintings, if not actually black (Figs 2, 4). So this is a minor nuisance which can be tolerated.

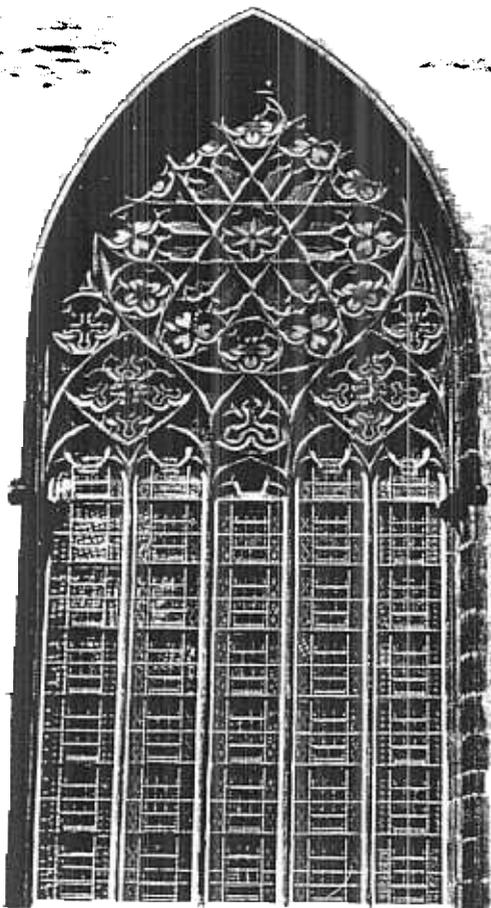
**Fig. 3**

*Lemogo, St. Nikolai. Heraldic window of 1670, in south-chancel. The danger of ball-throwing necessitated the use of laminated safety glass. The large-mush rectangular pattern repeats the main of the heraldic panels and does not disrupt the delicate tracery of this magnificent window.*

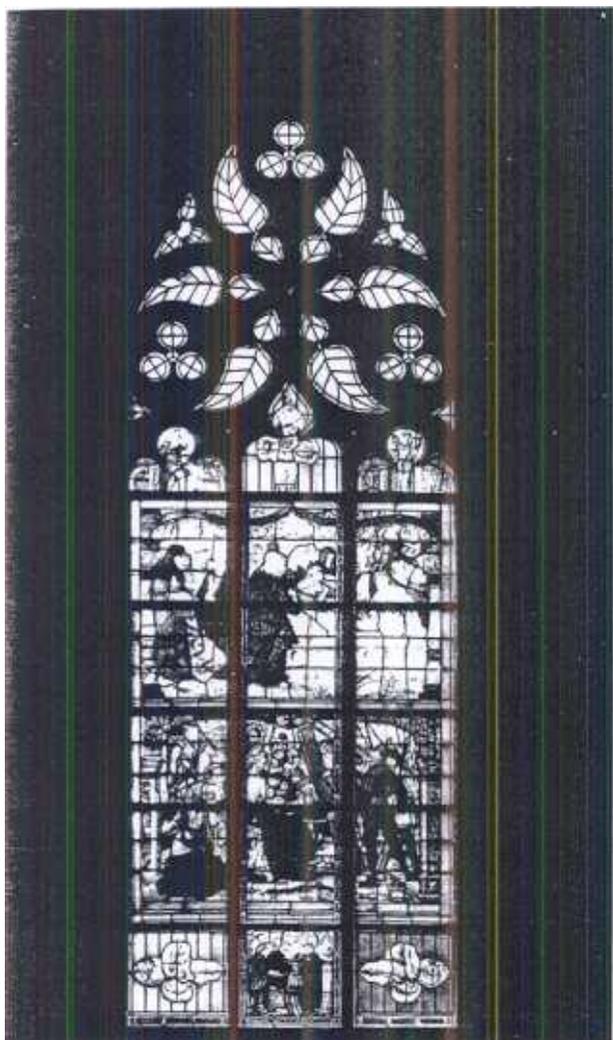
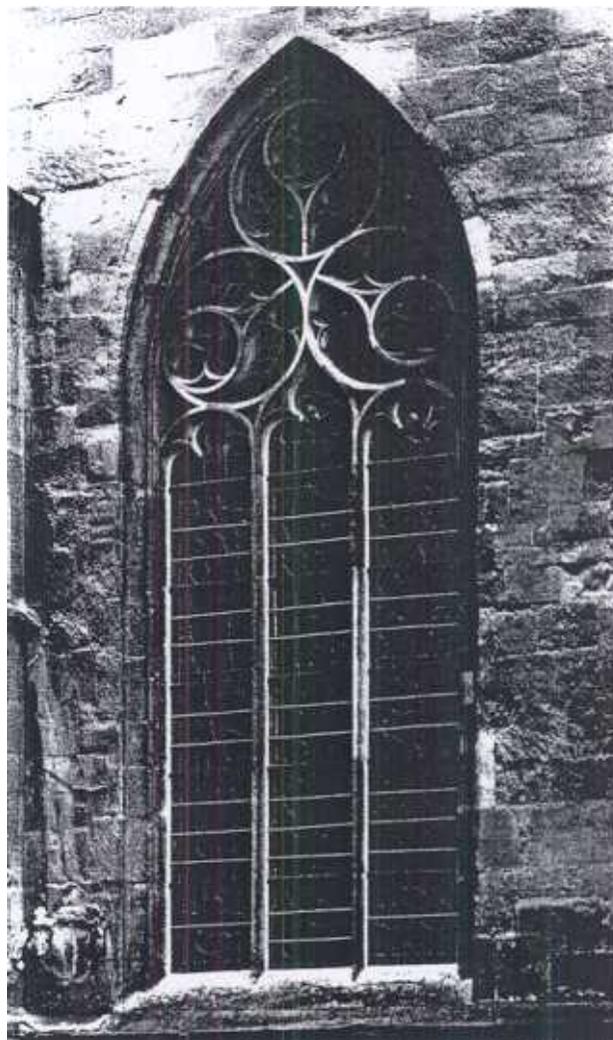
Fig. 4 - 5

*Muster, Cathedral, north window XV, The Marienfeld window of about 1550, after protective work and restoration, ready installed with isothermal protective glazing.*

*The outside shows the simplified leading outline. The lead webs of the original and the protective glazing can only be seen separately from a side view.*

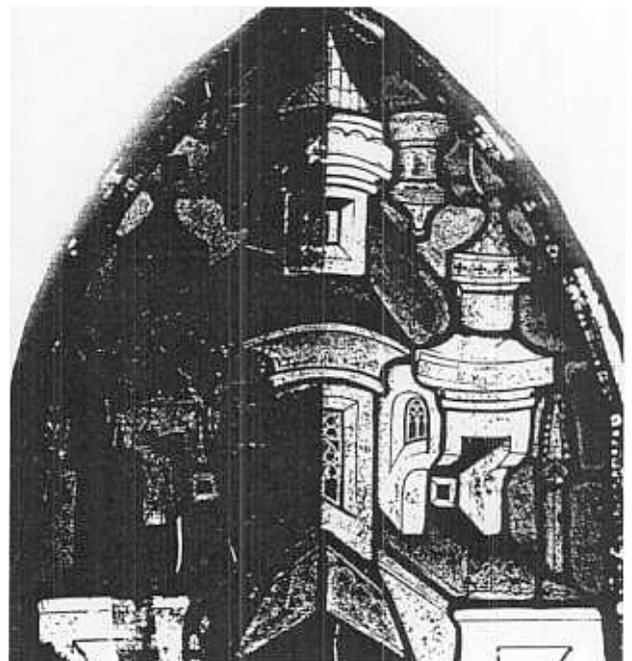
Fig. 7

*Ebstorf, nunnery chancel window N II, 9c (about 1930). The window was last cleaned and repaired in 1852. In 130 years, it has become obscured, to the point of opaqueness, by the deposits of dirt, algae and outside corrosion. The removal of the weathering crusts considerable brightening; cleaning of the inside exposes the almost intact painting.*

Preliminary cleaning at different spots, using fine brushes or - for thick layers of dirt-water and a soft sponge, will reveal the condition of the glass and the paint (Fig. 7). It often happens that the layer of dirt can be removed relatively easily and that there is sound and undamaged black enamel underneath. Occasionally, old records will show that the same extent of damaged black enamel was present centuries ago. However, the inside of the window should always be cleaned with the greatest care and caution.

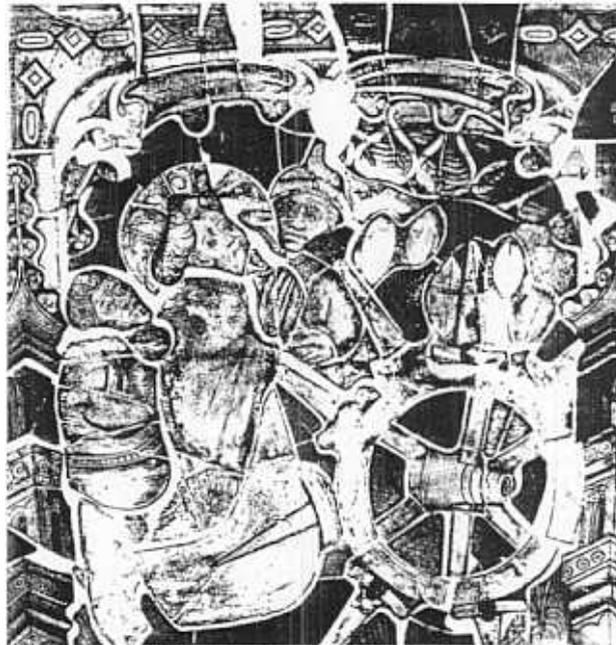
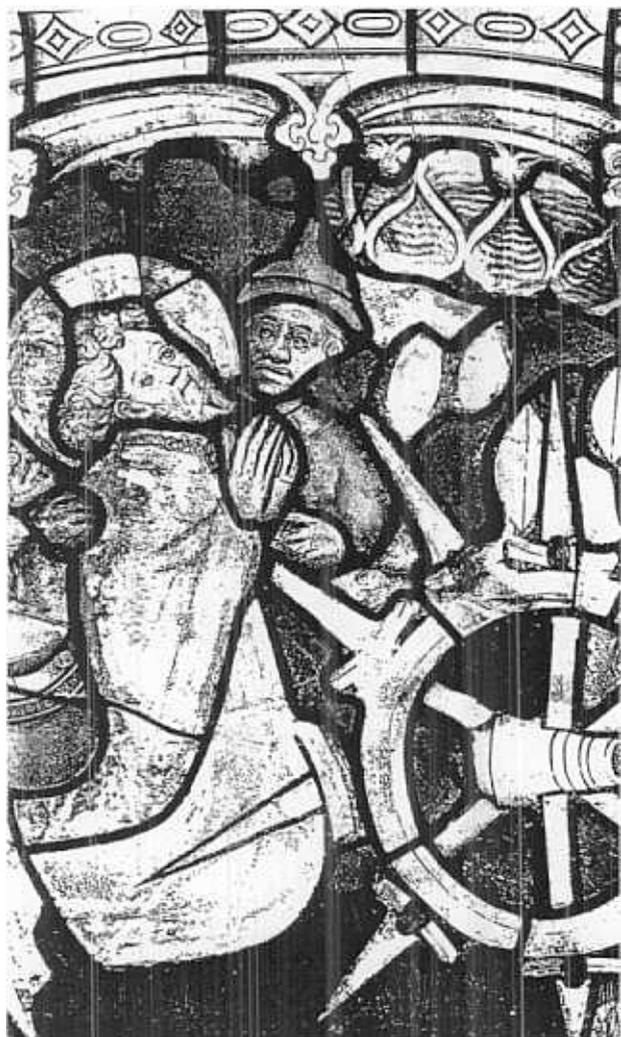
*Figs. 8-10*

*Hannover, Marktliche, window 1,5c (about 1400). The condition before restoration appears almost hopeless: rough patching and thick mending leads have created a ruin out of a work of art. The same panel after dismantling of the leading: innumerable fragments and bits of glass which can hardly be recognized as parts of a coherent picture. -The restored panel does reveal the marks of its in the eroded surfaces and fading outlines, but nevertheless, the picture is still clear; St George is to be tortured on the wheel, but the judgement wheel, which is stuck with swords, is destroyed by stones which fall from the clouds.*

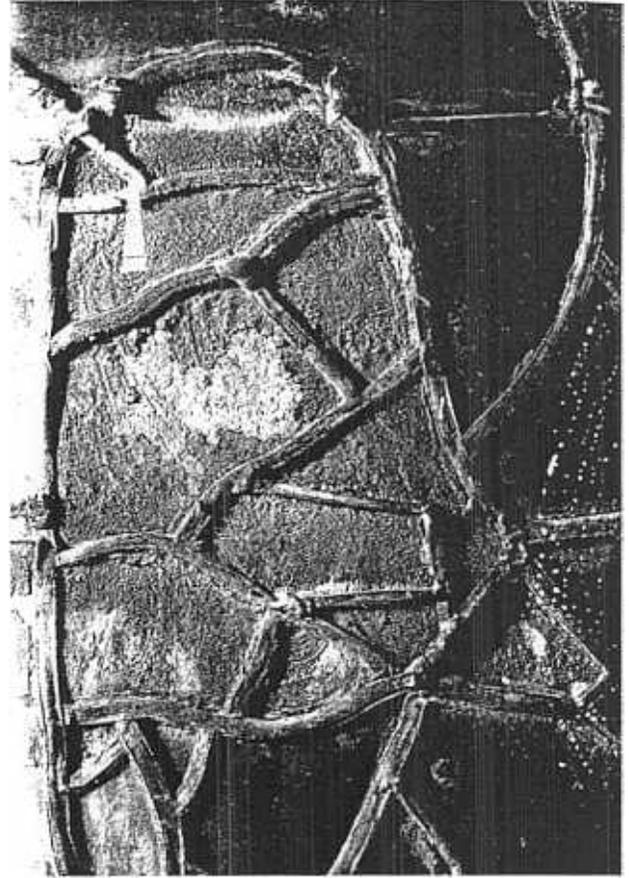
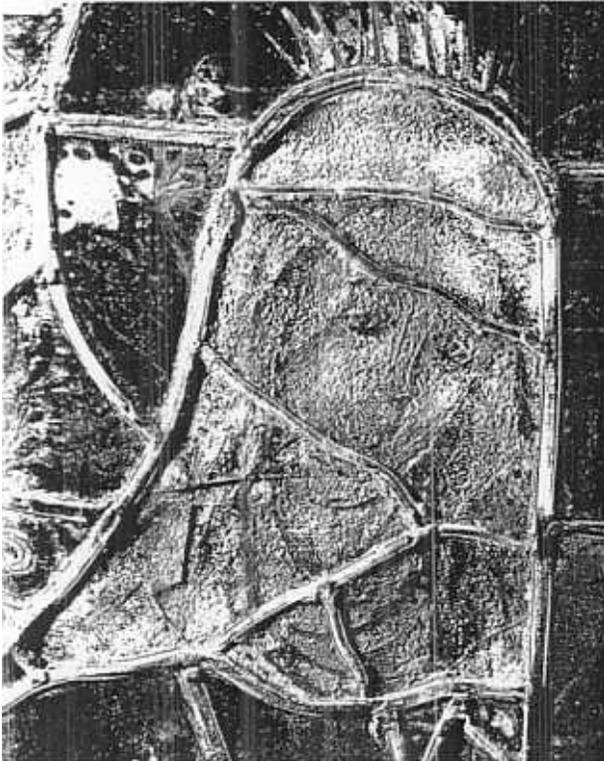
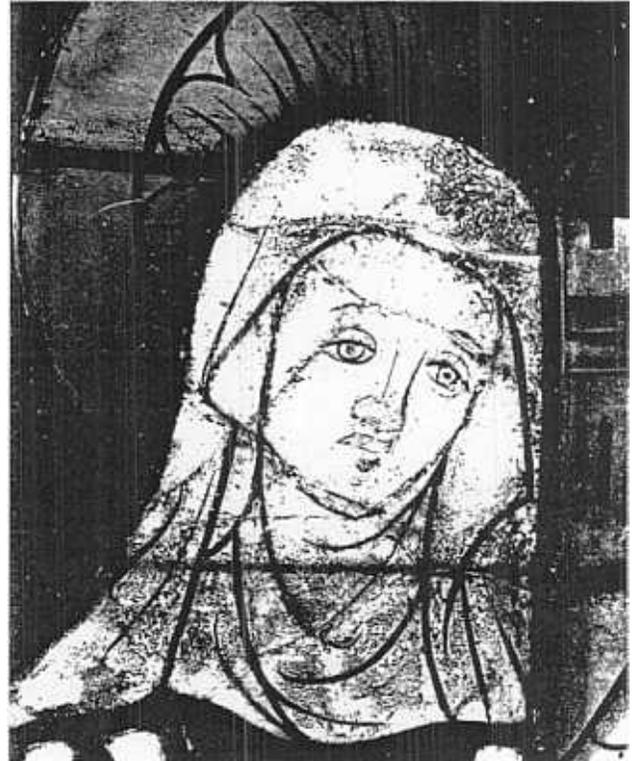
*Figs. 11-14*

*Hannover, Marktkirche, south window II, 4a, section (about 1420). The view and illuminated picture of the front and rear, in the un-restored state, reveal the darkening caused by weathering encrustations and the scarred as well as the numerous leading repairs and cracks. All the*

*temporary leadings were removed, the brittle fragments were glued edge to edge and overlaid on the reverse side with a thin clear glass pane. The affected paint is protected, but not restored.*

One of the most serious defects in glass paintings is the large number of mending and temporary leads (Figs. 11-13). The lead work is part of the graphic composition so any lead strips added later will disrupt the pattern. On many old repairs, the edges of cracked panes have been grozed or have been roughly broken off; mending leads can often be remedied only with a great deal of sticking and "plating". Cutting of the flanges, which are unnecessarily wide in any case, helps to reduce the problem to manageable proportions without reducing the solidity. In the case of part

A documentary record of the various states of deterioration should of course be part and parcel of all restoration work. This has long since been customary practice in studios and workshops engaged in the restoration of paintings and sculptures. Written reports describing states of damage and the materials and techniques used in repairing same are indeed very useful but at the same time extremely laborious and time-consuming; moreover, it is in the majority of cases very difficult to find adequate words to describe with any exactitude the extent and phenomena of damage or deterioration. In such cases it is far more expedient to use a camera for the purpose of recording the actual condition of the part to be restored. In this way it is possible to achieve the desired degree of exactitude without having to resort to long-winded descriptions. It is at least necessary that photographs be taken of each individual panel, both immediately after its removal and after the completed preservation or restoration work, prior to its replacement. Such photographic records can, and should, be complemented by detailed photographs which clearly show not only the nature and extent of the damage on both sides of the panel and the methods used in its repair but also the artistic, stylistic or technical peculiarities of the glass painting itself (Figs. 11-14).

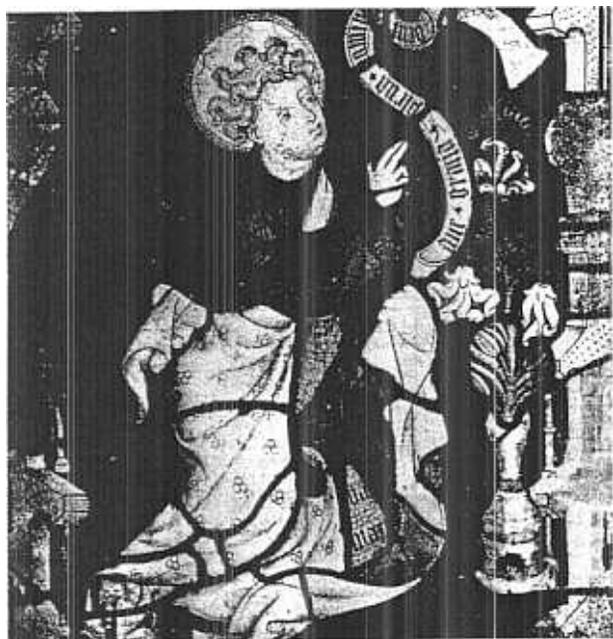
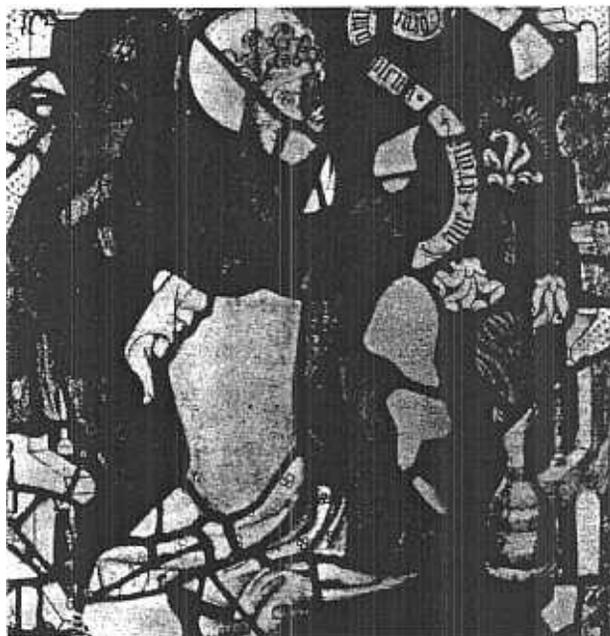
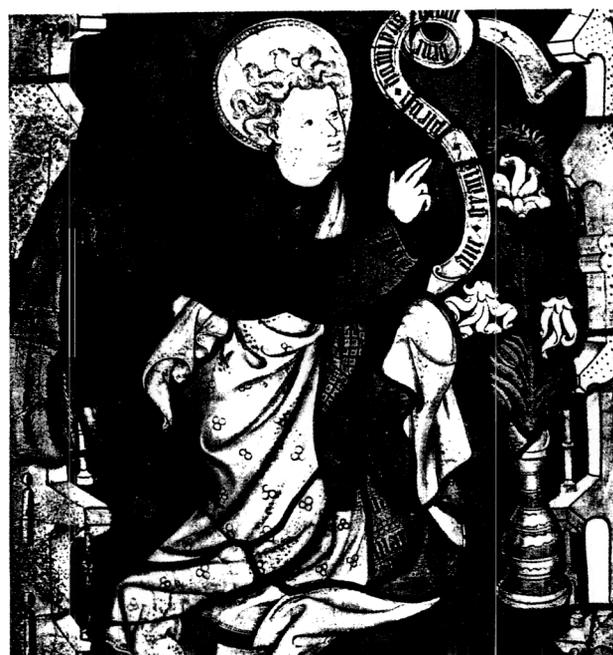
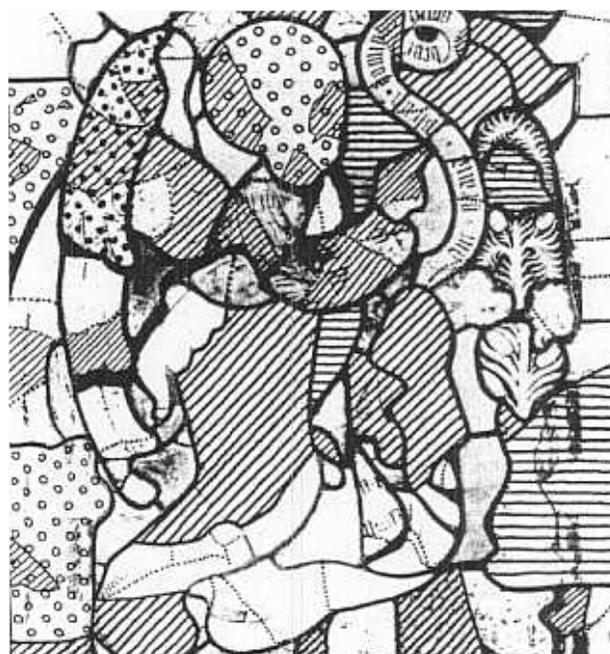
*Figs. 15-18*

*Uelzen, Chapel of the Holy Ghost, north window III, 2a (about 1412). In the salvage operation in 1942, the panel with the Angel of the Annunciation was in reasonably good condition. It was badly damaged in 1946 by stone-throwing, after which it had to be patched. With the aid of a good photograph of its 1942 condition, the panel was restored and reconstructed in 1980/81. The hatched drawing shows which pieces were restored and from which period they come*

*(horizontal: 19th century,*

*diagonal: 1980/81; dots and rings represent platings).*

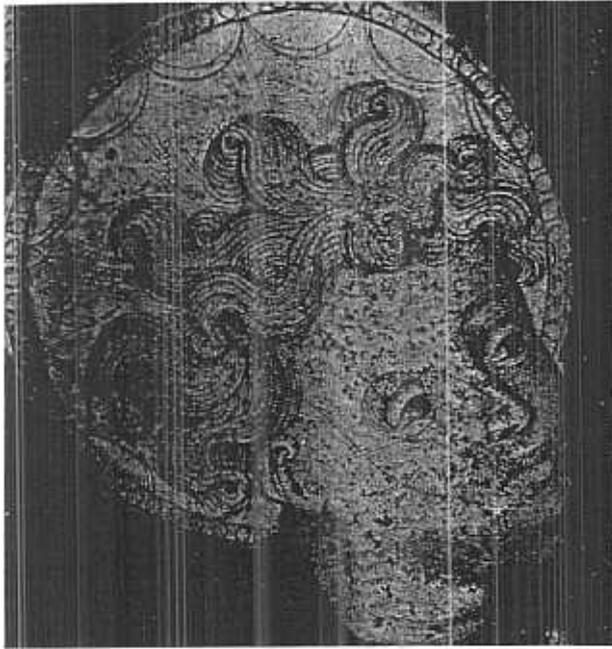
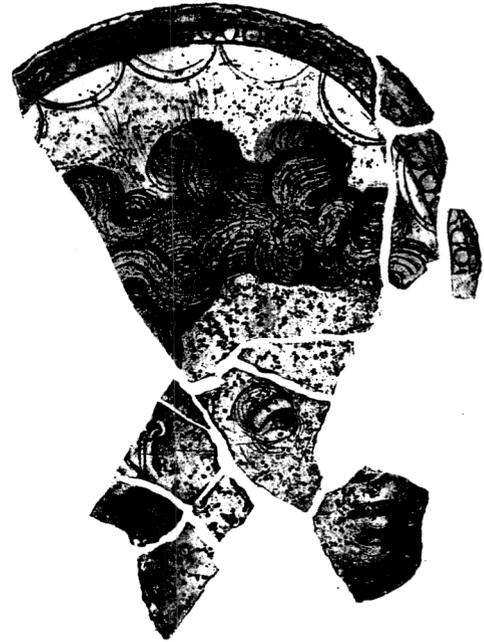
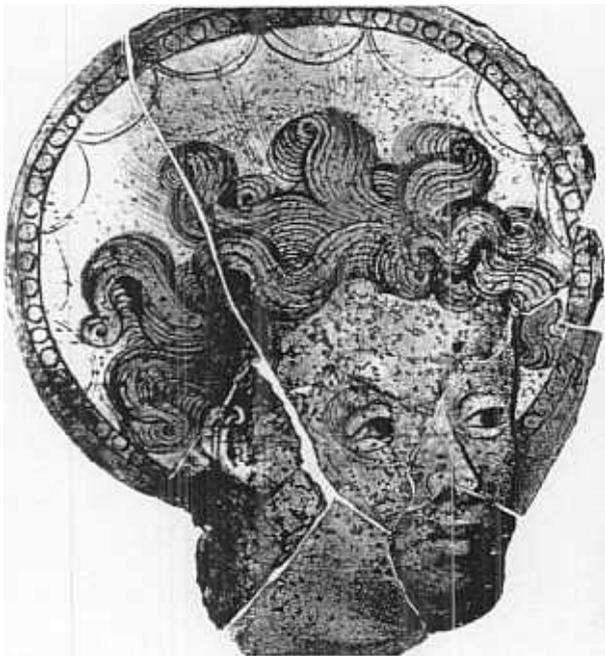
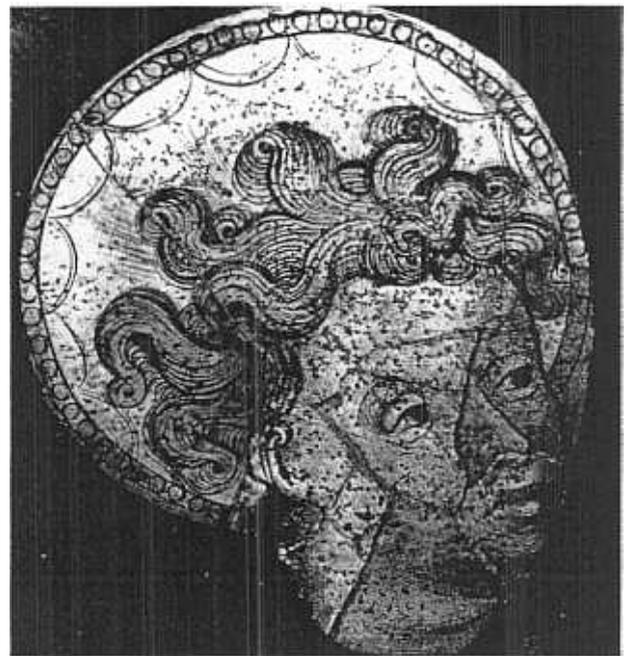
**Figs. 19-22**

*Uelzen. Chapel of the Holy Ghost, north window III, 2a. The head of the Angel of the Annunciation was already cracked in 1942, while almost half of the original was lost in 1946 because of stone-throwing. After careful bonding of the fragments and the grinding of the new panes with the subtly restored fine painting, the fact that a large part of the head dates, not from 1412, but from 1980/81, is scarcely noticeable.*

Glueing also includes the insertion of precise-fitting and painted additional pieces, which often have to be used to close gaps in fragmented pieces to avoid using new, extra leading (Figs. 19-22), Panes which are fragmented, or covered with large numbers of cracks or mending lead "spiders" often have to be

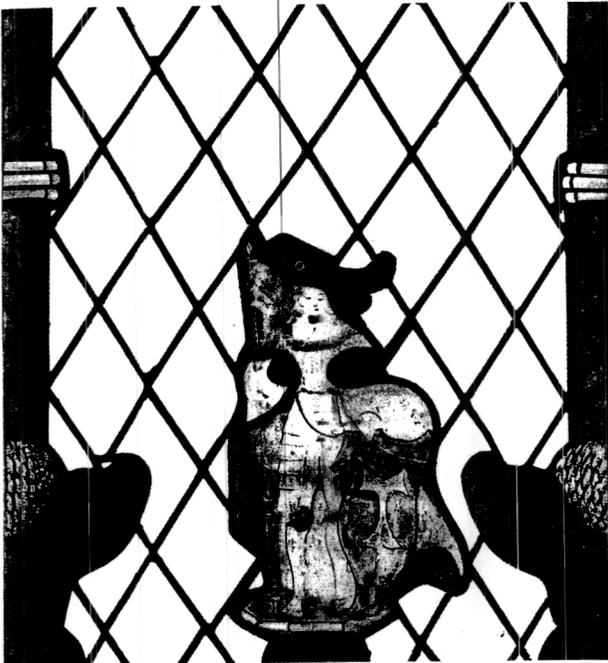
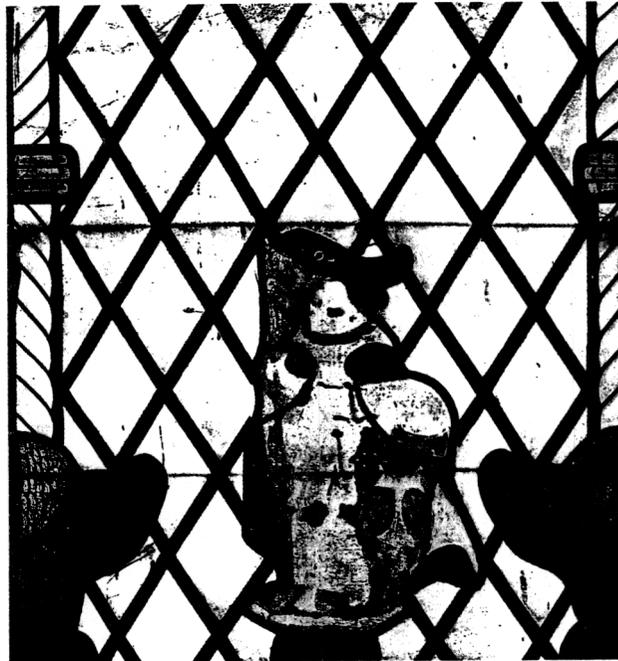
*Figs. 23 - 24*

*Ebstor, nunnery chancel, north window IV, 7b, section. The 1523 window has almost completely lost the insufficiently fired black enamel. part of the painting was revealed during restoration using a thin, non-fired, shading wash; a covering pane carries the completed main outlines.*

Provided that the glass itself is not corroded, half-tones which have been weathered away can be rendered visible again by coating the formerly painted parts with a thin shading wash of black enamel, but which is not then fired (Figs. 23, 24). This can be wiped off again without difficulty, but is sufficiently fast to allow panels treated in this way to be handled.

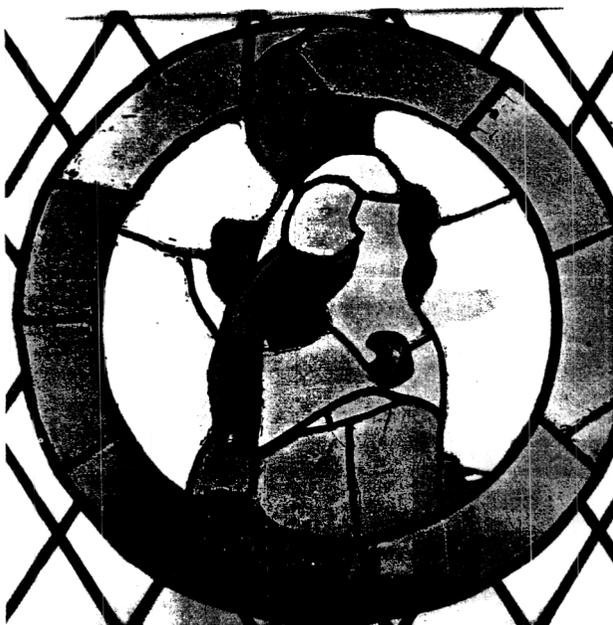
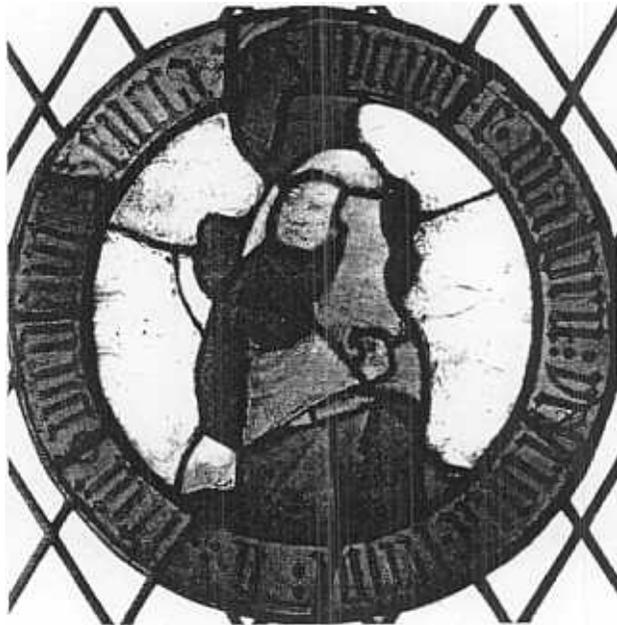
*Figs. 25 - 26*

*Luneburg, town, law court's hall, window II, 2a. The inscription on this early 15th century panel, "optimum est maiorum vestigia sequi, hirecte praecedant Seneca." which was completely erased, was reconstructed from faint marks, on to a covering pane. Thus the small figure is identified as the Roman philosopher.*

A practical method which does not interfere with or damage the original, but which is reversible at any time, is that of dry overlaying with clear, thin covering glass, on which the painting is completed and fired to the required depth (Figs. 25, 26). In this way a panel which has been completely effaced or corroded can be made legible, so that the picture content is revealed to the observer. It is true that the shape of the worn-off outlines can often be distinguished only by faint marks and scarcely perceivable variations in the glass surface. The extent to which the painting is restored in these cases depends not least on the degree

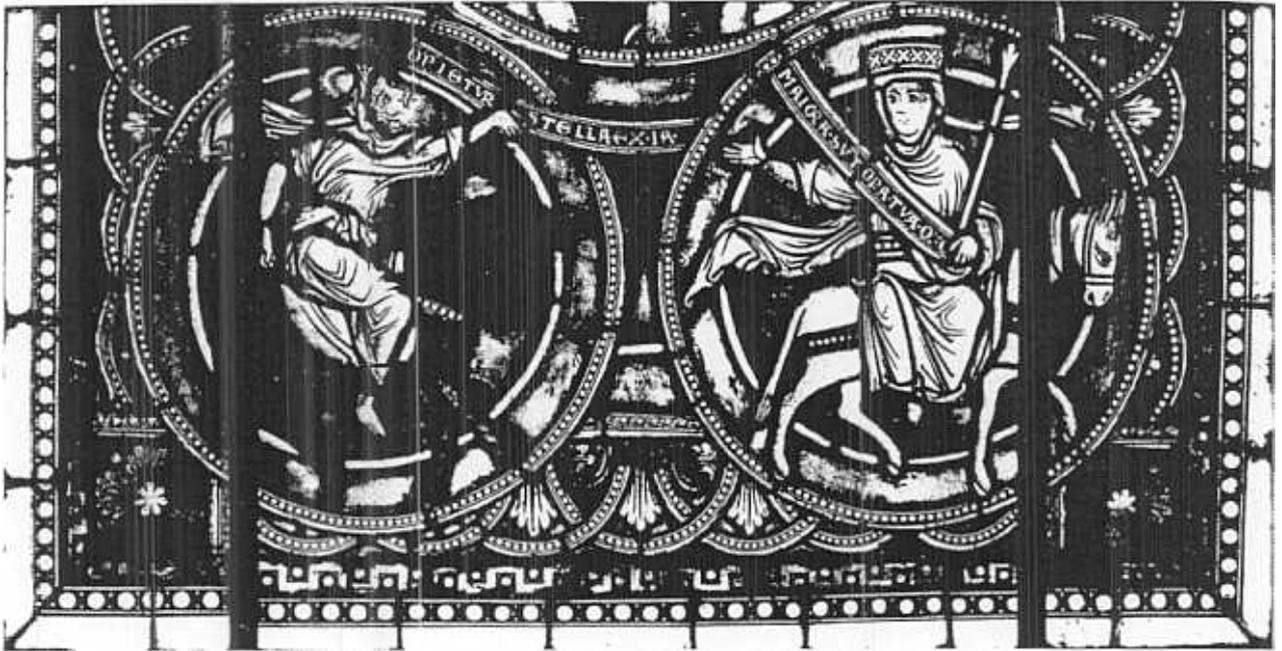
*Figs. 27*  
*Munster, Westfälisches Landesmuseum. Reconstructive*  
*replica of the Tree of Jesse Window (1230/40) from Legden,*  
*St. Brigida, 1969, Detail.*
