MAJ VOGT REITHER:

Bergen, The Timber Town

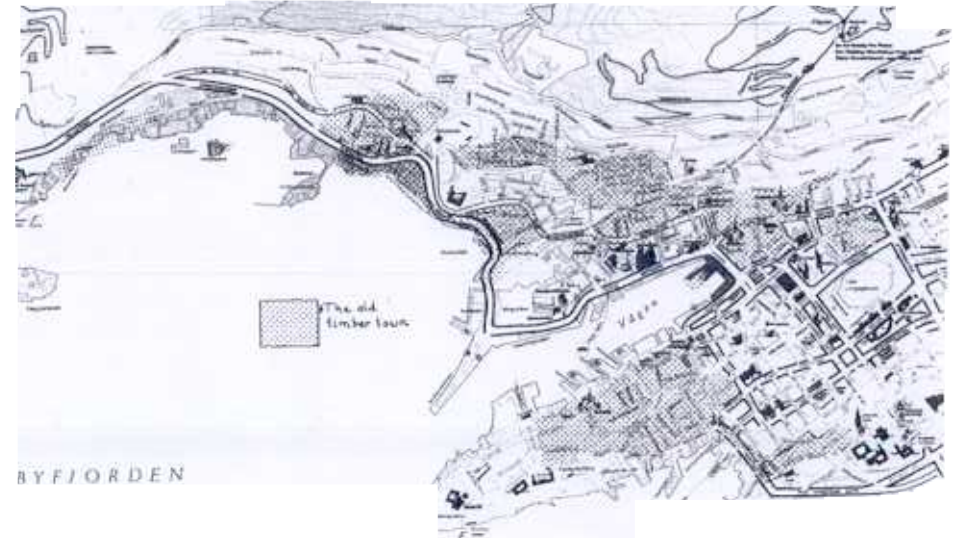
*Map of Bergen: extension of the timber town.
Carte de Bergen: extension de la ville en bois.
Municipality of Bergen.*

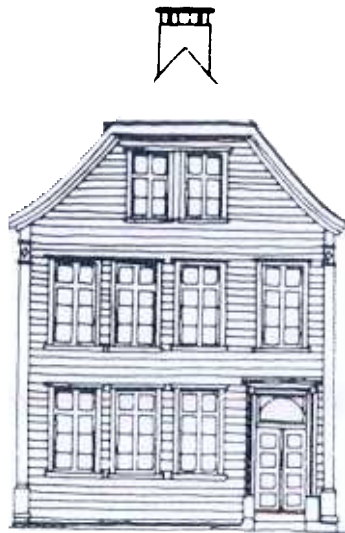
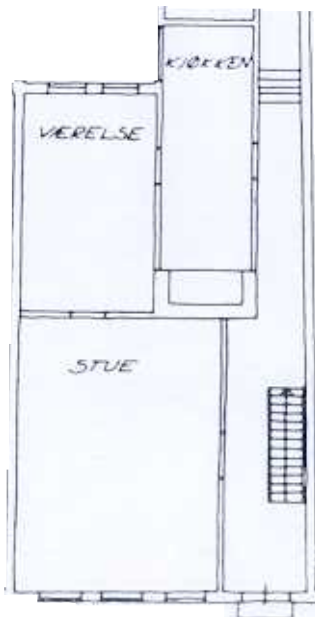
Examples of primary forms with side alleys.
Exemples de formes type avec passage latéral.
K. Bjørknes «Gamle borgerhus i Bergen»

A long narrow site is best utilized when access and horizontal traffic is directed along one of the long sides of the building. This solution provides an acceptable room size as well as access to several rooms and space behind the frontage when the site and building are about 6 m. wide. We also find that relatively narrow buildings with side alleys are a general feature of large parts of the old timber town.

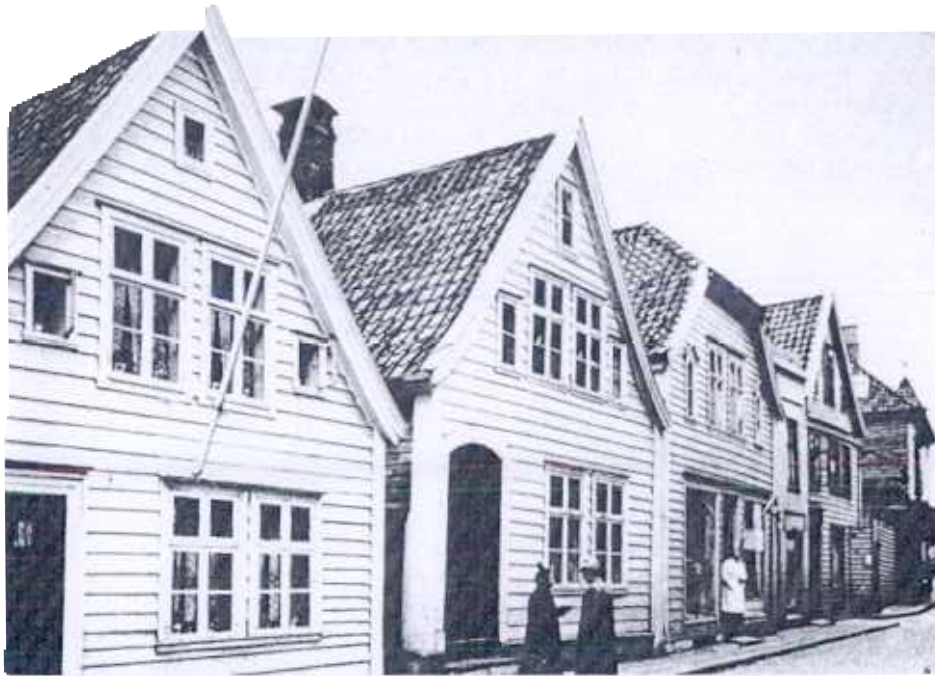
*Traditional houses with gables facing the street.
Maisons traditionnelles avec pignons sur rue.
Photo Espevoll 1930*

house faced the street. This was prohibited after 1757 when it was decided that all roof ridges had to run parallel to the street. In 1800 regulations concerning hipped roofs and gabled roofs were introduced for the same reason. Part of the aim of these regulations was also to create visual orderliness in the landscape. These regulations came from Denmark, the seat of the government, and also had some basis in stylistic ideas.

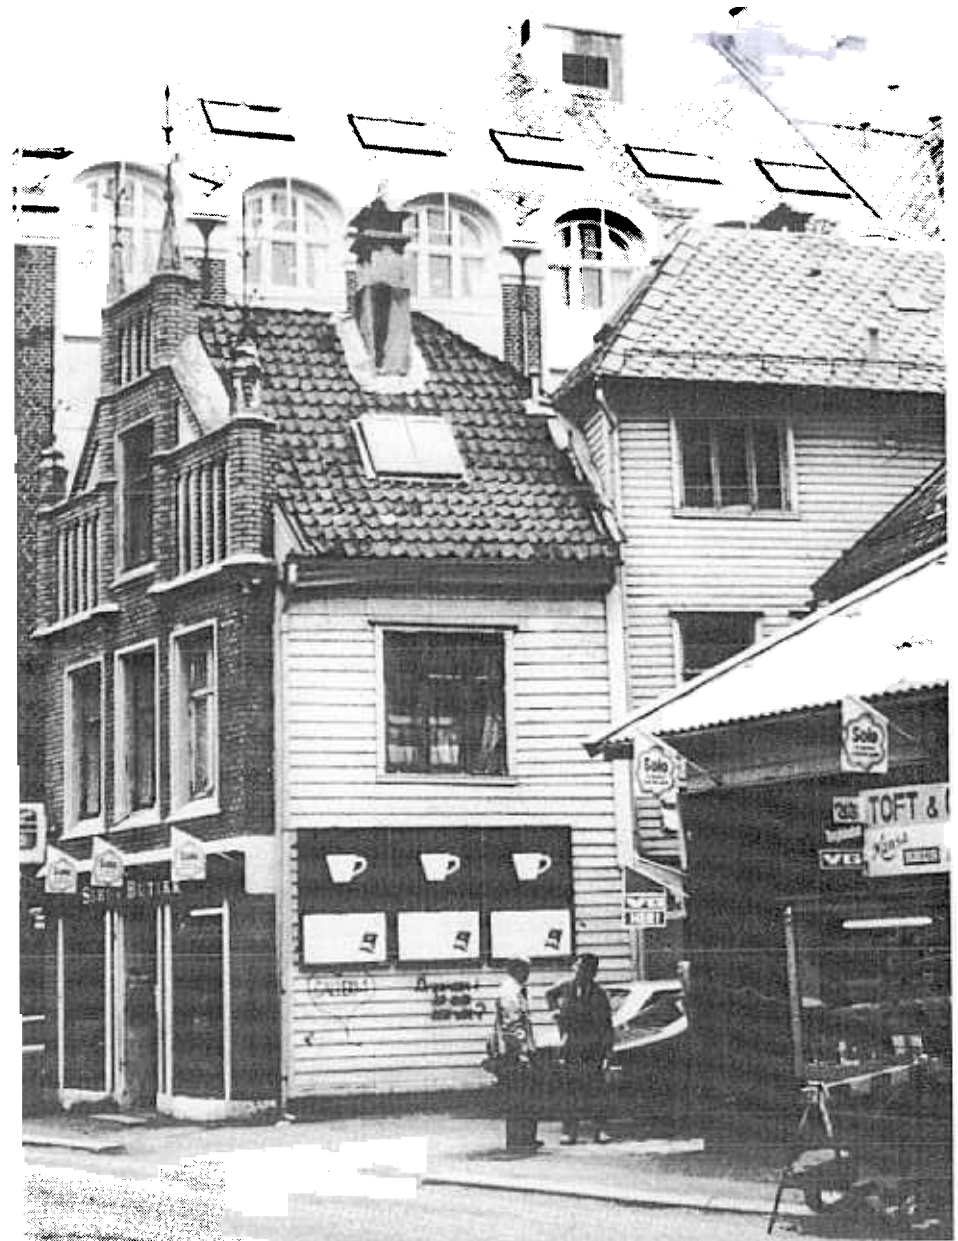
*A traditional timber building with a newer brick wall facing the street.
Une maison en bois traditionnelle parée d'une façade en briques vers la rue.
Photo. Maj Vogt Reither 1983.*

Attempt were made to introduce compulsory brick walls but the town dwellers opposed these regulations. As a compromise solution it was decided that new buildings should have brick walls facing the street. This was placed outside the timber facade as a false front.
