# KENYA

## Case Study One – Mtwapa Heritage Site

## Case Study Two – Qorahey Wells

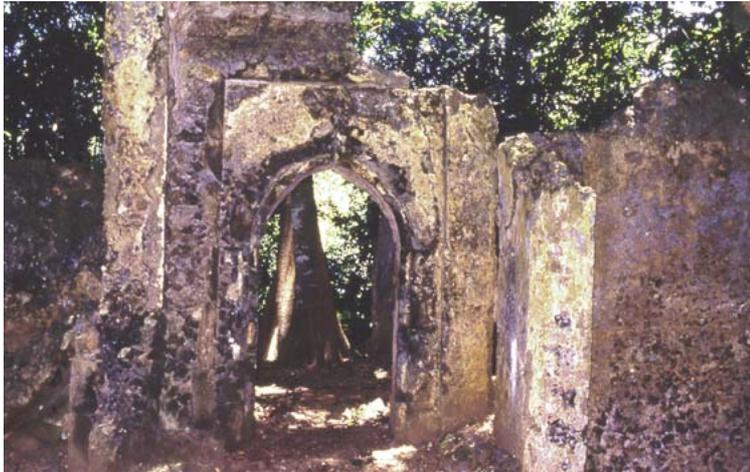
Part of the ruins

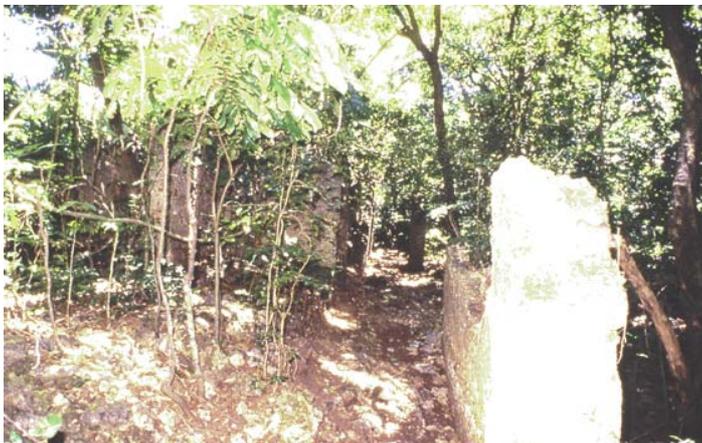
The threats to the Mtwapa Heritage Site are natural and man-made. The natural risk factors include rain, erosion, vegetation, micro-organisms and natural aging of the ruins. The man-made risk factors include pollution, population and or development pressure, vandalism and looting, lack of financial resources leading to inadequate maintenance and neglect.

Currently the entire site is an open area as it does not have a protective perimeter fence around the site, making it difficult to control entry and movement within the site. The people living in the neighbourhood are themselves a threat as they vandalise the ruins, collect easily available coral rubble and also destroy the local vegetation for domestic use. Infrastructure such as high-tension electrical power lines diagonally traverse the site. This situation predisposes the monument to imminent future development that may take the form of roads, housing construction etc.

Vegetation growing among the ruins

Several issues need to be addressed with regard to a thorough preservation and protection of the Mtwapa Heritage Site. The main concern is the development of a thorough and comprehensive management plan that is proposed to adopt a multidisciplinary approach and involve all the relevant stakeholders. A thorough implementation of this management plan is necessary to realise this positive move towards this site's conservation.

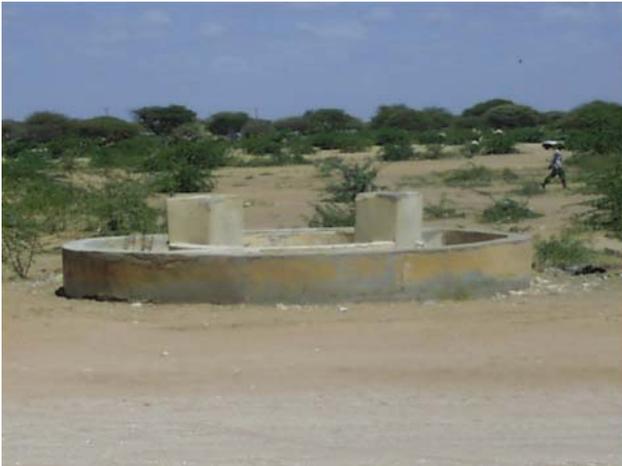
One of the Qorahey wells

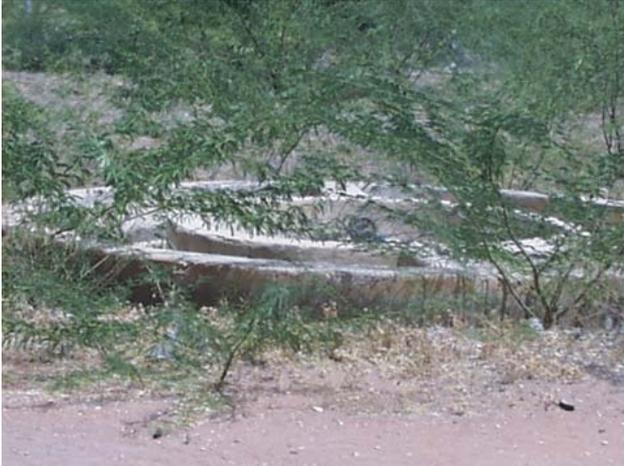
The wells are not protected by law. The people using the wells are also a threat to the wells as they pollute them by littering. There are also threatened by encroachment, both both developmental and urbanisation. Vegetation growing near the wells is also a threat.

Vegetation growing around one of the Qorahey wells

The wells need to be protected by law by having them gazetted under the *Antiquities and Monuments Act* Cap 215. There is also need to educate the local inhabitants of the importance of protecting the wells as an essential component of their heritage.
