MEXICO

San Juan Cuauhtinchan, Puebla

The high altar of the church of San Juan Bautista, Cuauhtinchan

Vernacular Mexican Architecture in Danger

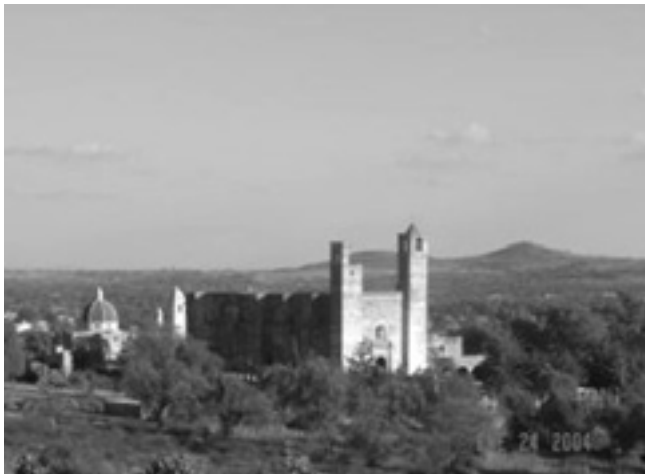
General view and ground-plan of San Juan Cuauhtinchan ▲ ▶

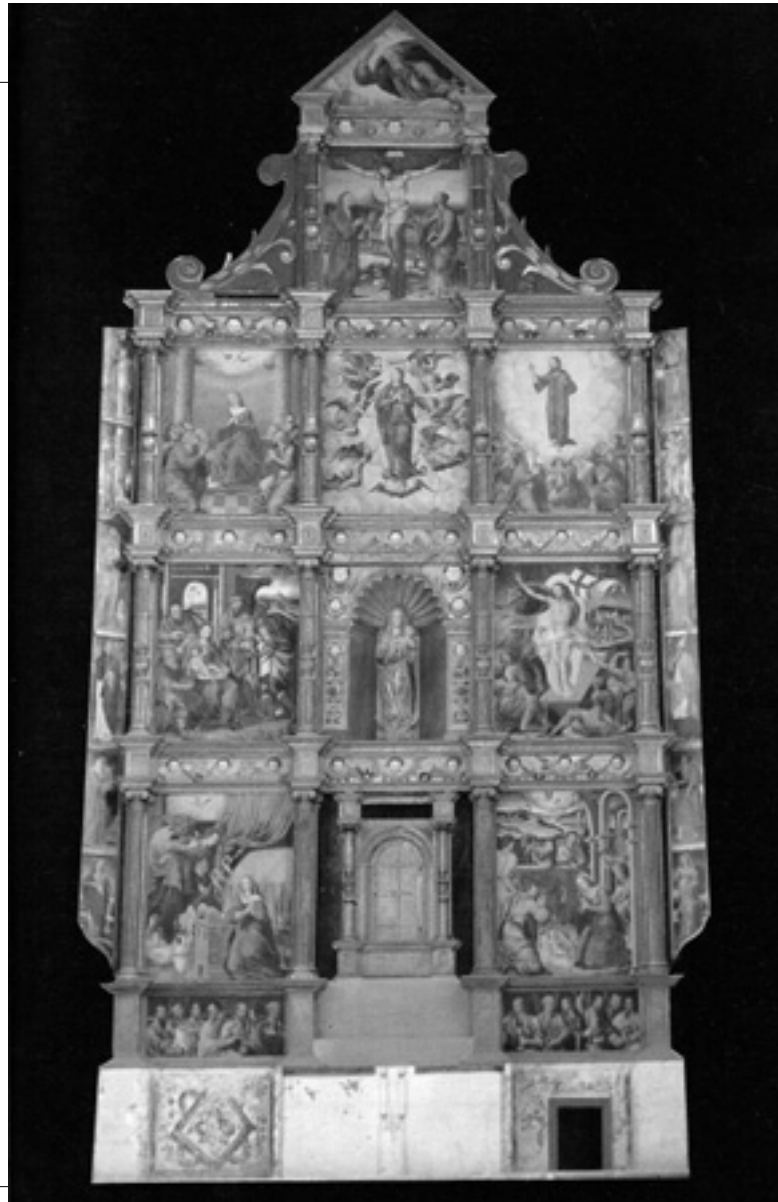
Major retablo of San Juan Bautista Cuauhtinchan after the restoration in 1986

Retablo mayor de San Juan Bautista Cuauhtinchan, Puebla después de la restauración de 1986

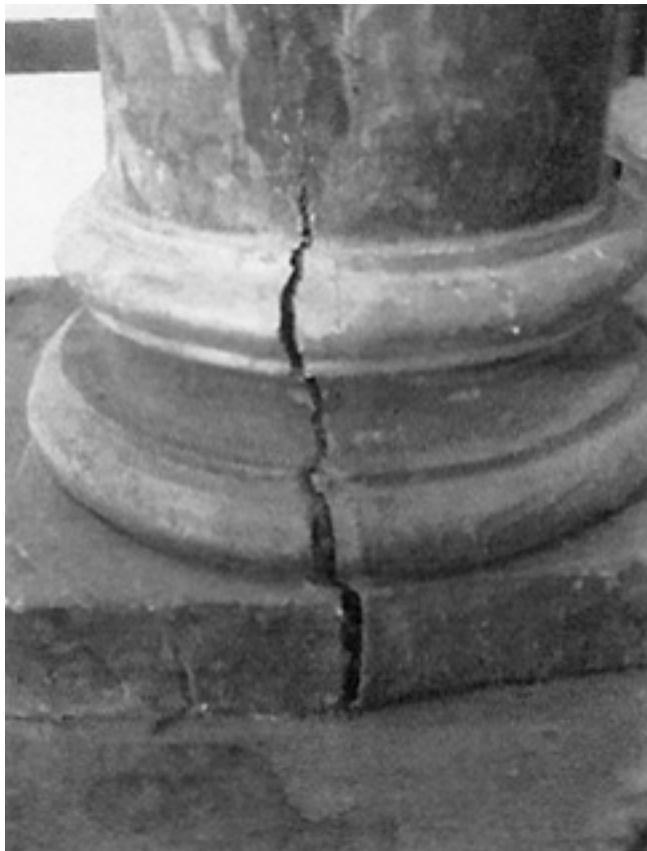
- Changes in humidity cause the severe shrinking of the painted panels and the animal-fibre fabric that covers the panels, which, on reducing in size, are insufficient for the area covered by the pictorial paint and the undercoat, materials which are not as drastically affected as timber and fibre;

Structural cracks caused by changing humidity

Grietas en estructura por cambios de humedad

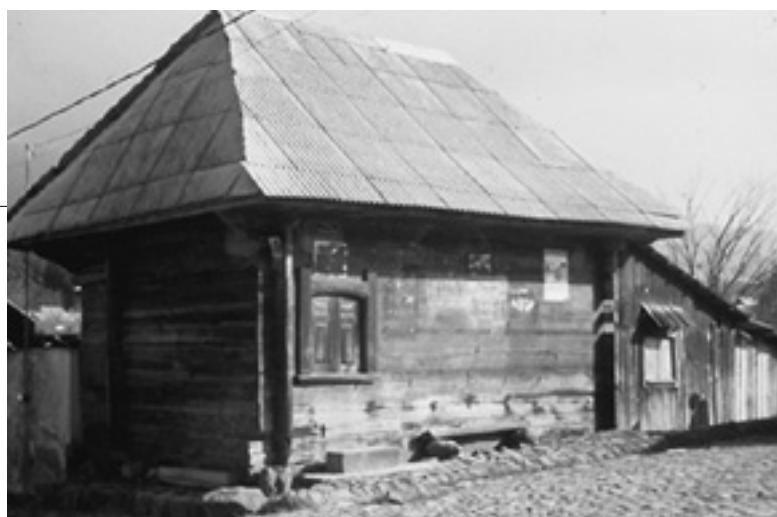
Local people, who call themselves *purepechas* and who have an indigenous origin, kept their building tradition until several years ago. Their houses are built completely in wood, once abundant in the surroundings, although nowadays it is a scarce resource. Wood construction in Michoacan is one of the techniques that goes back several years as a craft taught to the Indians by Vasco de Quiroga. It consists of wooden joints without any nails, the buildings being based on a plank and beam system. The roof is covered with tiles and pronounced, strongly sloping eaves, with an attic built into it and used as grain storage as well as helping to insulate the house against the winter cold and the rainy season. This type of traditional house is known as *troje*, meaning grain storage.

Wooden construction in Angahuan (Michoacan)

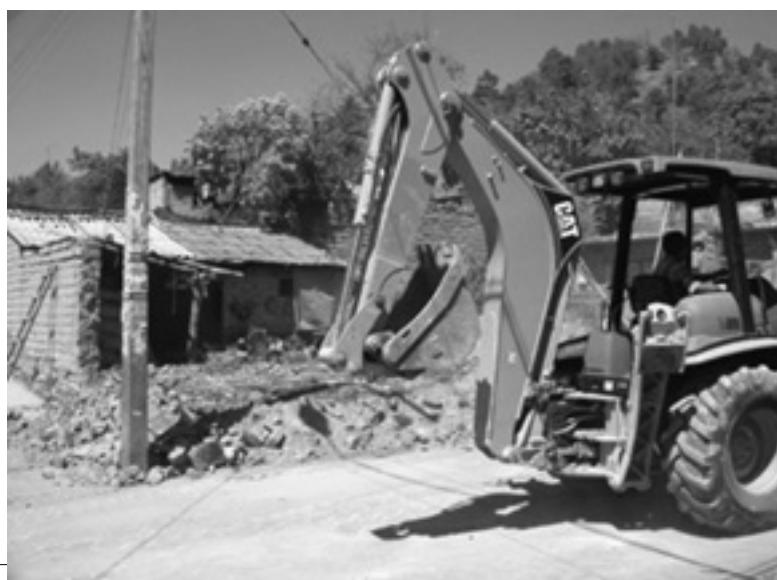
Destruction of adobe buildings in Hueyapan (Morelos)

As in the above case of the *troje*, the reasons relating to the destruction of this built heritage have a cultural background. They are also a result of the impact of the influence of the cement industry, poor housing programs and an absence of policy on preserving and improving the traditional vernacular houses of rural communities.

In fact, only 30% of the houses that existed ten years ago survive. They are quickly being replaced. Yet while local people accept that their adobe houses are much more comfortable to insulate against extreme temperatures, they claim: "But we need to feel modern".
