## TURKEY

### Churches built in Ottoman times

#### The present state of some of the surviving monuments

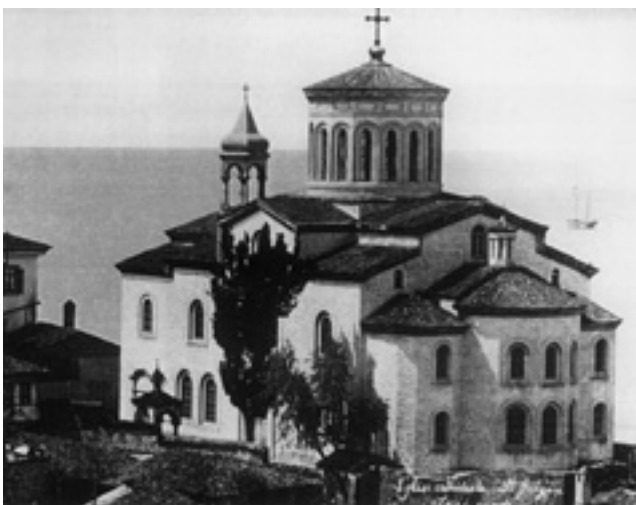
Trebizond, church 'Hagios Gregorios of Nyssa (1863), blown up in the 1930s

Anatolian churches were and are being blown up, destroyed and are still being used inappropriately. For example, the impressive cathedral-church of Hagios Gregorios of Nyssa built in 1863, that dominated the silhouette and skyline of Trebizond, was blown up in the 1930s to permit modern city development.

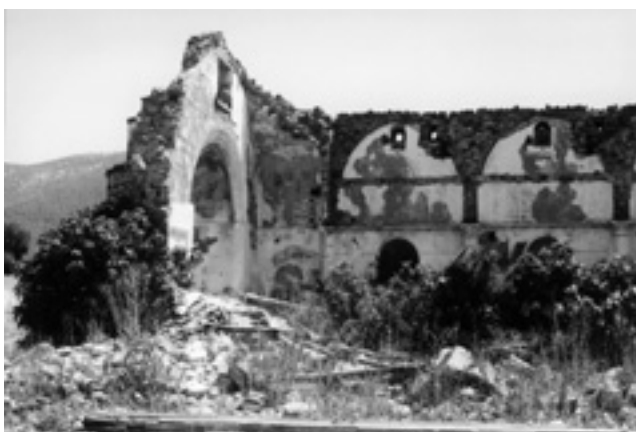
Yayla Köyü, area of Muğla (Caria), village church (19th c.): View from the north

Other reasons also lead to the total destruction of the often empty and ruined buildings: the destruction of the south-western Anatolian one-aisled 19<sup>th</sup> century village church of Yayla Köyü (the former Greek village of Hagios Antonios), near Muğla in the historical landscape of Caria, was caused by the collapse of its rotten wooden roof construction reported in 1998. It is mostly the domes and vaults of these churches that are structurally at risk, and such cracked masonry can clearly be seen in the village of Cunda on Cunda Adası (Greek: Moscho-Nisi) near Ayvalık

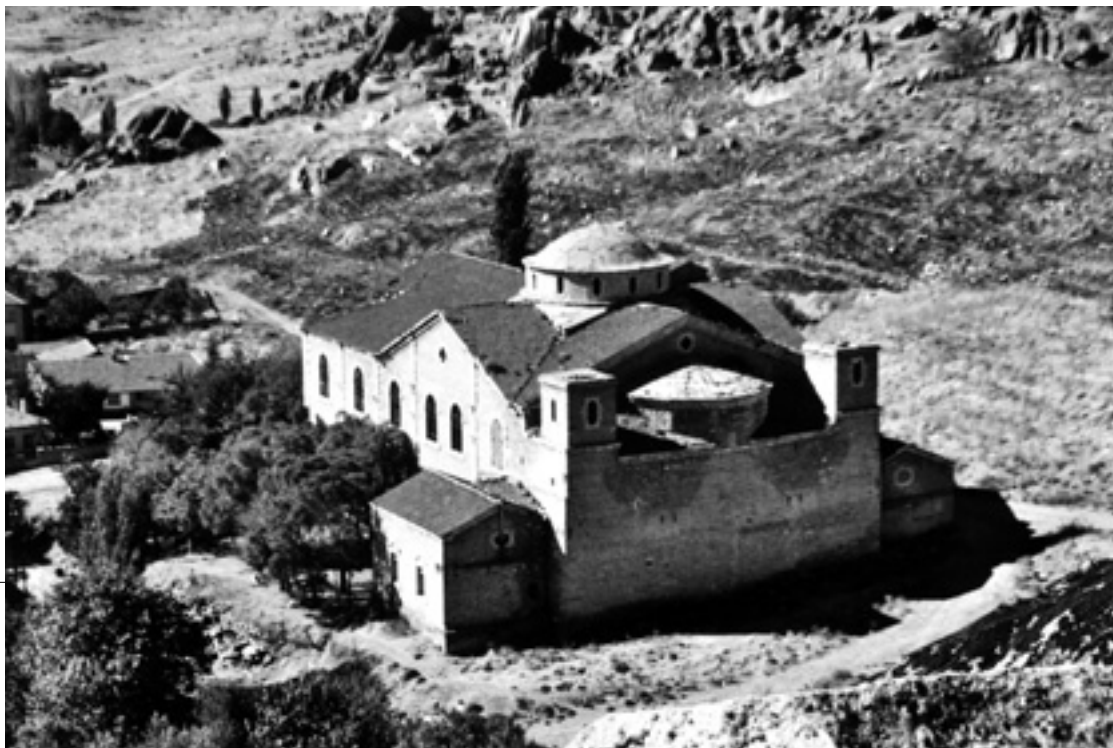
Sivrihissar, large Armenian domed basilica built in 1881 (2003)

Also architectural changes to buildings can be demonstrated and are causing damage to the original structure. The large Armenian domed basilica of Sivrihissar, built in 1881 some 120 km south-west of Ankara, was used as a factory for a long time and it was decided to add walls in the western interior, so destroying the concept and sense of its original architecture. The building now stands empty. Also the large basilica of Misti, built 1844 in southern Cappadocia, is now used as a storehouse for building materials such as sand, wood and stones. There is finally the non-religious use of a church as a farm-house as mentioned above.

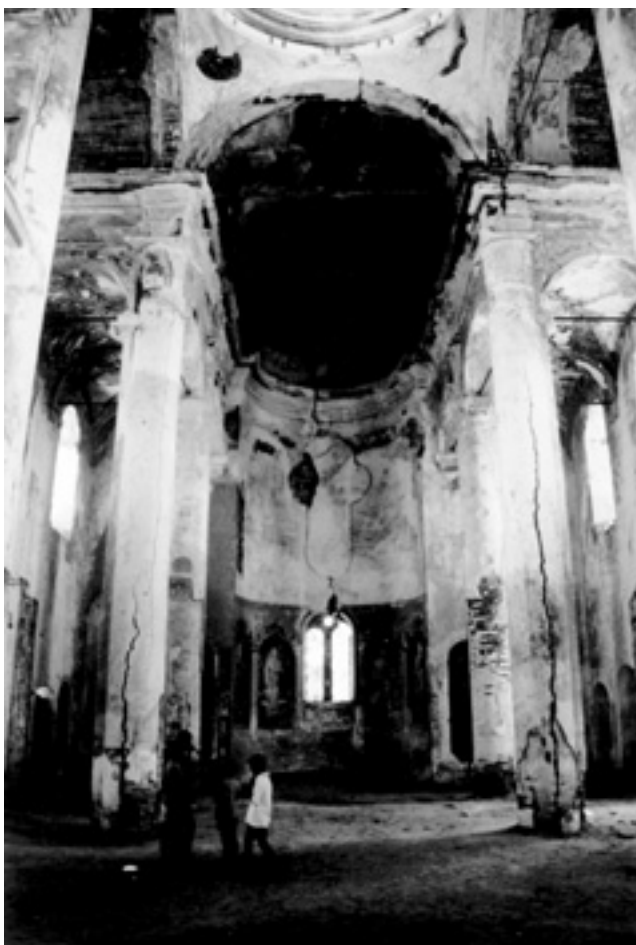
Cunda Adası, near Ayvalık, domed church, cracked brick-pillars and vaults

(Greek: Kydonia) on the West coast. The triconch cross-domed church of this village is in definite danger of collapsing. Cracks in the building's brickwork are undeniably threatening the pillars and the vaults, and this might lead to a total collapse of the building in the near future. As well as this, we still find remains of the church furnishing, such as the iconostases, which often were constructed of wood, and bishop's thrones and chancels, in a ruined state, for example inside the church of Hagios Archangelos Michael in Sille near Konya in Phrygo-Lycaonia. In addition, stucco decorations

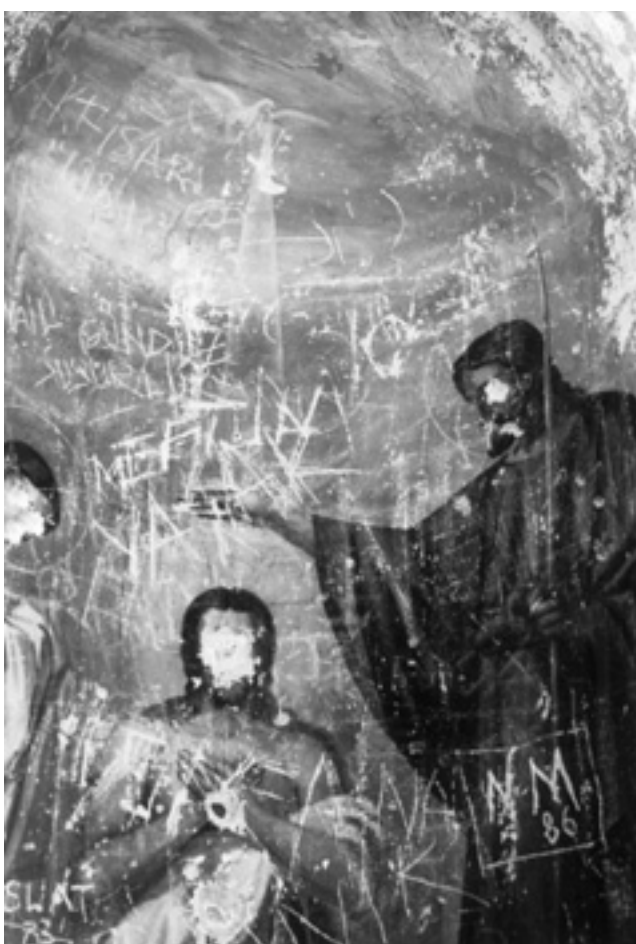
Cunda Adası, domed church, vandalised niche painting 'Baptism of Christ'

and wall-paintings of the churches are particularly at great risk of total loss and destruction, mostly because of vandalism to the lower parts of the unused buildings. Consider for example the 19<sup>th</sup> century painting 'Baptism of Christ' in a niche on the south of the eastern apse of the domed triconch church in Cunda, Cunda-Island off the coast of Ayvalık-Kydonia. Another risk is water, which can pour through leaking vaults and roof constructions and cause the loss of painted and decorated plaster.
