### The Ancient Diolkos

The Diolkos, the unique paved way that enabled Greek warships and merchantmen to be moved overland across the Isthmus of Corinth from sea to sea, has been crumbling into the water at its western end for decades. Neglect and total absence of remediation actions have caused its deterioration.

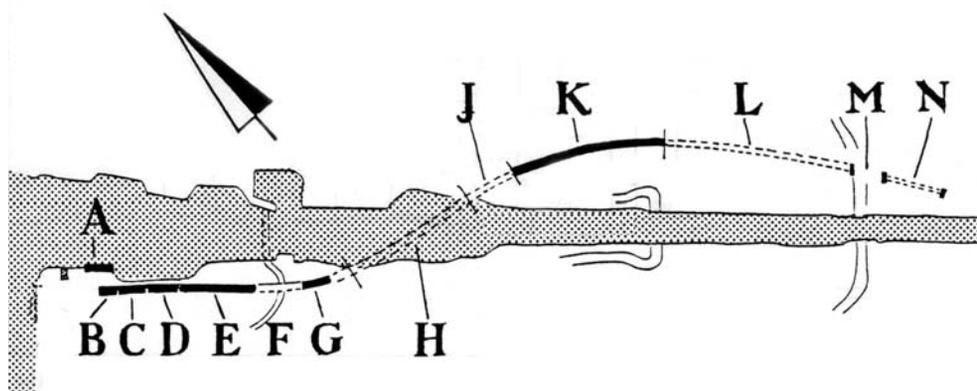
A plan of the Diolkos by Walter Werner. The letters C and D correspond to different states of disruption at the time the plan was drawn.

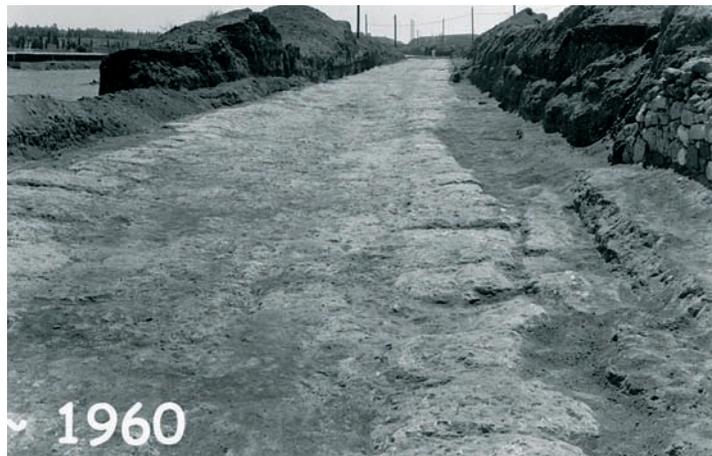
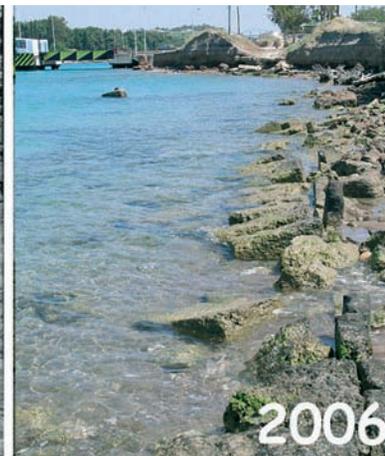
The Diolkos around 1960, in a photo of the En Athinais Arhaiologiki Etairia and the same part in 2006.

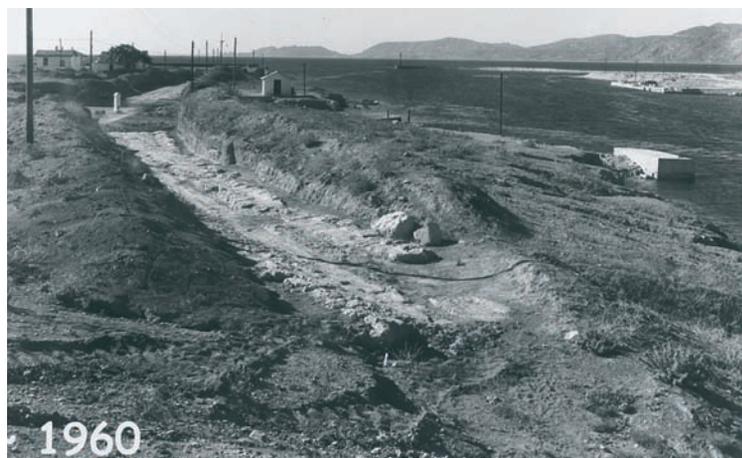
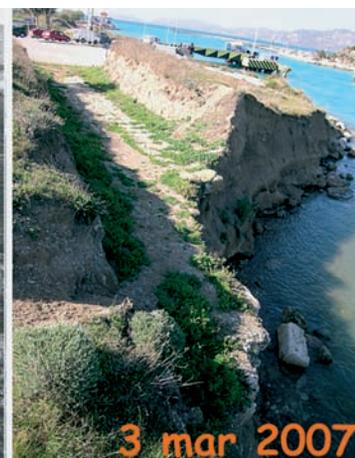
Sector "G" (according to Werner's description) as it was after the excavations (in a photo of the En Athinais Arhaiologiki Etairia) and in 2007. An internal report by an antiquities' guard in 1992, saying that the erosion was approaching this part of the monument and urging the local ephorate to take measures, was disregarded.

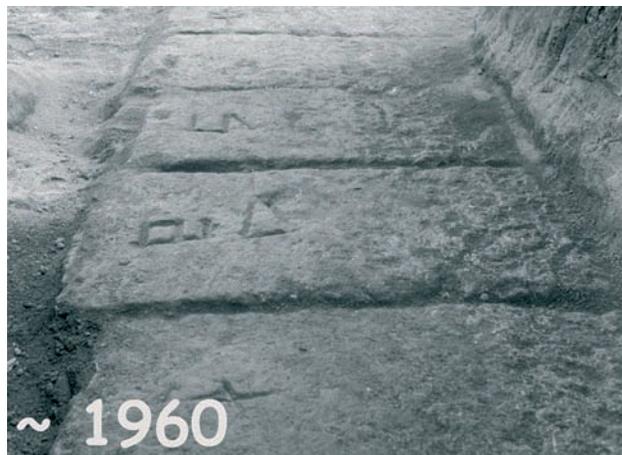
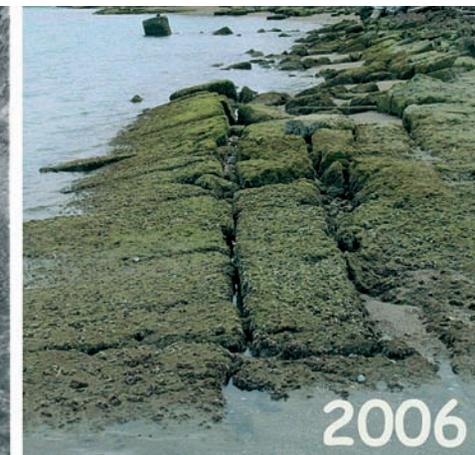
An interesting feature of the Diolkos, engraved letters which appear with increasing frequency near its western terminal (as can be seen in a photo of the En Athinais Arhaiologiki Etairia taken during the excavations), lies in the sea.

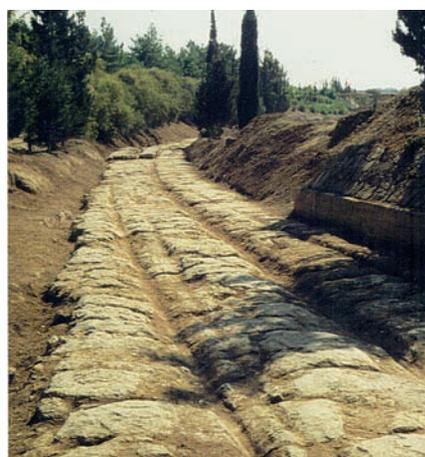
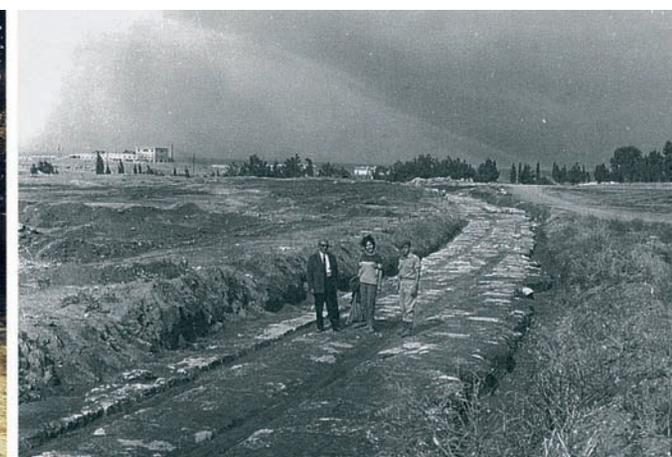
Two preserved parts of the monument, on the Sholi Mihanikou grounds, in images taken by Walter Werner (in color, 1978) and the En Athinais Arhaiologiki Etairia (around 1960). This second part is visible today only in its general form, since it has been covered by natural growth.

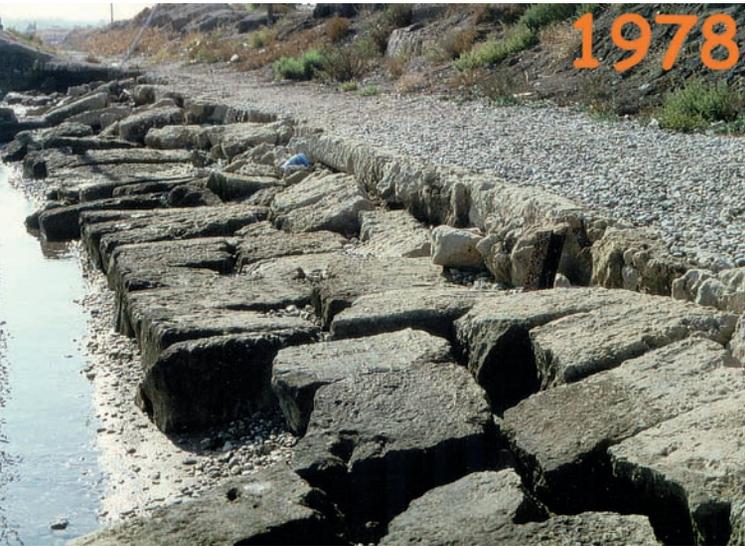
An image taken in 1978 by the German researcher Walter Werner shows already serious erosion.

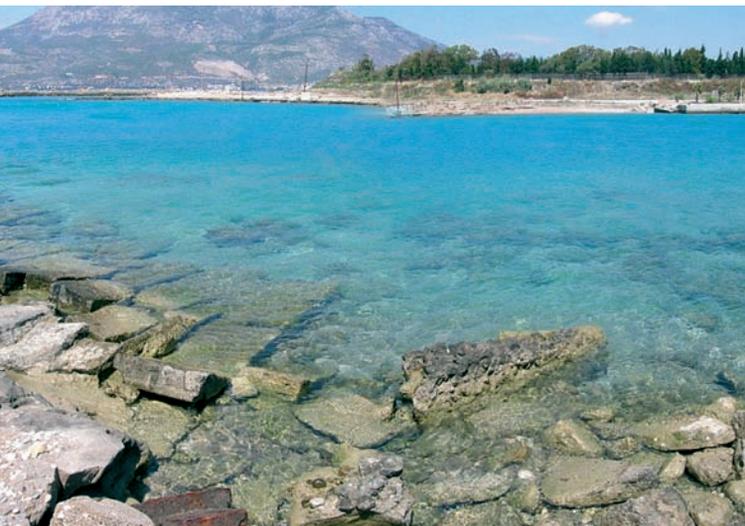
The extended platform which once constituted a part of the western terminus of the Diolkos today lies in ruins.

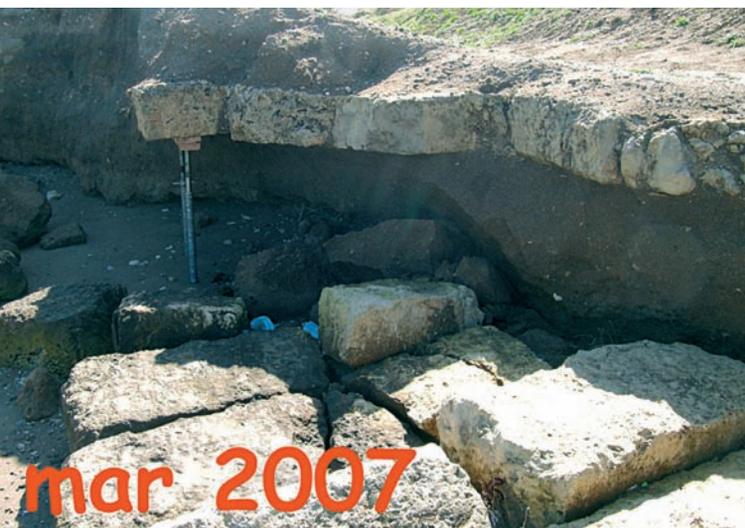
mar 2007

One of the two points supported at the beginning of March 2006 by the Direction for the Restoration of Ancient Monuments.
