Logistic and Other Factors Constraining Conservation of Heritage Sites in Antarctica

Borchgrevink's huts – Cape Adare

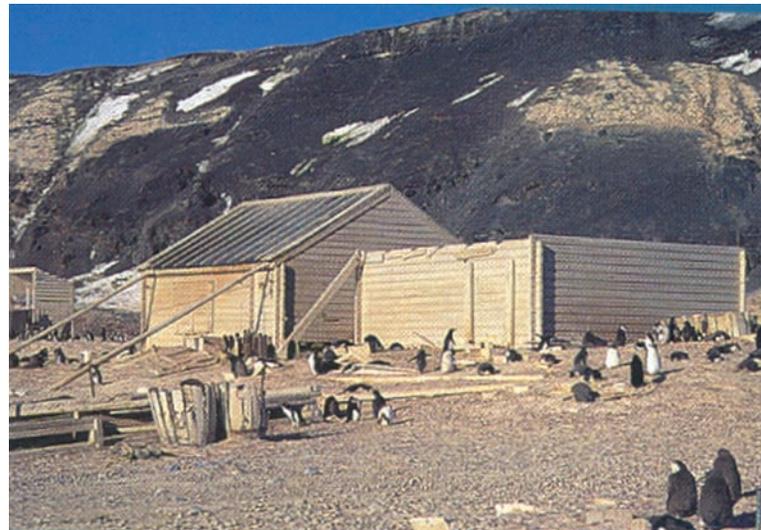
Cape Adare huts (Credit: Paul Chaplin)

Cape Adare is without doubt one of the world's most isolated historic places and where the first structures ever built on the Antarctic continent still stand. They were erected on the same rocky beach where, in 1895, the first documented landing on the continent took place. These two unique huts were built five years later by Norwegian Carsten Borchgrevink as his base for the

"British Antarctic ("Southern Cross") Expedition" - 1898-1900. This expedition became the first to winter-over on the Antarctic mainland. The two wooden structures, built side by side, were originally connected by an improvised annex.

Fluctuations in temperature and relative humidity. It is well known that the effect of temperature change, and in particular freeze/thaw cycles, can cause a breakdown of many materials. The site at Cape Adare is no exception as the wooden structure absorbs water from surrounding snow and ice as well as windborne salt water. The surface layers of the wood are then regularly subjected to freeze/thaw cycles causing mechanical breakdown of the fibres.

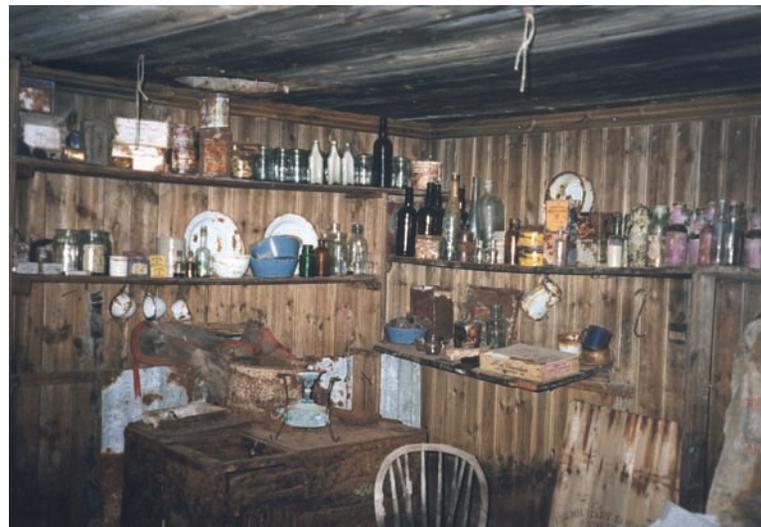
Interior artefacts (Credit: Paul Chaplin)

Wildlife. As previously mentioned the constant presence of penguins during the short months of summer hinders work because the prescribed codes of conduct mean that wildlife cannot be disturbed. A greater problem however comes from the guano they deposit. When the original human occupants departed they left many of their stores around the huts and these have now been buried under a thick layer of guano. The same guano provides a fertile medium for bacteria and other organisms that attack historic materials.

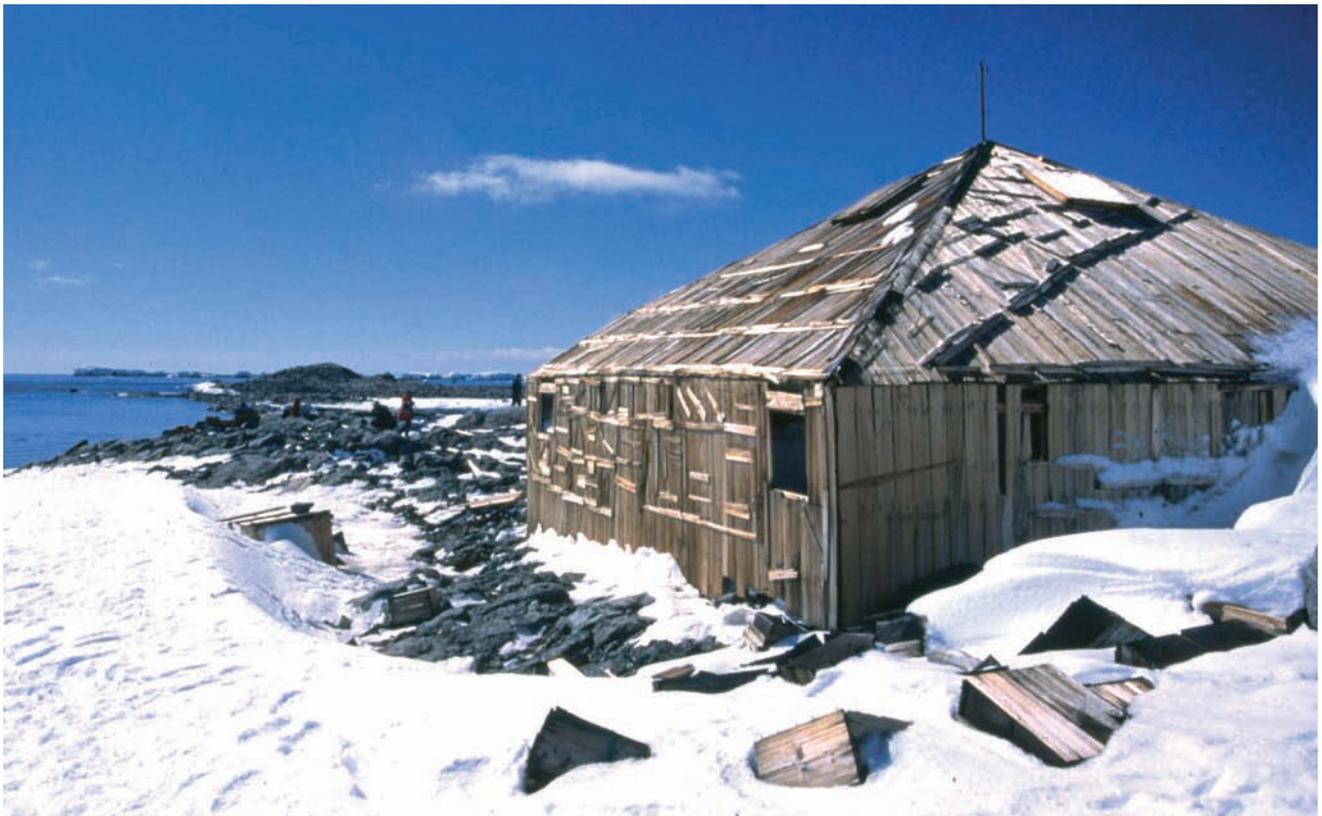
Mawson's hut (Credit: Geoff Ashley)

By way of providing a similar example of these problems, it is relevant to mention an equally difficult site built in 1912 by Sir Douglas Mawson for his "Australasian Antarctic Expedition (AAE) 1911-14". The huts he built remain at Cape Denison, in

Commonwealth Bay, over 1,000 km to the west of Cape Adare. Cape Denison has justifiably earned a reputation as "the windiest place on earth". In historic terms, Mawson's achievements were unfortunately overshadowed by the events surrounding Amundsen's and Scott's bids to be first to the South Pole, but he nevertheless left a very important legacy of scientific study and discovery in Antarctica. His former base at Cape Denison remains one of the most significant historic sites on the Antarctic continent.
