Case Study: Captain Robert Falcon Scott's 1910-13 British Antarctic Expedition Hut at Cape Evans

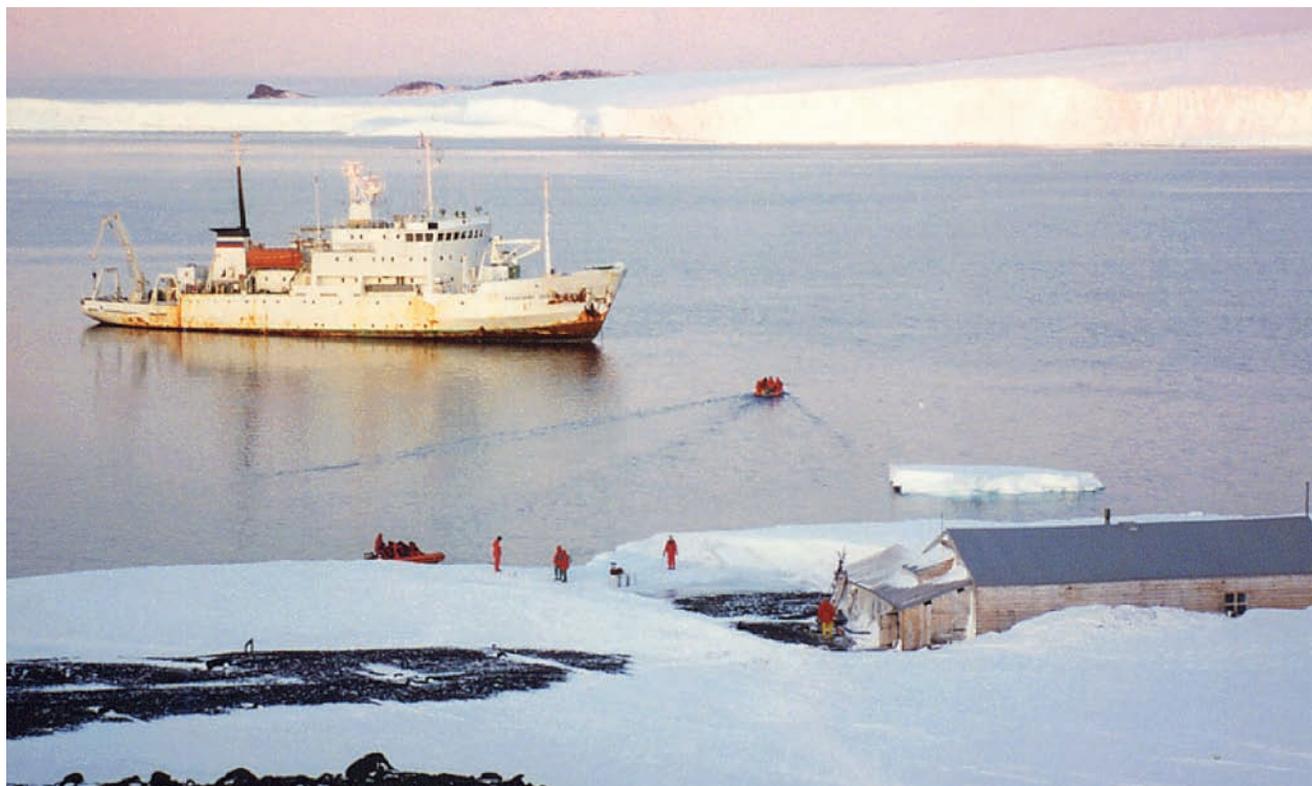
Scott's hut at Cape Evans is located on a shingle beach less than 50 metres from the water's edge and no more than 2 metres above high water level. Little more than a kilometre to the north the Barne Glacier terminates in a massive wall of ice up to 50 metres high that floats out onto the sea. (Credit: Paul Chaplin)

Scott's hut is located on a shingle beach less than 50 metres from the water's edge and no more than 2 metres above high water level. Little more than a kilometre away to the north is the Barne Glacier which terminates in a massive wall of ice up to 50 metres high that floats out onto the sea. In winter the hut is "shielded" by the sea-ice but for several weeks in summer there is only a short stretch of open water between it and the glacier.

glacier, but if global warming continues, a major collapse from the face of the Barne Glacier is a real possibility. Such a collapse could easily create a wave capable of sweeping up the beach and destroying the hut and its contents. It goes without saying that any increase in global sea levels not only increases this risk, but creates a risk of its own.

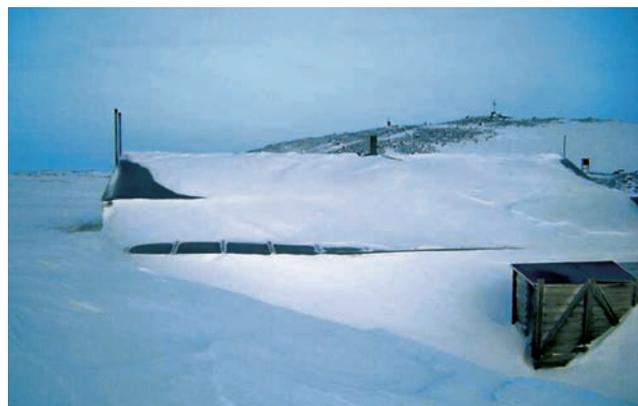
In recent years there has been a significant increase in the build up of snow on and around the hut during winter. September 2003. (Credit: Scott Base Winter Staff)

In recent years a significant increase in the winter build up of snow on and around the hut has been observed. The cause of this can possibly be attributed to increased precipitation as well as possible wind pattern changes that combine to increase snow drift.

This build up of snow has two serious adverse affects, the first being the increase of mechanical loading on the structure. In summer 2006-07 it was estimated that over 100 tonnes of snow were removed from in and around the hut. Much of this was taken from roof areas, in particular over the stables where it has cracked rafters in both of the last two years.

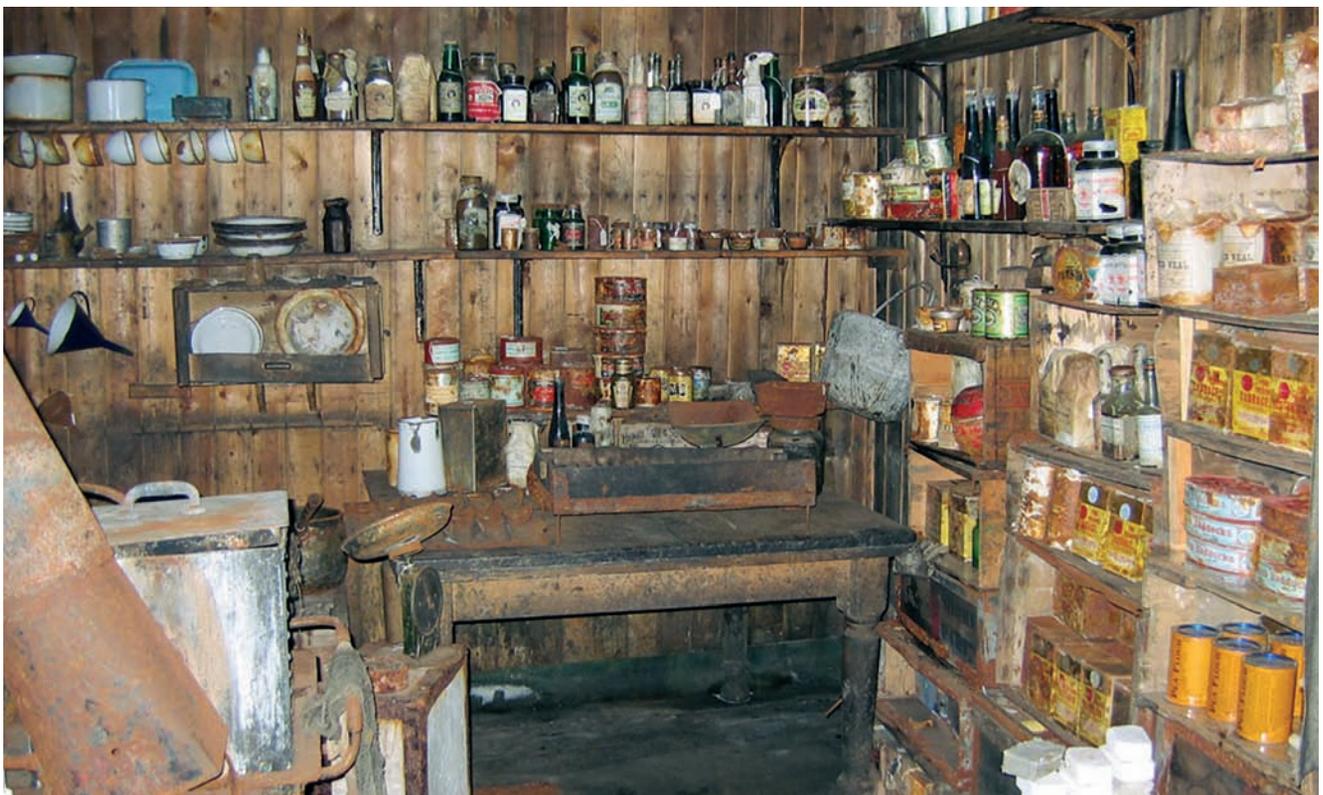
Objects within the hut do not warm as quickly as the air inside the hut so when the higher RH air contacts them condensation occurs on the cold surfaces. Freeze/thaw problems and dampness can cause a breakdown of materials such as paper (labels on metal cans) and it provides a "fertile" medium for forms of biological decay. (Credit: Paul Chaplin)

Increases in ambient air temperature can also exacerbate the effects of solar warming. Solar energy is transmitted through the roof and walls of the hut causing an increase of internal temperature and when this occurs relative humidity (RH) increases. Objects within the hut do not warm so quickly, so when higher RH internal air contacts them, condensation forms on the cold surfaces. This dampness causes a breakdown of materials such as paper (labels on metal cans) and it provides a "fertile" medium for forms of biological decay. When interior temperatures cool again, the condensation freezes and contributes to the freeze/thaw problems and mechanical damage already mentioned.
