ICOMOS Sri Lanka

**Preliminary Survey of Tsunami-affected Monuments
and Sites in the Maritime Region of Sri Lanka**

PART THREE
The Western Maritime Region:
from the Gin Ganga to the Kalu Ganga

March 2005

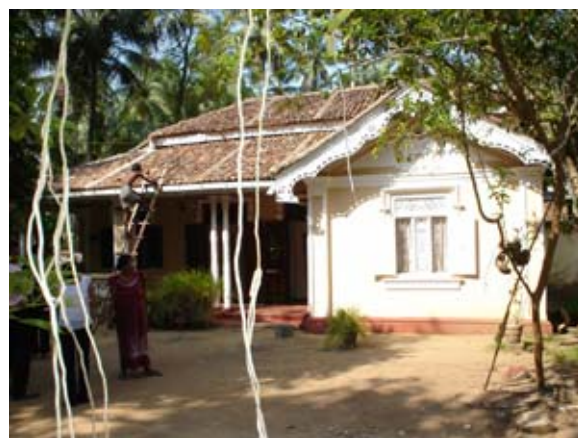
1

Name – MANGALASIRI
Type – HISTORICAL - RESIDENTIAL
Address – Mangalasiri, Kalamulla, Kalutara
DS Division - Kalutara
GN Division – Kalamulla North
GPS Coordinates - 06⁰ N 33.280
- 079⁰ E 58.011
Distance from the Sea – 200 m
Extent of Damage – Back walls are cracked.
Estimated Cost for Conservation
- Rs. 0.2 million

ELEMENT	MATERIAL	EXTENT OF DAMAGE
ROOF	Half round tiles, timber frame	No damage
WALLS	Cabock	Back walls are cracked.
DOORS	Timber	No damage
WINDOWS	Timber	No damage
FLOOR	Cement rendered	No damage
FOUNDATION	Cabock	No damage
SITE	Shrubs, coconut cultivation	No damage
OTHER		No damage

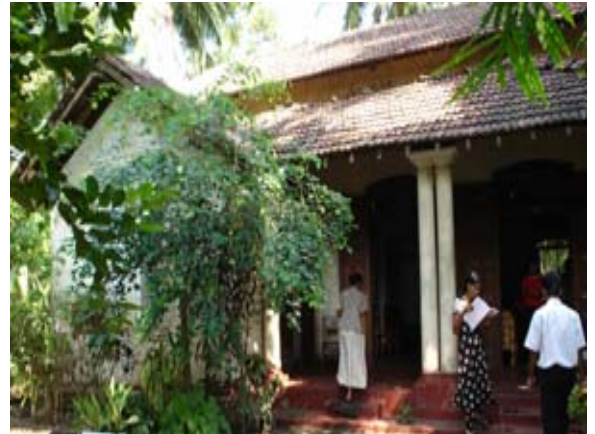
2

Name –
Type – HISTORICAL - RESIDENTIAL
Address – No. 149/A, St. Anthony's
Mawatha, Kalamulla, Kalutara
DS Division - Kalutara
GN Division – Kalamulla North
GPS Coordinates - 06⁰ N 33.247
- 079⁰ E 58.049
Distance from the Sea – 250 m
Extent of Damage – Walls are cracked.
Estimated Cost for Conservation
- Rs. 0.1 million

ELEMENT	MATERIAL	EXTENT OF DAMAGE
ROOF	Half round tiles, timber frame	No damage
WALLS	Cabock	Walls are cracked
DOORS	Timber	No damage
WINDOWS	Timber	No damage
FLOOR	Cement rendered	No damage
FOUNDATION	Cabock	No damage
SITE	Shrubs, coconut cultivation	No damage
OTHER

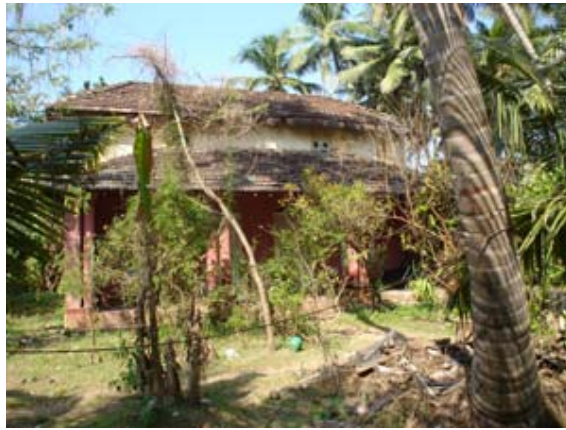
3

Name – SUDHARMAN
Type – HISTORICAL - RESIDENTIAL
Address – St. Anthony's Mawatha, Kalamulla, Kalutara
DS Division - Kalutara
GN Division – Kalamulla North
GPS Coordinates - 06⁰ N 33.283
- 079⁰ E 57.966
Distance from the Sea – 75 m
Extent of Damage – Walls are cracked. Plaster has fallen off.
Estimated Cost for Conservation
- Rs. 0.2 million

ELEMENT	MATERIAL	EXTENT OF DAMAGE
ROOF	Calicut tiles, timber frame	No damage
WALLS	Cabock	Walls are cracked. Plaster is damaged.
DOORS	Timber	No damage
WINDOWS	Timber	No damage
FLOOR	Cement rendered	No damage
FOUNDATION	Cabock	No damage
SITE	Shrubs, coconut cultivation	No damage
OTHER

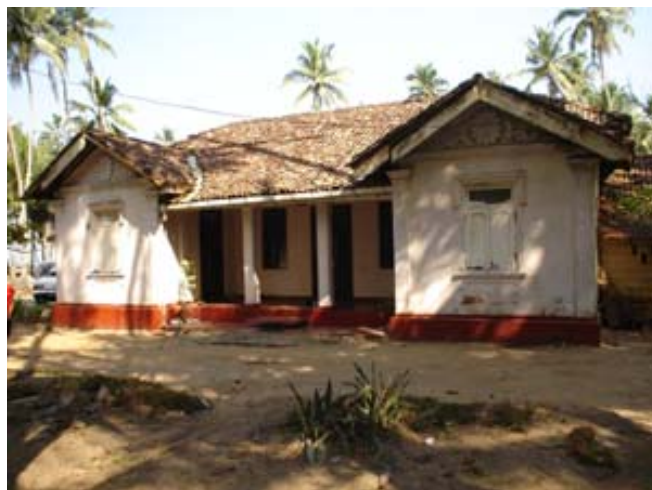
4

Extent of Damage – Walls are cracked.

ELEMENT	MATERIAL	EXTENT OF DAMAGE
ROOF	Calicut tiles, timber frame	No damage
WALLS	Cabock	Walls are cracked. Plaster is damaged.
DOORS	Timber	No damage
WINDOWS	Timber	No damage
FLOOR	Cement rendered	No damage
FOUNDATION	Cabock	No damage
SITE	Coconut cultivation	No damage
OTHER

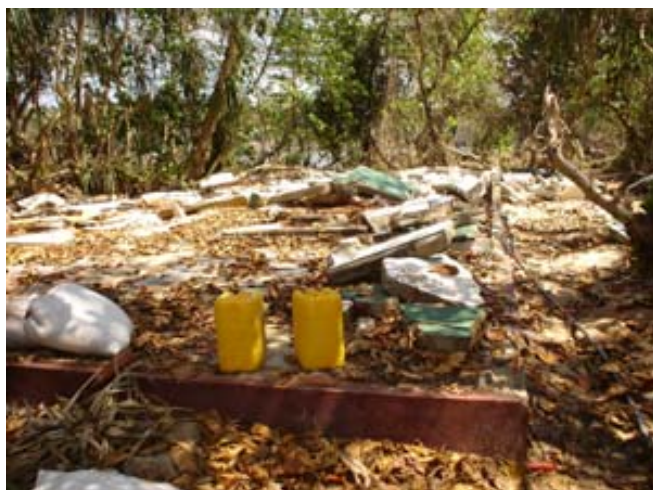
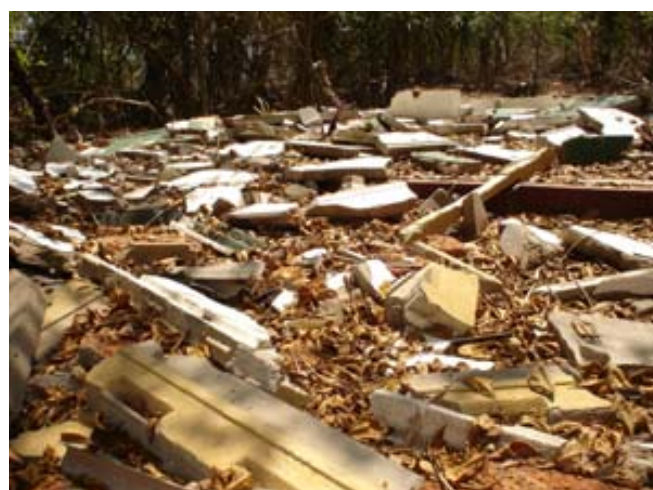
Extent of Damage – Completely destroyed.

ELEMENT	MATERIAL	EXTENT OF DAMAGE
ROOF	Timber frame	Completely destroyed
WALLS	Cabock	Completely destroyed
DOORS	Timber	Completely destroyed
WINDOWS	Timber	Completely destroyed
FLOOR	Cement rendered	Completely destroyed
FOUNDATION	Cabock	No damaged
SITE	Sand with scrub	Washed away.
OTHER

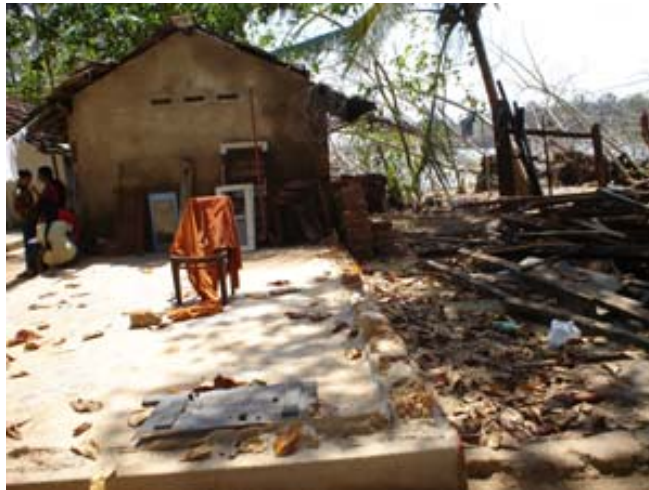
14

Extent of Damage – The *dharmasalava* and two bhikku *kuti*'s have been completely destroyed.

ELEMENT	MATERIAL	EXTENT OF DAMAGE
ROOF	Calicut tiles, timber frame	Completely destroyed
WALLS	Cabock	Completely destroyed
DOORS	Timber	Completely destroyed
WINDOWS	Timber	Completely destroyed
FLOOR	Cement rendered	Completely destroyed
FOUNDATION	Cabock	No damage
SITE	Sandy with coconut trees.	Washed away
OTHER

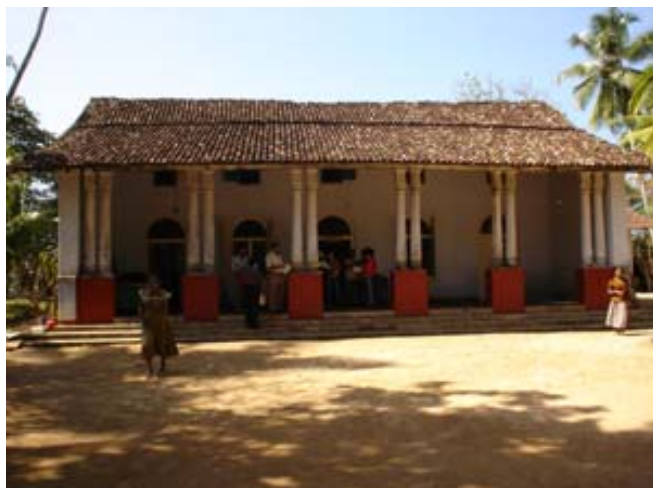
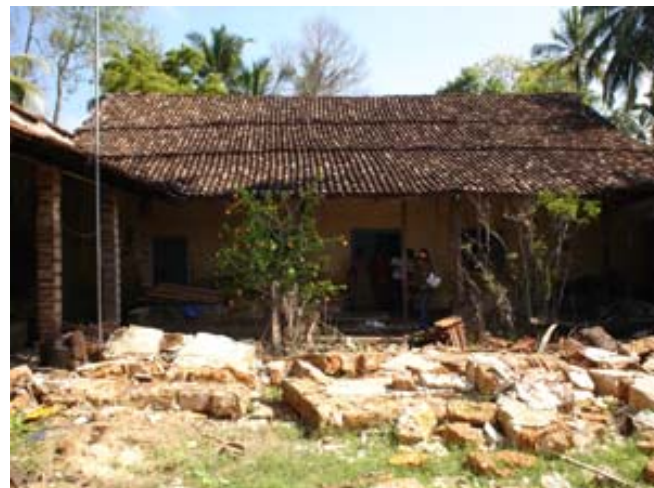
Extent of Damage – Buildings around the courtyard have been destroyed. The internal carvings have been damaged.

ELEMENT	MATERIAL	EXTENT OF DAMAGE
ROOF	Half Round and Calicut tiles, timber frame	Rear roof has collapsed.
WALLS	Cabock	Rear section has collapsed.
DOORS	Decorated timber	Damaged
WINDOWS	Decorated timber	Damaged
FLOOR	Terracotta, brick, cement rendered	Damaged
FOUNDATION	Cabock	No damage
SITE	Sandy soil with coconut trees.	Washed away
OTHER	Storied house.	No damage

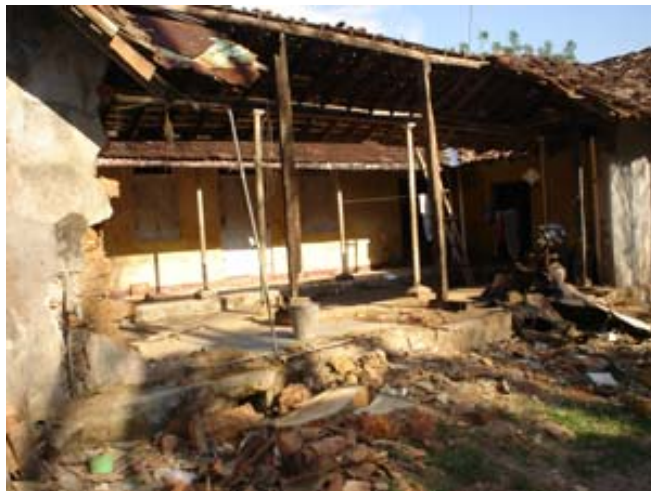
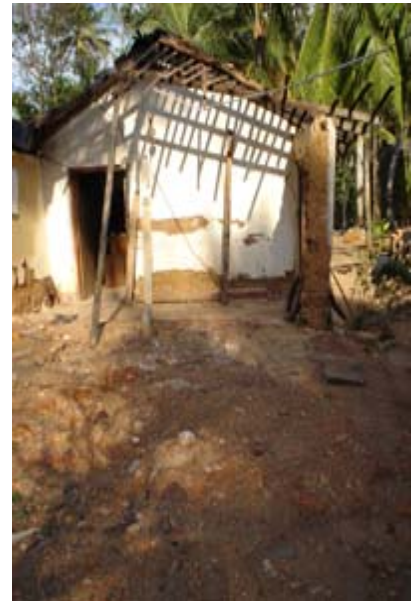
16

Extent of Damage – Back portion and parapet walls completely destroyed.

ELEMENT	MATERIAL	EXTENT OF DAMAGE
ROOF	Calicut tiles, timber frame	Rear roof has collapsed.
WALLS	Cabock	Rear section has collapsed.
DOORS	Decorated timber	Damaged
WINDOWS	Decorated timber	Damaged
FLOOR	Cement rendered	Damaged
FOUNDATION	Cabock	No damage
SITE	Sandy soil with coconut trees	Washed away
OTHER	Storied house	No damage

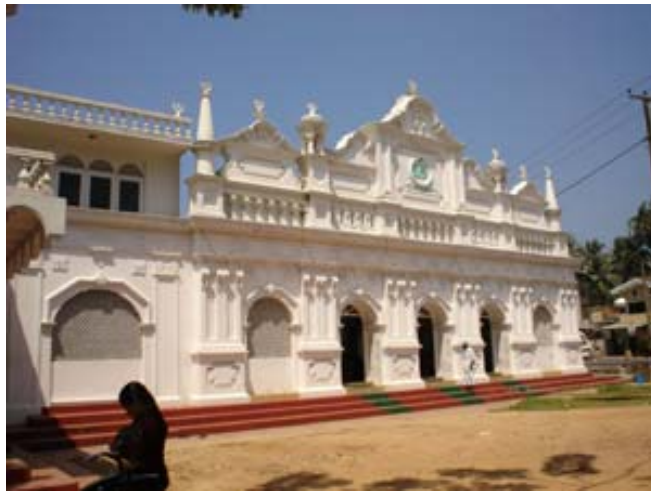
Extent of Damage – Front doors have been damaged.

Parapet wall has been destroyed. The store has been damaged.

ELEMENT	MATERIAL	EXTENT OF DAMAGE
ROOF	Calicut tiles, timber frame	No damage
WALLS	Cabock	No damage
DOORS	Timber	Damaged
WINDOWS	Glazed, timber	No damage
FLOOR	Terrazzo	No damage
FOUNDATION	Cabock	No damage
SITE	Trees	No damage
OTHER		Store has been destroyed.

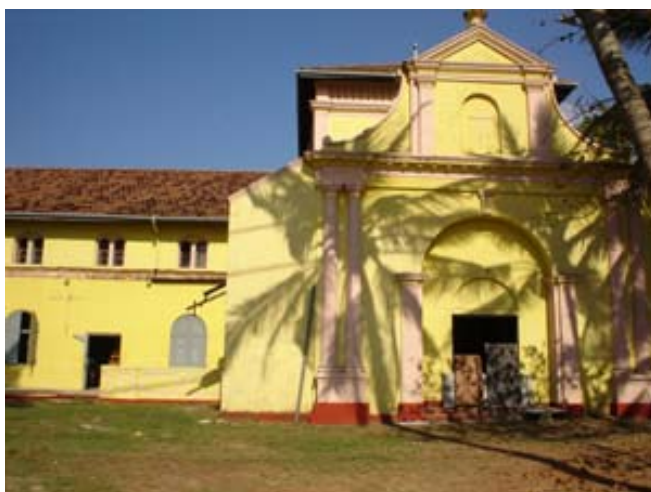
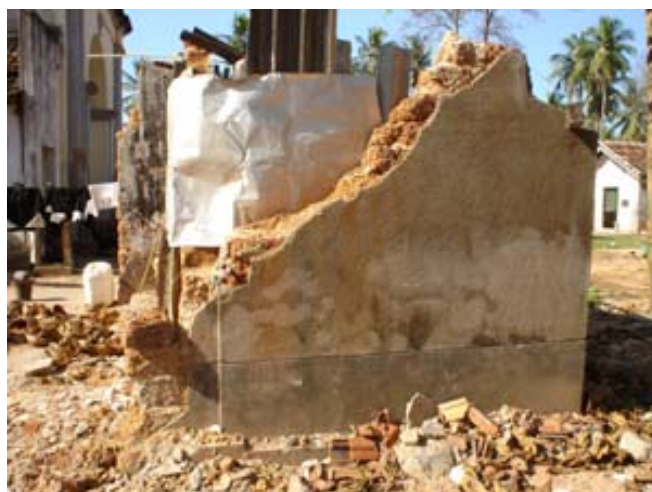
20

Name – ST. FRANCIS ZAVIER’S CHURCH
Type – RELIGIOUS - CULTURAL - HISTORICAL
Address – Palapolwatta, Payagala South
DS Division - Beruwala
GN Division - Payagala South
GPS Coordinates - 06⁰ N 31.226
- 079⁰ E 58.788
Distance from the Sea – 100 m
Extent of Damage – Rear Portion is destroyed.
Doors are damaged. The parapet wall is destroyed.
Estimated Cost for Conservation
- Rs. 1.5 million

ELEMENT	MATERIAL	EXTENT OF DAMAGE
ROOF	Calicut tiles, timber frame	Rear is damaged.
WALLS	Cabock	Rear is damaged.
DOORS	Timber	Damaged
WINDOWS	Glazed, timber	Damaged
FLOOR	Tiled	Rear is damaged.
FOUNDATION	Cabock	No damage
SITE	Sandy with trees	Washed away.
OTHER		Parapet wall has been destroyed.

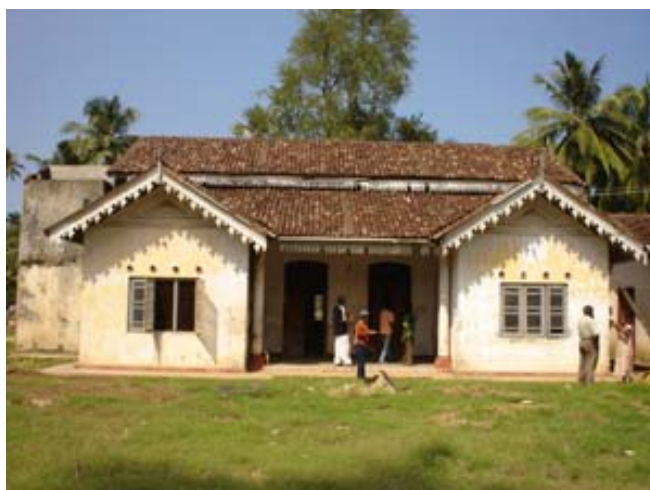
Extent of Damage – Walls are cracked. Doors are damaged.

ELEMENT	MATERIAL	EXTENT OF DAMAGE
ROOF	Half round tiles, timber frame	No damage
WALLS	Cabock	Cracked.
DOORS	Timber	No damage
WINDOWS	Timber	No damage
FLOOR	Cement rendered	No damage
FOUNDATION	Cabock	No damage
SITE	Turf	No damage
OTHER

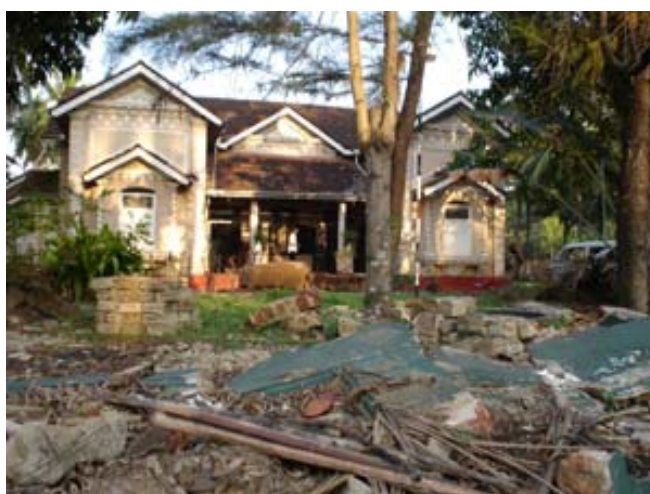
Extent of Damage – Plaster is damaged. Parapet wall is destroyed.

ELEMENT	MATERIAL	EXTENT OF DAMAGE
ROOF	Calicut tiles, timber frame	No damage
WALLS	Cabock	Plaster is damaged.
DOORS	Timber	No damage
WINDOWS	Timber	No damage
FLOOR	Cement rendered	No damage
FOUNDATION	Cabock	No damage
SITE	Coconut cultivation	No damage
OTHER		Parapet wall is destroyed.

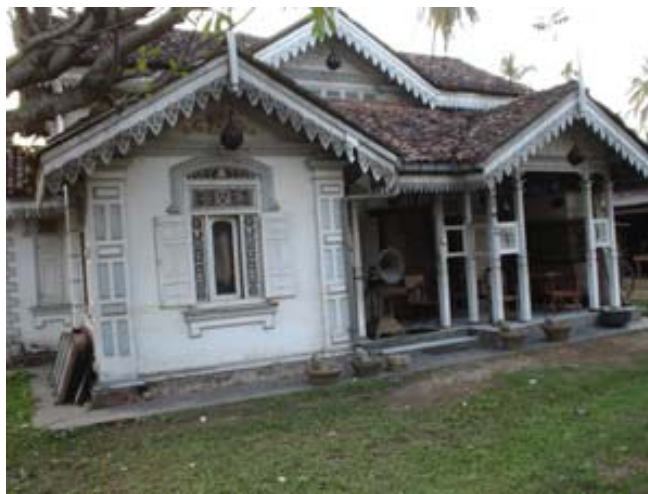
25

Extent of Damage – Doors has been damaged. Parapet wall is destroyed.

ELEMENT	MATERIAL	EXTENT OF DAMAGE
ROOF	Half round tiles, timber frame	No damage
WALLS	Cabock	Plaster is damaged. Walls are cracked.
DOORS	Timber	No damage
WINDOWS	Timber	No damage
FLOOR	Cement rendered	No damage
FOUNDATION	Cabock	No damage
SITE	Coconut cultivation	No damage
OTHER

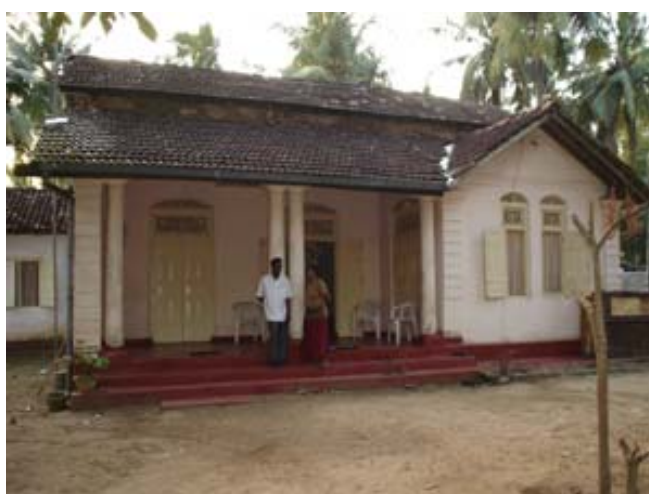
26

Extent of Damage – **Plaster is damaged. Walls are cracked.**

ELEMENT	MATERIAL	EXTENT OF DAMAGE
ROOF	Half round tiles, timber frame	No damage
WALLS	Cabock	Plaster is damaged. Walls are cracked.
DOORS	Timber	No damage
WINDOWS	Timber	No damage
FLOOR	Cement rendered	No damage
FOUNDATION	Cabock	No damage
SITE	Coconut cultivation	No damage
OTHER

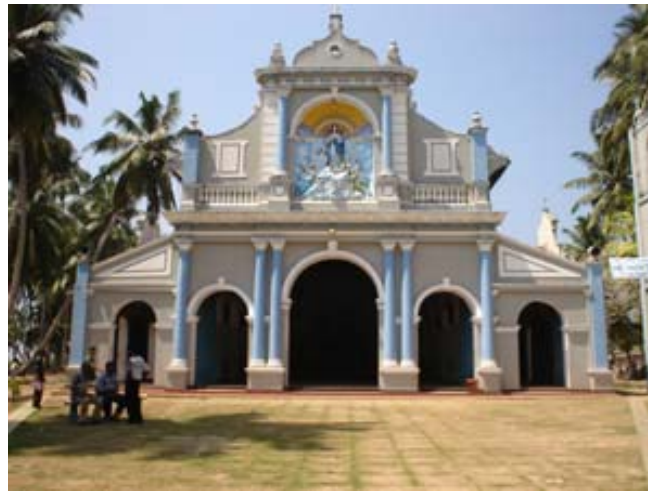
27

Extent of Damage – Parapet wall is completely destroyed. Doors and windows are damaged.

ROOF	Asbestos, timber frame	No damage
WALLS	Bricks	Plaster is damaged. Walls are cracked.
DOORS	Timber	Damaged
WINDOWS	Timber, glass	Damaged
FLOOR	Cement rendered	No damage
FOUNDATION	Rubble	No damage
SITE	Coconut cultivation	No damage
OTHER		Parapet wall is destroyed.

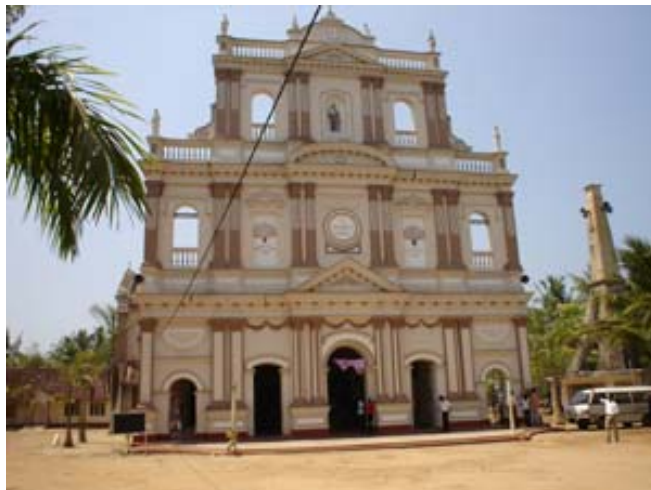
28

Name – ST. JOSEPH'S CHURCH
Type – RELIGIOUS - CULTURAL - HISTORICAL
Address – Kuda Payagala, Payagala
DS Division - Beruwala
GN Division -Payagala North
GPS Coordinates - 06⁰ N 31.840
- 079⁰ E 58.603
Distance from the Sea – 300 m
Extent of Damage – Parapet wall is completely destroyed.
Estimated Cost for Conservation
- Rs. 0.5 million

ELEMENT	MATERIAL	EXTENT OF DAMAGE
ROOF	Calicut tiles, timber frame	No damage
WALLS	Brick	Plaster is damaged. Walls are cracked.
DOORS	Timber	Damaged
WINDOWS	Timber, coloured glass	Damaged
FLOOR	Cement rendered	No damage
FOUNDATION	Rubble	No damage
SITE	Coconut cultivation	No damage
OTHER		Parapet wall is destroyed.

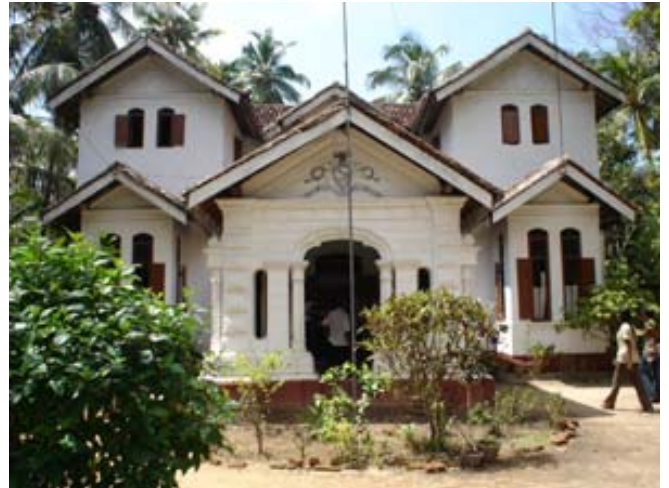
33

Name – NANDAVASA
Type – HISTORICAL - RESIDENTIAL
Address – Nandavasa, Moragalla, Beruwala
DS Division - Beruwala
GN Division - Moragalla
GPS Coordinates - 06⁰ N 27.079
- 079⁰ E 59.149
Distance from the Sea – 1000 m
Extent of Damage – No damage.
Estimated Cost for Restoration
- Rs. 000 million

ELEMENT	MATERIAL	EXTENT OF DAMAGE
ROOF	Half round and Calicut tiles, timber frame	No damage
WALLS	Cabock	No damage
DOORS	Decorated timber	No damage
WINDOWS	Decorated timber	No damage
FLOOR	Cement rendered	No damage
FOUNDATION	Cabock	No damage
SITE	Sand, coconut trees	No damage
OTHER

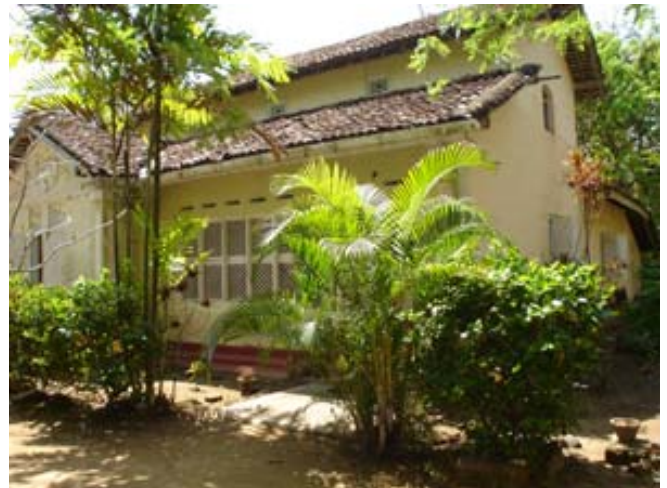
34

Name – KULASEVANA
Type – HISTORICAL - RESIDENTIAL
Address – Kulasevana, Moragalla, Beruwala
DS Division - Beruwala
GN Division - Moragalla
GPS Coordinates - 06⁰ N 27.188
- 079⁰ E 59.047
Distance from the Sea – 600 m
Extent of Damage – No damage
Estimated Cost for Restoration
- Rs. 000 million

ELEMENT	MATERIAL	EXTENT OF DAMAGE
ROOF	Half round tiles, timber frame	No damage
WALLS	Cabock	No damage
DOORS	Timber	No damage
WINDOWS	Timber	No damage
FLOOR	Cement rendered	No damage
FOUNDATION	Cabock	No damage
SITE	Sand, coconut trees	No damage
OTHER

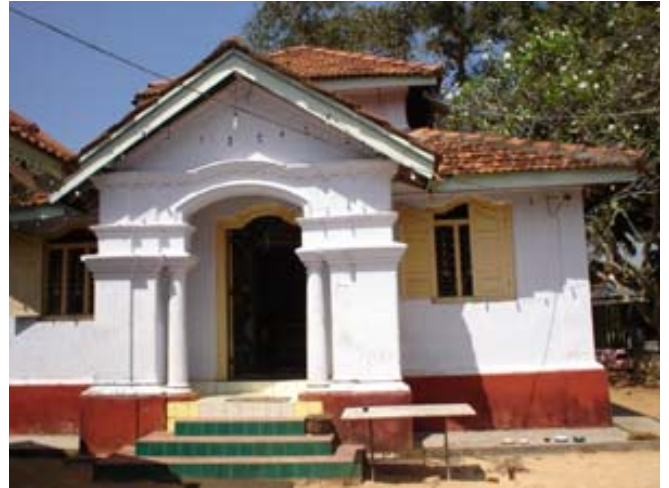
35

Name – GANGARAMAYA PURANA VIHARAYA
Type – RELIGIOUS - CULTURAL
Address – Gangoda Purana Viharaya, Moragalla, Beruwala
DS Division - Beruwala
GN Division - Moragalla
GPS Coordinates - 06⁰ N 27.365
 - 079⁰ E 59.169
Distance from the Sea – 1000 m
Extent of Damage – No damage
Estimated Cost for Restoration
 - Rs. 000 million

ELEMENT	MATERIAL	EXTENT OF DAMAGE
ROOF	Half round and Calicut tiles, timber frame	No damage
WALLS	Cabock	No damage
DOORS	Decorated timber	No damage
WINDOWS	Decorated timber	No damage
FLOOR	Cement rendered	No damage
FOUNDATION	Cabock	No damage
SITE	Trees	No damage
OTHER

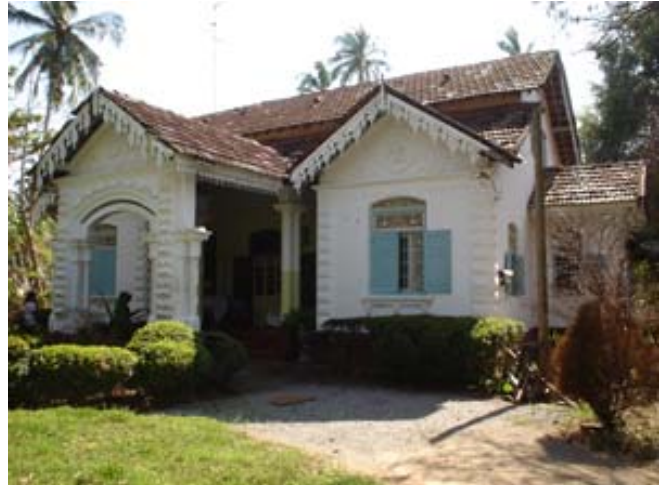
36

Name – SIRINIDULA
Type – HISTORICAL - RESIDENTIAL
Address – Sirinidula, Moragalla, Beruwala
DS Division - Beruwala
GN Division - Moragalla
GPS Coordinates - 06⁰ N 26.949
- 079⁰ E 59.206
Distance from the Sea – 200 m
Extent of Damage – No damage
Estimated Cost for Restoration
- Rs. 000 million

ELEMENT	MATERIAL	EXTENT OF DAMAGE
ROOF	Calicut tiles, timber frame	No damage
WALLS	Cabock	No damage
DOORS	Timber	No damage
WINDOWS	Timber	No damage
FLOOR	Cement rendered	No damage
FOUNDATION	Cabock	No damage
SITE	Trees	No damage
OTHER

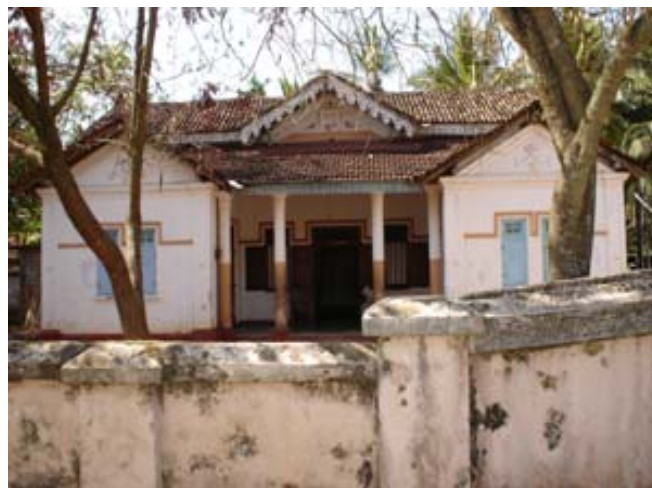
37

Name – SIRINIVASA
Type – HISTORICAL - RESIDENTIAL
Address – No. 2, Awariwatta, Moragalla, Beruwala
DS Division - Beruwala
GN Division - Moragalla
GPS Coordinates - 06⁰ N 26.968
- 079⁰ E 59.203
Distance from the Sea – 200 m
Extent of Damage – No damage
Estimated Cost for Restoration
- Rs. 000 million

ELEMENT	MATERIAL	EXTENT OF DAMAGE
ROOF	Calicut tiles, timber frame	No damage
WALLS	Cabock	No damage
DOORS	Timber	No damage
WINDOWS	Timber	No damage
FLOOR	Cement rendered	No damage
FOUNDATION	Cabock	No damage
SITE	Coconut trees	No damage
OTHER

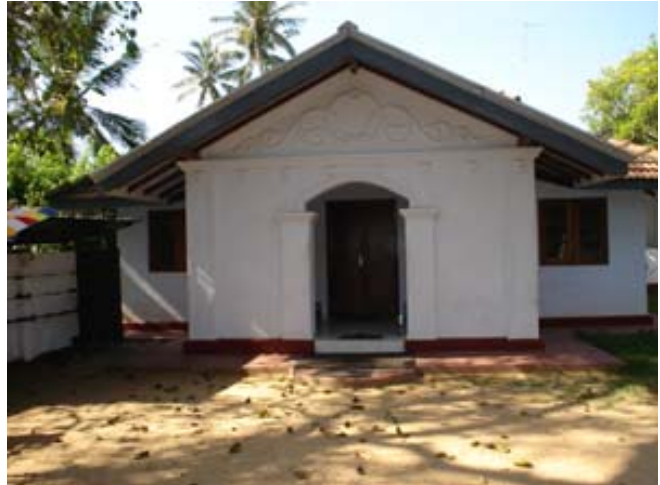
38

Name – DAMMIKARAMAYA
Type – HISTORICAL - CULTURAL - RELIGIOUS
Address – Dammikaramaya, Moragalla, Beruwala
DS Division - Beruwala
GN Division - Moragalla
GPS Coordinates - 06⁰ N 27.298
- 079⁰ E 58.720
Distance from the Sea – 350 m
Extent of Damage – No damage.
Estimated Cost for Restoration
- Rs. 000 million

ELEMENT	MATERIAL	EXTENT OF DAMAGE
ROOF	Calicut tiles, timber frame	No damage
WALLS	Cabock	No damage
DOORS	Decorated timber	No damage
WINDOWS	Decorated timber	No damage
FLOOR	Cement rendered	No damage
FOUNDATION	Cabock	No damage
SITE	Coconut trees	No damage
OTHER

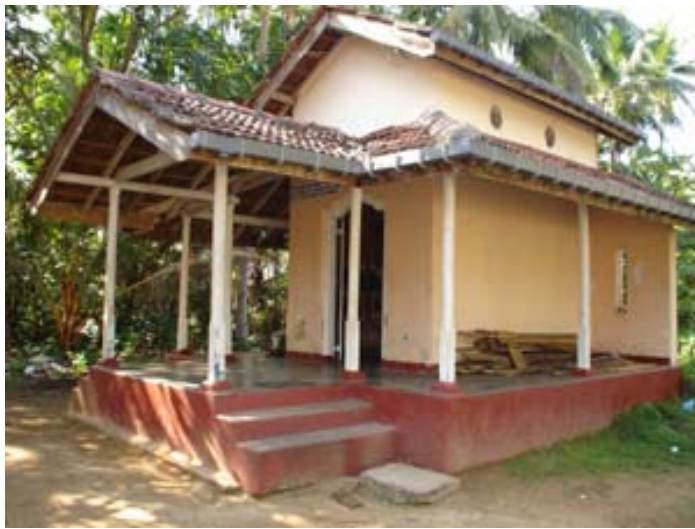
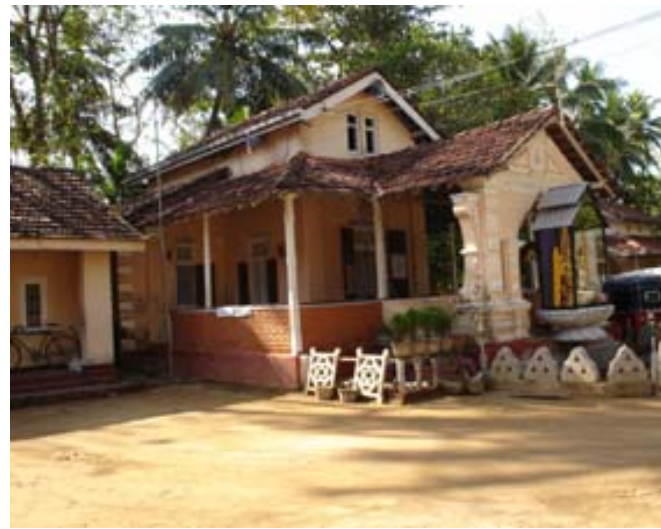
39

Name – SRI BUDDHASIRI VIHARAYA
Type – HISTORICAL - CULTURAL - RELIGIOUS
Address – Sri Buddhasiri Viharaya, Moragalla, Beruwala
DS Division - Beruwala
GN Division - Moragalla
GPS Coordinates - 06⁰ N 27.312
- 079⁰ E 59.050
Distance from the Sea – 200 m
Extent of Damage – No damage.
Estimated Cost for Restoration
- Rs. 000 million

ELEMENT	MATERIAL	EXTENT OF DAMAGE
ROOF	Calicut tiles, timber frame	No damage
WALLS	Cabock	No damage
DOORS	Decorated timber	No damage
WINDOWS	Decorated timber	No damage
FLOOR	Cement rendered	No damage
FOUNDATION	Cabock	No damage
SITE	Coconut trees	No damage
OTHER

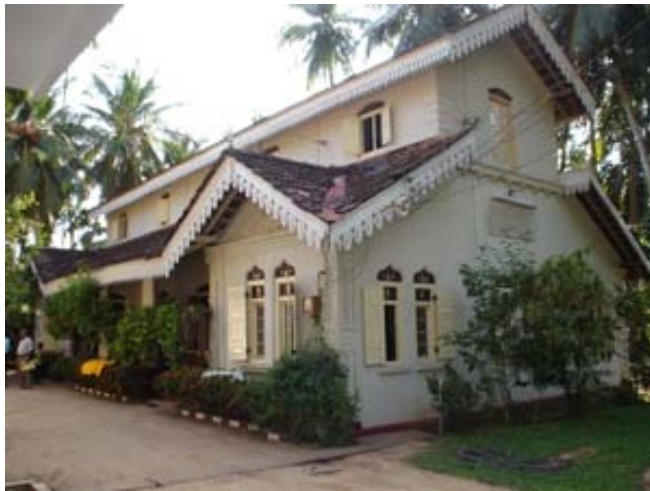
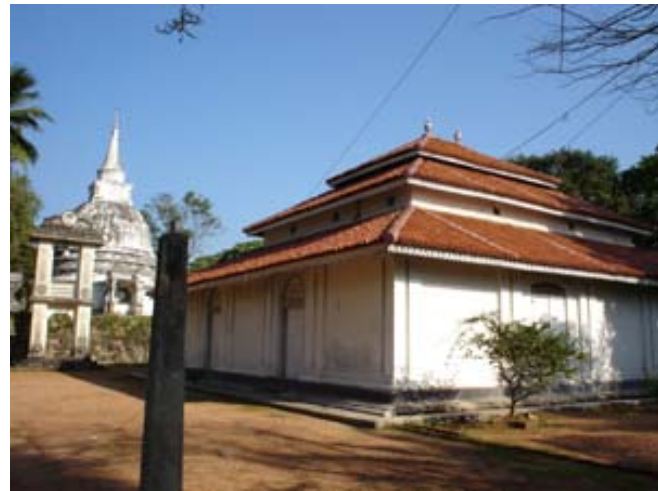
40

Name – SAPUGODA SRI MAHA VIHARAYA
Type – HISTORICAL - CULTURAL - RELIGIOUS
Address – Sapugoda Sri Maha Viharaya, Temple Road, Beruwala
DS Division - Beruwala
GN Division - Masalgoda
GPS Coordinates - 06⁰ N 28.110
- 079⁰ E 58.964
Distance from the Sea – 500 m
Extent of Damage – No damage
Estimated Cost for Restoration
- Rs. 000 million

ELEMENT	MATERIAL	EXTENT OF DAMAGE
ROOF	Asbestos, timber frame	No damage
WALLS	Bricks	No damage
DOORS	Glazed, timber	No damage
WINDOWS	Glazed, timber	No damage
FLOOR	Cement rendered	No damage
FOUNDATION	Rubble	No damage
SITE	Turf	No damage
OTHER

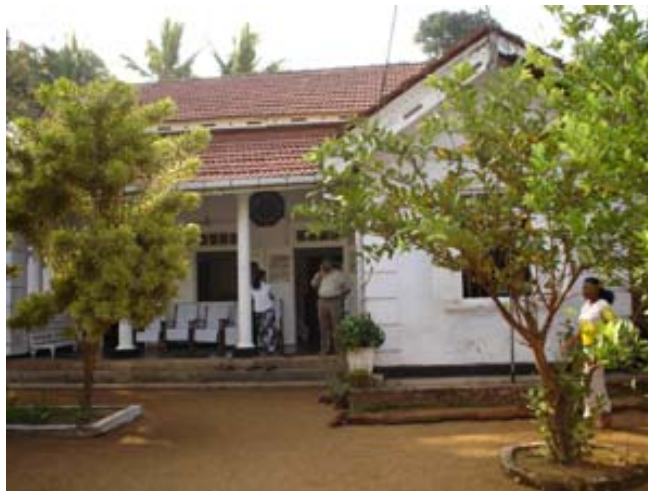
41

Name – ABINAVARAMAYA
Type – CULTURAL - RELIGIOUS
Address – Abinavaramaya, Temple Road, Beruwala
DS Division - Beruwala
GN Division - Hettiyakanda
GPS Coordinates - 06⁰ N 28.128
- 079⁰ E 58.792
Distance from the Sea – 300 m
Extent of Damage – No damage
Estimated Cost for Restoration
- Rs. 000 million

ELEMENT	MATERIAL	EXTENT OF DAMAGE
ROOF	Calicut tiles, Timber frame	No damage
WALLS	Cabock	No damage
DOORS	Decorated timber	No damage
WINDOWS	Decorated timber	No damage
FLOOR	Cement rendered	No damage
FOUNDATION	Cabock	No damage
SITE	Coconut trees, well maintained.	No damage
OTHER

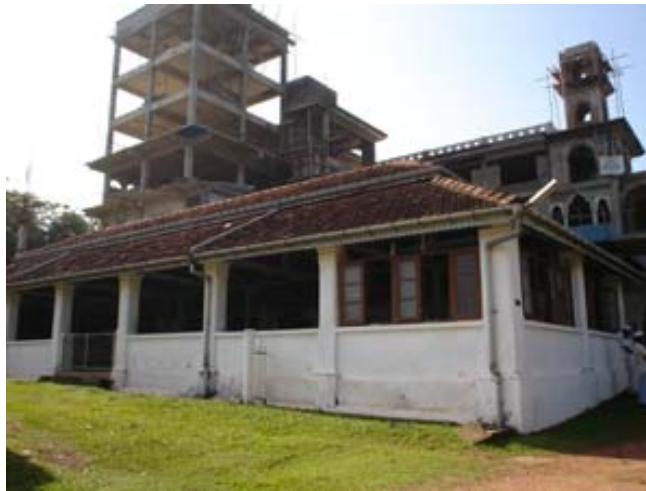
42

Name – BUHARI MOSQUE
Type – CULTURAL - RELIGIOUS
Address – Buhari Mosque, Hettiyakanda Beruwala
DS Division - Beruwala
GN Division - Hettiyakanda
GPS Coordinates - 06⁰ N 27.836
- 079⁰ E 58.744
Distance from the Sea – 200 m
Extent of Damage – No damage
Estimated Cost for Restoration
- Rs. 000 million

ELEMENT	MATERIAL	EXTENT OF DAMAGE
ROOF	Calicut tiles, timber frame	No damage
WALLS	Cabock	No damage
DOORS	Decorated timber	No damage
WINDOWS	Decorated timber	No damage
FLOOR	Cement rendered	No damage
FOUNDATION	Cabock	No damage
SITE	Trees well maintained	No damage
OTHER

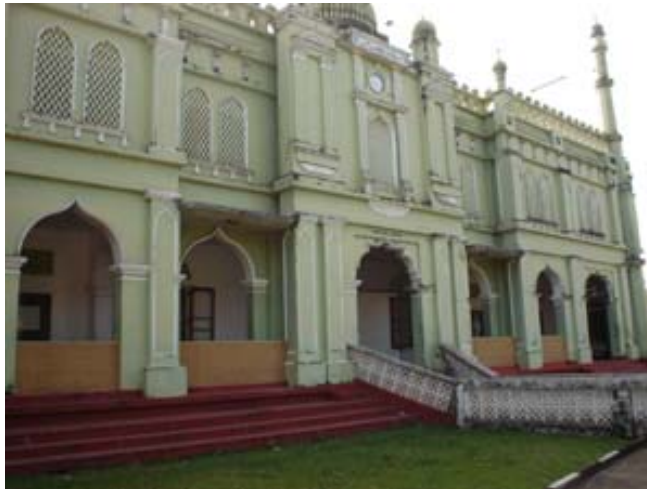
43

Name – MARADANA MOSQUE
Type – CULTURAL - RELIGIOUS
Address – Maradana Mosque, Maradana, Beruwala
DS Division - Beruwala
GN Division - Maradana
GPS Coordinates - 06⁰ N 27.810
- 079⁰ E 58.553
Distance from the Sea – 150 m
Extent of Damage – No damage.
Estimated Cost for Restoration
- Rs. 000 million

ELEMENT	MATERIAL	EXTENT OF DAMAGE
ROOF	Calicut tiles, timber frame	No damage
WALLS	Cabock	No damage
DOORS	Decorated timber	No damage
WINDOWS	Decorated timber	No damage
FLOOR	Cement rendered	No damage
FOUNDATION	Cabock	No damage
SITE	Trees, well maintained.	No damage
OTHER

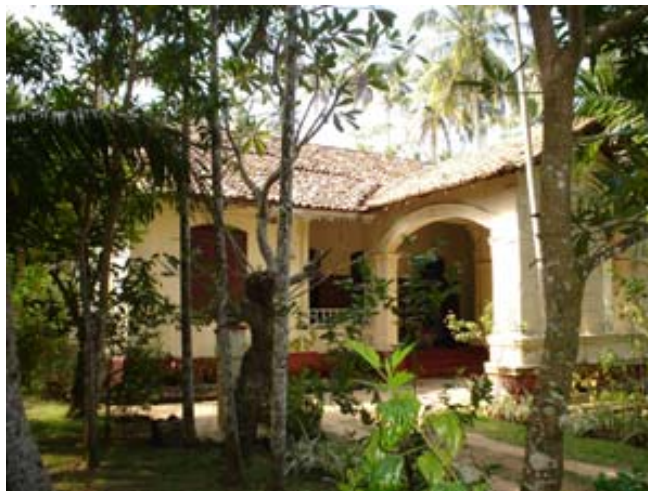
44

Name – AGNIDA
Type – HISTORICAL - RESIDENTIAL
Address – No. 5, Bandarawatta, Beruwala
DS Division - Beruwala
GN Division - Paranakade
GPS Coordinates - 06⁰ N 28.238
- 079⁰ E 58.580
Distance from the Sea – 200 m
Extent of Damage – No damage
Estimated Cost for Restoration
- Rs. 000 million

ELEMENT	MATERIAL	EXTENT OF DAMAGE
ROOF	Half round tiles, timber frame	No damage
WALLS	Cabock	No damage
DOORS	Timber	No damage
WINDOWS	Timber	No damage
FLOOR	Cement rendered and tiled	No damage
FOUNDATION	Cabock	No damage
SITE	Turf	No damage
OTHER

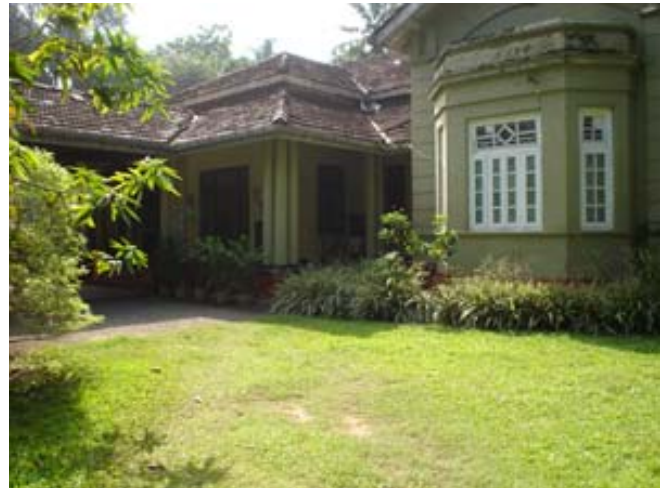
45

Name – SARVODAYA
Type – HISTORICAL - RESIDENTIAL
Address – No. 6, Bandarawatta, Beruwala
DS Division - Beruwala
GN Division - Paranakade
GPS Coordinates - 06⁰ N 28.220
- 079⁰ E 58.538
Distance from the Sea – 250 m
Extent of Damage – No damage
Estimated Cost for Conservation
- Rs. 000 million

ELEMENT	MATERIAL	EXTENT OF DAMAGE
ROOF	Calicut tiles, timber frame	No damage
WALLS	Cabock	No damage
DOORS	Timber	No damage
WINDOWS	Timber	No damage
FLOOR	Cement rendered	No damage
FOUNDATION	Cabock	No damage
SITE	Turf	No damage
OTHER

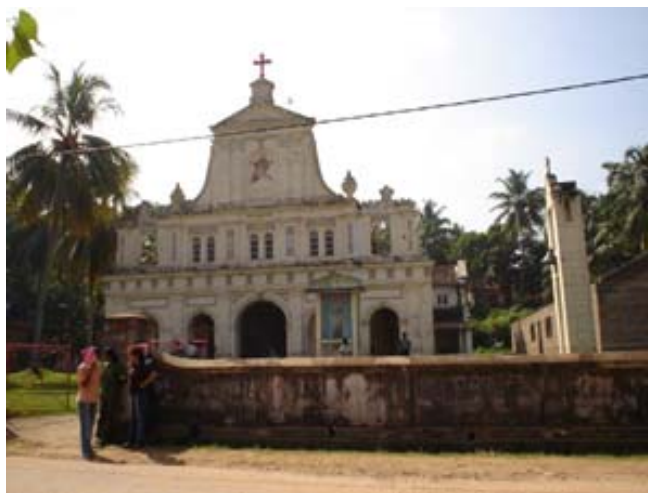
46

Name – ST. LAZARUS CHURCH
Type – HISTORICAL - CULTURAL - RELIGIOUS
Address – No. 85, Reguwa Road, Beruwala
DS Division - Beruwala
GN Division - Polkotuwa
GPS Coordinates - 06⁰ N 28.262
- 079⁰ E 58.725
Distance from the Sea – 100 m
Extent of Damage – No damage
Estimated Cost for Conservation
- Rs. 000 million

ELEMENT	MATERIAL	EXTENT OF DAMAGE
ROOF	Hal round tiles, timber frame	No damage
WALLS	Cabock	No damage
DOORS	Timber	No damage
WINDOWS	Timber	No damage
FLOOR	Cement rendered	No damage
FOUNDATION	Cabock	No damage
SITE	Turf	No damage
OTHER

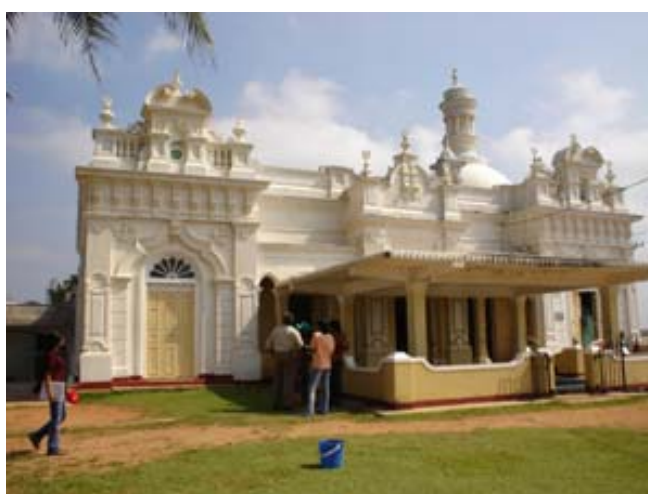
47

Name – KECHCHIMALE MOSQUE
Type – HISTORICAL - CULTURAL - RELIGIOUS
Address – Kechchimale Mosque, Beruwala
DS Division - Beruwala
GN Division - Paranakade
GPS Coordinates - 06⁰ N 28.382
- 079⁰ E 58.575
Distance from the Sea – 10 m
Extent of Damage – No damage
Estimated Cost for Conservation
- Rs. 000 million

ELEMENT	MATERIAL	EXTENT OF DAMAGE
ROOF	Half round tiles, timber frame	No damage
WALLS	Cabock	No damage
DOORS	Timber	No damage
WINDOWS	Timber	No damage
FLOOR	Cement rendered	No damage
FOUNDATION	Cabock	No damage
SITE	Turf, concreted	No damage
OTHER

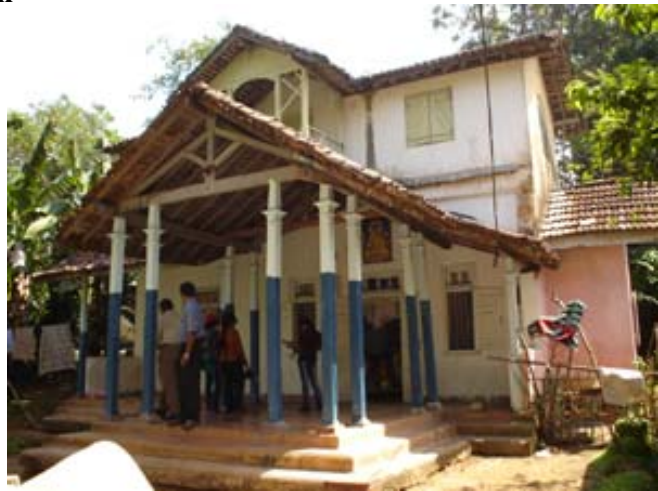
48

Extent of Damage – No damage

ELEMENT	MATERIAL	EXTENT OF DAMAGE
ROOF	Half round tiles, timber frame	No damage
WALLS	Cabock	No damage
DOORS	Timber	No damage
WINDOWS	Timber	No damage
FLOOR	Cement rendered	No damage
FOUNDATION	Cabock	No damage
SITE	Trees	No damage
OTHER

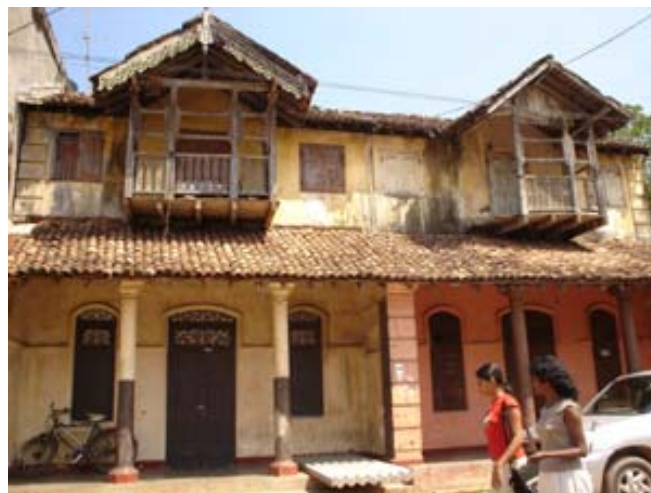
49

Extent of Damage – No damage

ELEMENT	MATERIAL	EXTENT OF DAMAGE
ROOF	Half round tiles, timber frame	No damage
WALLS	Cabock	No damage
DOORS	Timber	No damage
WINDOWS	Timber	No damage
FLOOR	Cement rendered	No damage
FOUNDATION	Cabock	No damage
SITE	Trees	No damage
OTHER

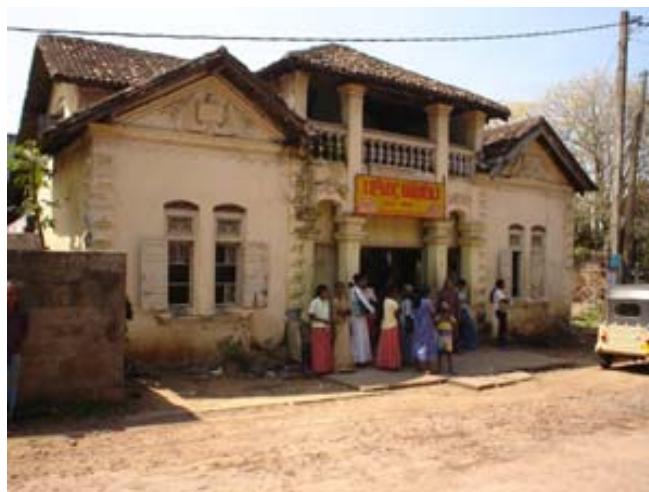
50

Name – SALGADO STORES
Type – HISTORICAL - COMMERCIAL
Address – 6, Station Road, Beruwala
DS Division - Beruwala
GN Division - Polkotuwa
GPS Coordinates - 06⁰ N 28.624
- 079⁰ E 58.981
Distance from the Sea – 100 m
Extent of Damage – No damage
Estimated Cost for Conservation
- Rs. 000 million

ELEMENT	MATERIAL	EXTENT OF DAMAGE
ROOF	Half round tiles, timber frame	No damage
WALLS	Cabock	No damage
DOORS	Timber	No damage
WINDOWS	Timber	No damage
FLOOR	Cement rendered	No damage
FOUNDATION	Cabock	No damage
SITE	Trees	No damage
OTHER

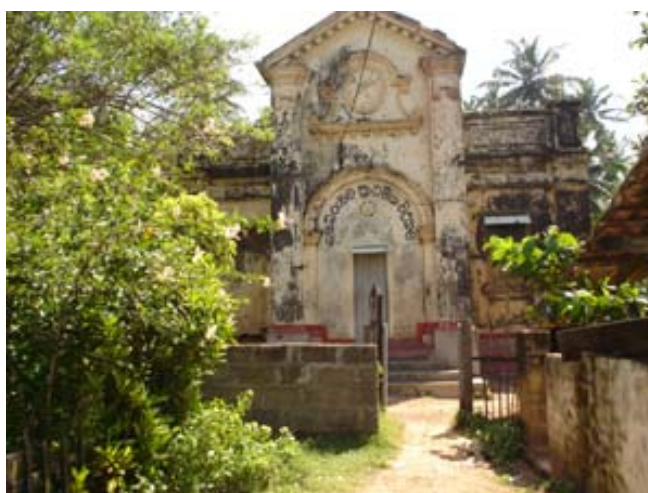
51

Name – BERUWALA PRIMARY SCHOOL
Type – HISTORICAL - SERVICES
Address – Beruwala Primary School, Galle Road, Beruwala
DS Division - Beruwala
GN Division - Polkotuwa
GPS Coordinates - 06⁰ N 28.642
- 079⁰ E 58.988
Distance from the Sea – 100 m
Extent of Damage – No damage
Estimated Cost for Conservation
- Rs. 000 million

ELEMENT	MATERIAL	EXTENT OF DAMAGE
ROOF	Calicut tiles, timber frame	No damage
WALLS	Cabock	No damage
DOORS	Timber	No damage
WINDOWS	Timber	No damage
FLOOR	Cement rendered	No damage
FOUNDATION	Cabock	No damage
SITE	Trees	No damage
OTHER

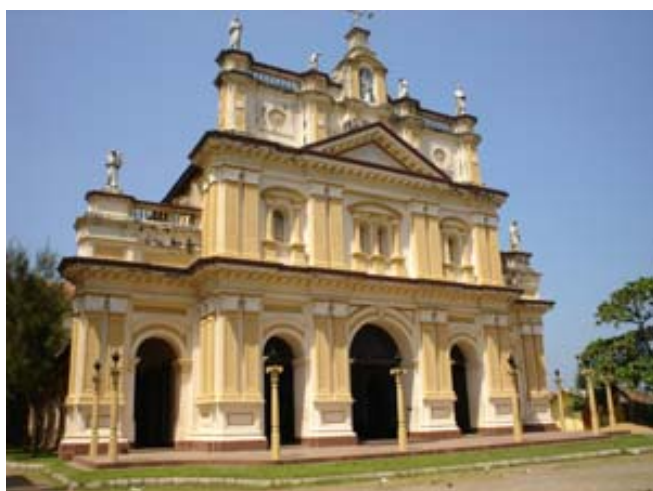
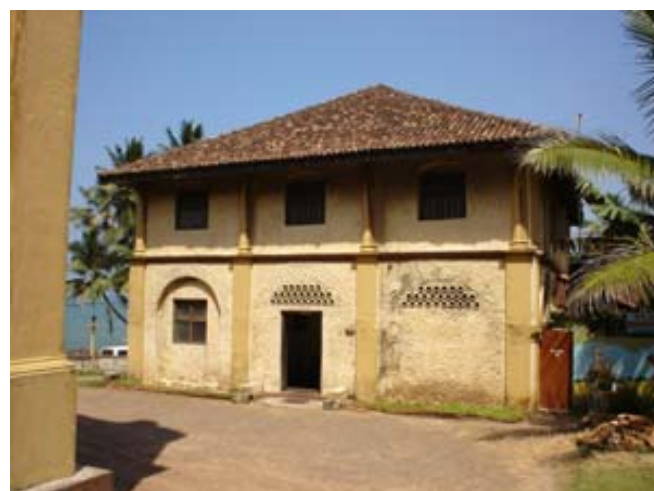
52

Name – ST. ANN’S CHURCH
Type – RELIGIOUS - CULTURAL
Address – St. Ann’s Church, Galle Road, Polkotuwa, Beruwala
DS Division - Beruwala
GN Division - Polkotuwa
GPS Coordinates - 06⁰ N 28.897
- 079⁰ E 59.026
Distance from the Sea – 20 m
Extent of Damage – No damage
Estimated Cost for Conservation
- Rs. 000 million

ELEMENT	MATERIAL	EXTENT OF DAMAGE
ROOF	Calicut tiles, timber frame	No damage
WALLS	Cabock	No damage
DOORS	Timber	No damage
WINDOWS	Glazed, timber	No damage
FLOOR	Cement rendered	No damage
FOUNDATION	Cabock	No damage
SITE	Trees	No damage
OTHER

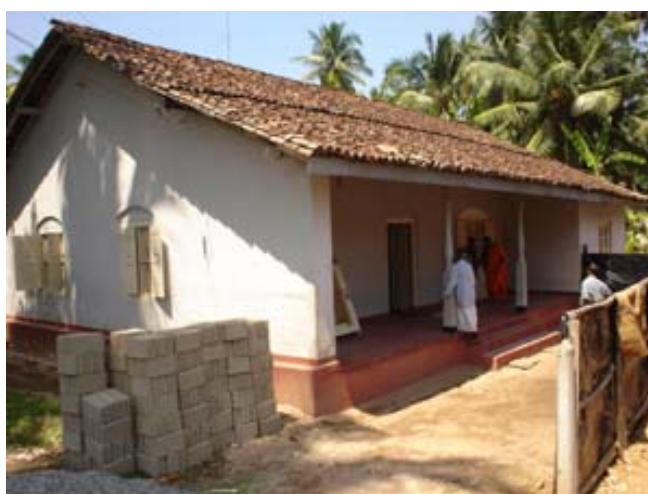
53

Extent of Damage – **No damage**

ELEMENT	MATERIAL	EXTENT OF DAMAGE
ROOF	Half round tiles, timber frame	No damage
WALLS	Cabock	No damage
DOORS	Timber	No damage
WINDOWS	Timber	No damage
FLOOR	Cement rendered	No damage
FOUNDATION	Cabock	No damage
SITE	Trees and sand	No damage
OTHER

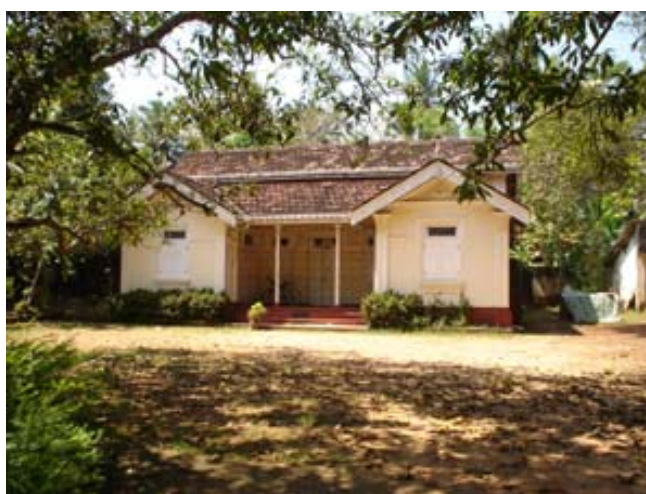
54

Name –
Type – HISTORICAL- RESIDENTIAL
Address – Thudawa Road, Maggona
DS Division - Beruwala
GN Division – Maggona West
GPS Coordinates - 06⁰ N 30.287
- 079⁰ E 58.733
Distance from the Sea – 300 m
Extent of Damage – No damage
Estimated Cost for Conservation
- Rs. 000 million

ELEMENT	MATERIAL	EXTENT OF DAMAGE
ROOF	Calicut tiles, timber frame	No damage
WALLS	Cabock	No damage
DOORS	Timber	No damage
WINDOWS	Timber	No damage
FLOOR	Cement rendered	No damage
FOUNDATION	Cabock	No damage
SITE	Trees	No damage
OTHER

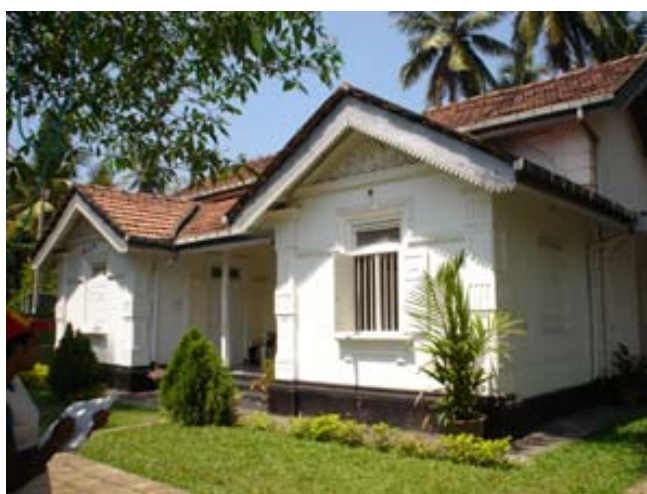
55

Name – LINDER VILLA
Type – HISTORICAL- RESIDENTIAL
Address – Thudawa Road, Maggona
DS Division - Beruwala
GN Division – Maggona West
GPS Coordinates - 06⁰ N 30.270
- 079⁰ E 58.680
Distance from the Sea – 300 m
Extent of Damage – No damage
Estimated Cost for Conservation
- Rs. 000 million

ELEMENT	MATERIAL	EXTENT OF DAMAGE
ROOF	Calicut tiles, timber frame	No damage
WALLS	Cabock	No damage
DOORS	Timber	No damage
WINDOWS	Timber	No damage
FLOOR	Cement rendered	No damage
FOUNDATION	Cabock	No damage
SITE	Trees	No damage
OTHER

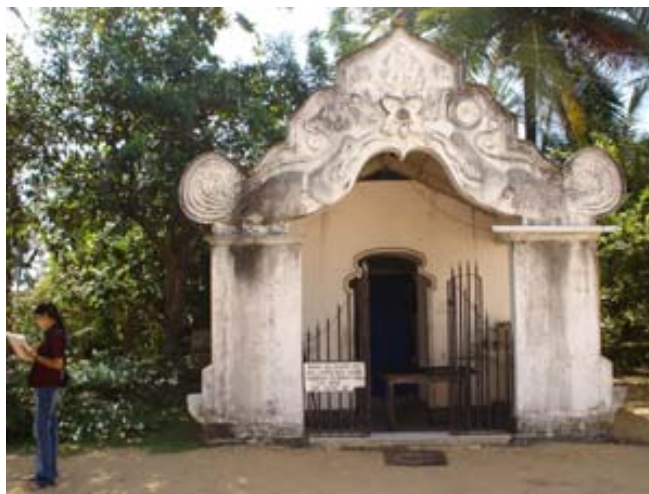
56

Name – PARAMA CHAITYARAMAYA
Type – RELIGIOUS - CULTURAL - HISTORICAL
Address – Parama Chaityaramaya, Magalkanda
DS Division - Beruwala
GN Division – Magalkanda South
GPS Coordinates - 06⁰ N 29.392
- 079⁰ E 59.005
Distance from the Sea – 100 m
Extent of Damage – No damage
Estimated Cost for Conservation
- Rs. 000 million

ELEMENT	MATERIAL	EXTENT OF DAMAGE
ROOF	Calicut tiles, timber frame	No damage
WALLS	Cabock	No damage
DOORS	Timber	No damage
WINDOWS	Timber	No damage
FLOOR	Tiled	No damage
FOUNDATION	Cabock	No damage
SITE	Turf and coconut trees.	No damage
OTHER

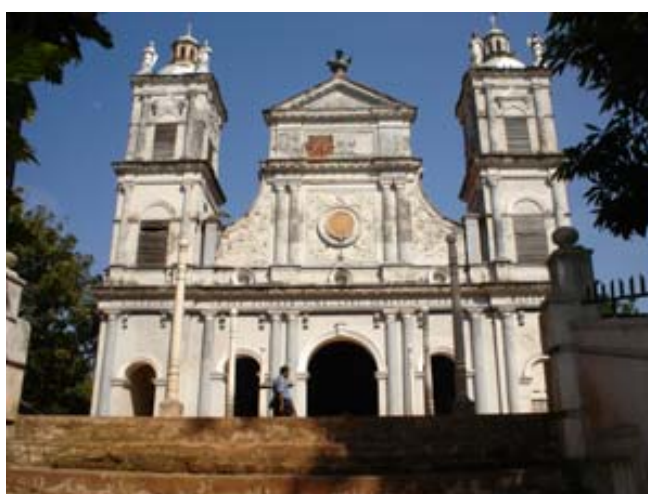
57

Name – ST. MARY’S CHURCH
Type – RELIGIOUS - CULTURAL - HISTORICAL
Address – St. Mary’s Church, Maggona
DS Division - Beruwala
GN Division – Magalkanda West
GPS Coordinates - 06⁰ N 30.121
- 079⁰ E 58.869
Distance from the Sea – 400 m
Extent of Damage – No damage
Estimated Cost for Conservation
- Rs. 000 million

ELEMENT	MATERIAL	EXTENT OF DAMAGE
ROOF	Calicut tiles, timber frame	No damage
WALLS	Cabock	No damage
DOORS	Timber	No damage
WINDOWS	Timber	No damage
FLOOR	Tiled	No damage
FOUNDATION	Cabock	No damage
SITE	Turf and coconut trees.	No damage
OTHER

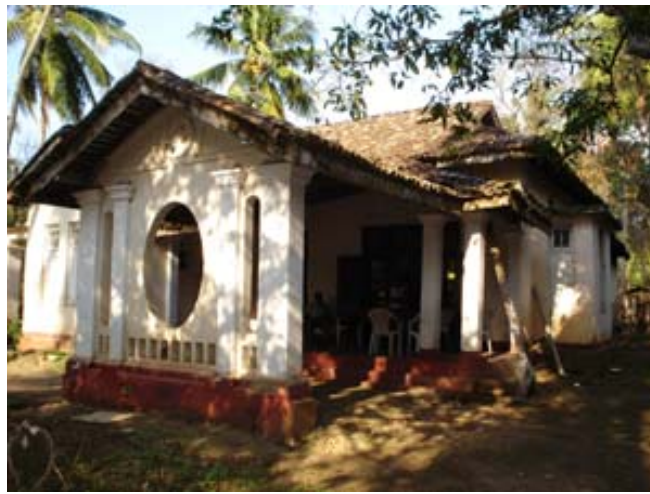
Extent of Damage – Walls are cracked. Plasters are damaged.

ELEMENT	MATERIAL	EXTENT OF DAMAGE
ROOF	Calicut tiles, timber frame	No damage
WALLS	Cabock	No damage
DOORS	Timber	No damage
WINDOWS	Timber	No damage
FLOOR	Tiled, cement rendered	No damage
FOUNDATION	Cabock	No damage
SITE	Coconut cultivation	No damage
OTHER

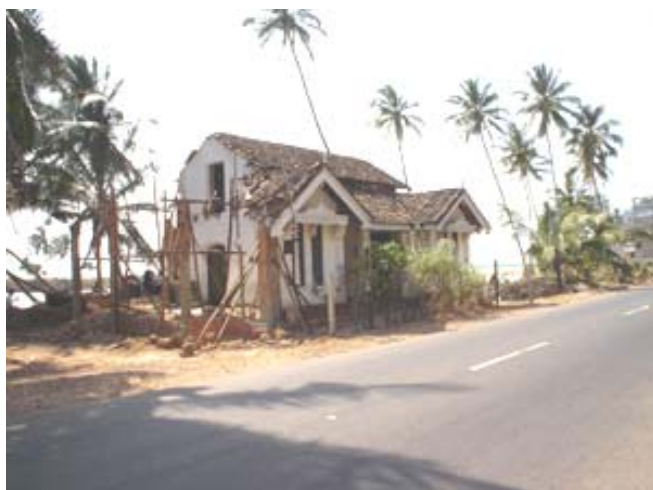
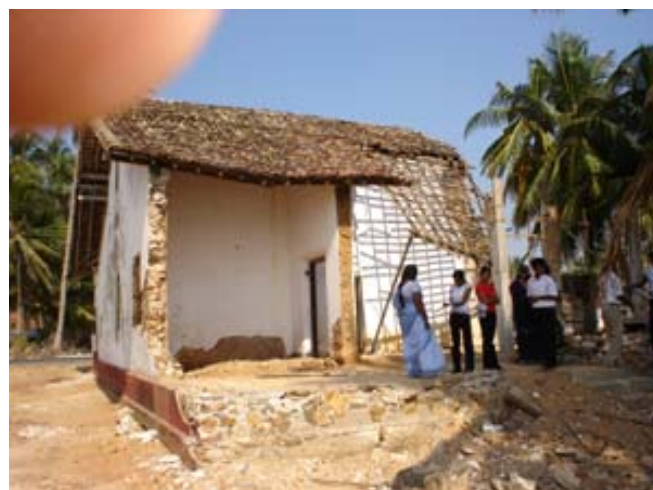
Extent of Damage – The entire building has been destroyed except for two rooms.

ELEMENT	MATERIAL	EXTENT OF DAMAGE
ROOF	Half round tiles, timber frame	Completely destroyed
WALLS	Cabock	Completely destroyed
DOORS	Timber	Damaged
WINDOWS	Timber	Damaged
FLOOR	Cement rendered, timber deck	Completely destroyed
FOUNDATION	Cabock, Rubble	Damaged
SITE	Coconut cultivation	Washed away
OTHER

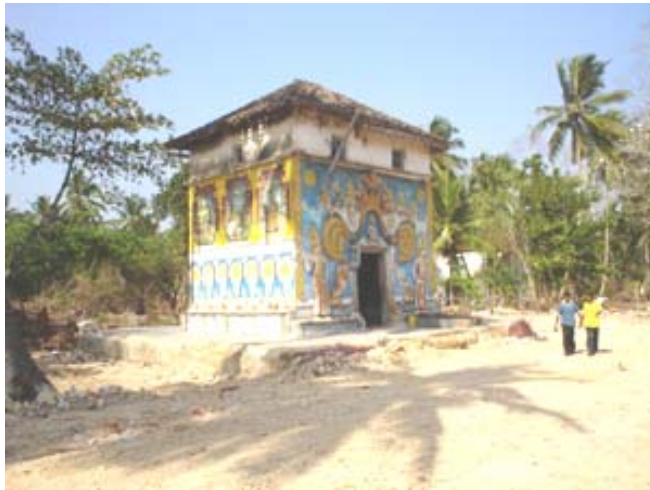
Extent of Damage – The image house and bell tower is badly damaged. *Devalage*, *poyage* and *sangavasa* is totally destroyed. Walls and flower alters of the Bo-tree and *stupa* are destroyed.

ELEMENT	MATERIAL	EXTENT OF DAMAGE
ROOF	Half round tiles, Calicut tiles, timber frame	Completely destroyed
WALLS	Cabock	Completely destroyed
DOORS	Timber	Completely destroyed
WINDOWS	Timber	Completely destroyed
FLOOR	Cement rendered	Completely destroyed
FOUNDATION	Rubble	Completely destroyed
SITE	Coconut cultivation	Completely washed away.
OTHER
