ICOMOS Sri Lanka

**Preliminary Survey of Tsunami-affected Monuments
and Sites in the Maritime Region of Sri Lanka**

PART THREE
The Western Maritime Region:
from the Gin Ganga to the Kalu Ganga

March 2005

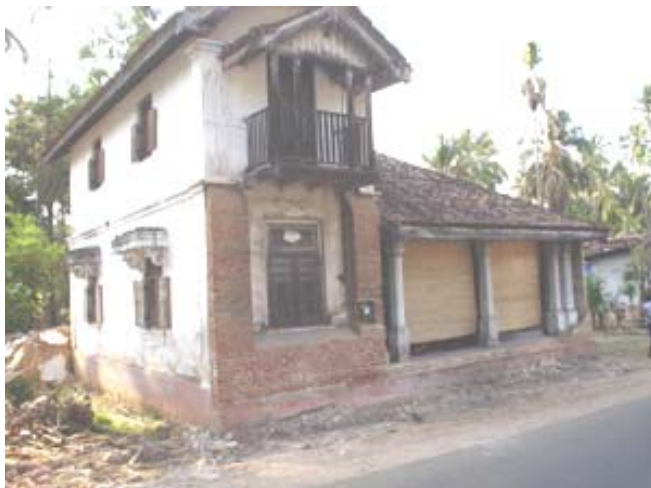
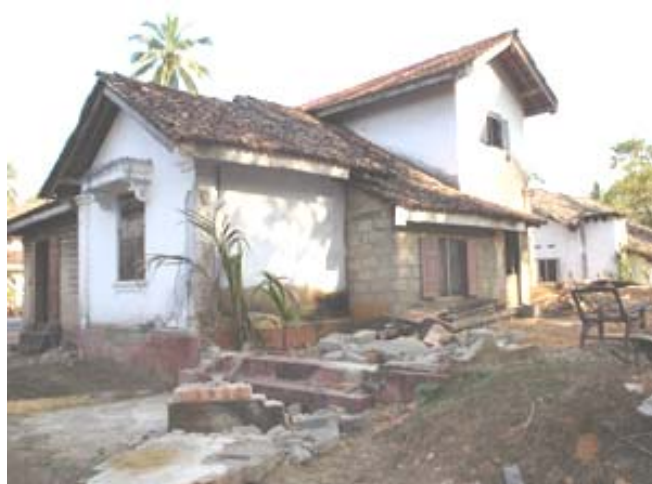
Extent of Damage – The rear portion is completely destroyed. Parapet wall is destroyed. Doors are damaged.

ELEMENT	MATERIAL	EXTENT OF DAMAGE
ROOF	Calicut tiles, timber frame	Rear is destroyed.
WALLS	Limestone, bricks	Rear is destroyed.
DOORS	Timber	Damaged
WINDOWS	Timber	Damaged
FLOOR	Cement rendered	Damaged
FOUNDATION	Rubble	No damage
SITE	Trees	No damage
OTHER		Parapet wall is destroyed.

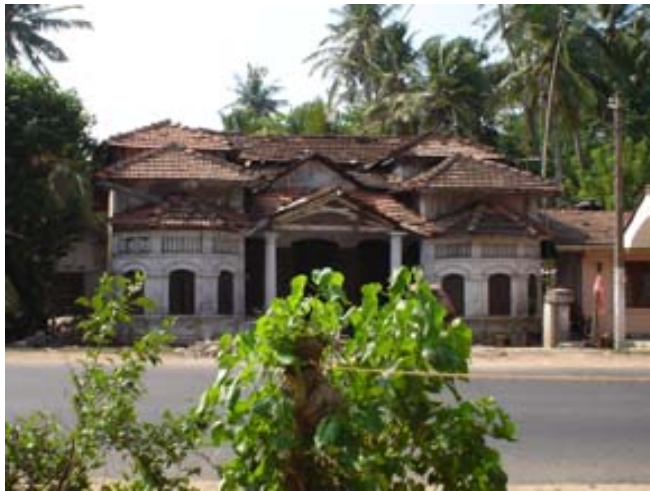
Extent of Damage – **The rear portion is completely destroyed. Doors and windows are damaged.**

ELEMENT	MATERIAL	EXTENT OF DAMAGE
ROOF	Half round tiles, Calicut tiles timber frame	Rear section is completely destroyed.
WALLS	Cabock Rubble	Rear section is completely destroyed.
DOORS	Timber	Damaged
WINDOWS	Timber	Damaged
FLOOR	Cement rendered	Damaged
FOUNDATION	Rubble	No damage
SITE		
OTHER

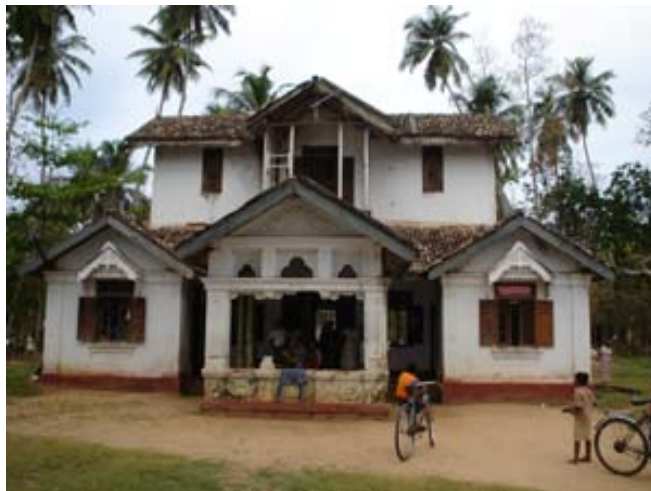
Extent of Damage – The rear portion of the house is destroyed. Walls are cracked. Plaster has been damaged.

ELEMENT	MATERIAL	EXTENT OF DAMAGE
ROOF	Half round tiles, timber frame	Rear portion is completely destroyed.
WALLS	Bricks	Rear portion is completely destroyed. Others are cracked. Plaster is damaged.
DOORS	Timber	Rear portion is completely destroyed.
WINDOWS	Timber	Rear portion is completely destroyed.
FLOOR	Cement rendered	Rear portion is completely destroyed.
FOUNDATION	Rubble	No damage
SITE	Coconut cultivation	No damage
OTHER

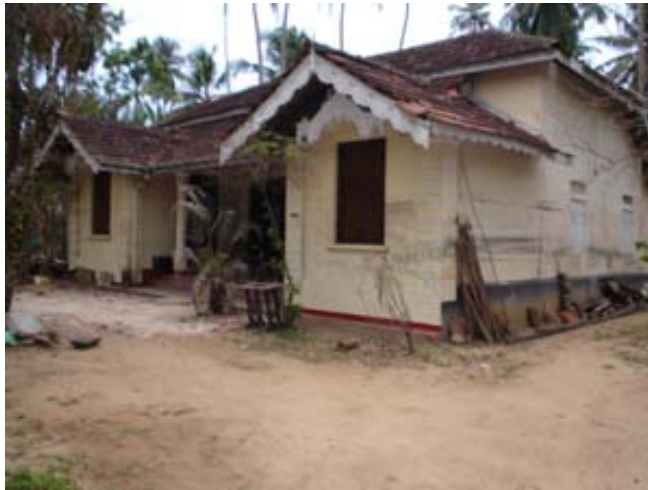
Extent of Damage – Part of the house is destroyed. Walls are cracked. Doors are damaged.

ELEMENT	MATERIAL	EXTENT OF DAMAGE
ROOF	Calicut tiles, timber frame	Rear portion is completely destroyed.
WALLS	Bricks	Rear portion is completely destroyed. Others are cracked. Plaster is damaged. Walls are cracked
DOORS	Timber	Rear portion is completely destroyed. Others are damaged.
WINDOWS	Timber	Rear portion is completely destroyed.
FLOOR	Cement rendered	Rear portion is completely destroyed.
FOUNDATION	Rubble	No damage
SITE	Coconut cultivation	No damage
OTHER

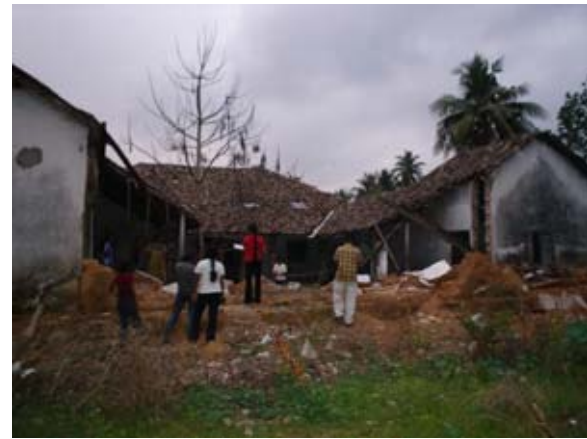
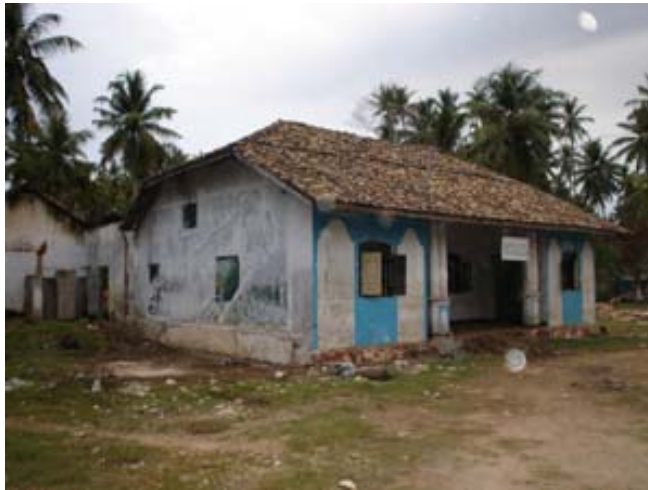
Extent of Damage – The rear portion is completely destroyed. Doors and windows are damaged. Walls are cracked.

ELEMENT	MATERIAL	EXTENT OF DAMAGE
ROOF	Half round tiles, timber frame	Rear portion is destroyed.
WALLS	Rubble, cabock, coral stone	Rear portion is destroyed. Cracked, plaster is damaged.
DOORS	Timber	Rear portion is destroyed. Damaged
WINDOWS	Timber	Rear portion is destroyed. Damaged
FLOOR	Cement rendered	Rear portion is destroyed. Damaged
FOUNDATION	Rubble	No damage
SITE	Sand	No damage
OTHER

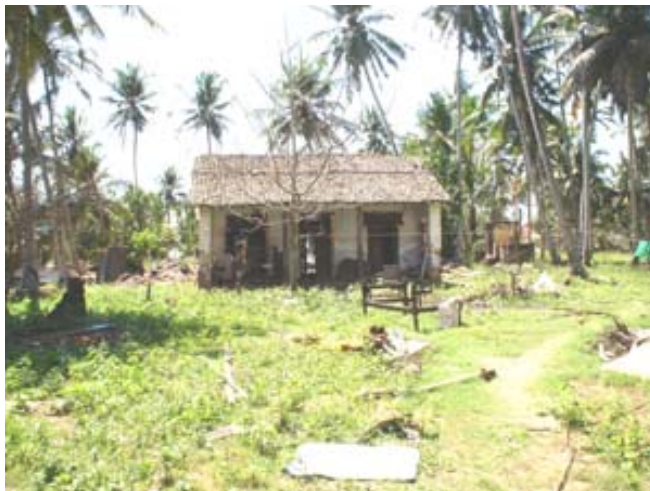
Extent of Damage – **The rear portion is completely destroyed. Doors and windows are damaged. Walls are cracked.**

ELEMENT	MATERIAL	EXTENT OF DAMAGE
ROOF	Half round tiles, timber frame	Rear portion is destroyed.
WALLS	Cabock, bricks	Rear portion is destroyed. Cracked, plaster is damaged.
DOORS	Timber	Rear portion is destroyed. Damaged
WINDOWS	Timber	Rear portion is destroyed. Damaged
FLOOR	Cement rendered	Rear portion is destroyed. Damaged
FOUNDATION	Rubble	No damage
SITE	Coconut cultivation	No damage
OTHER

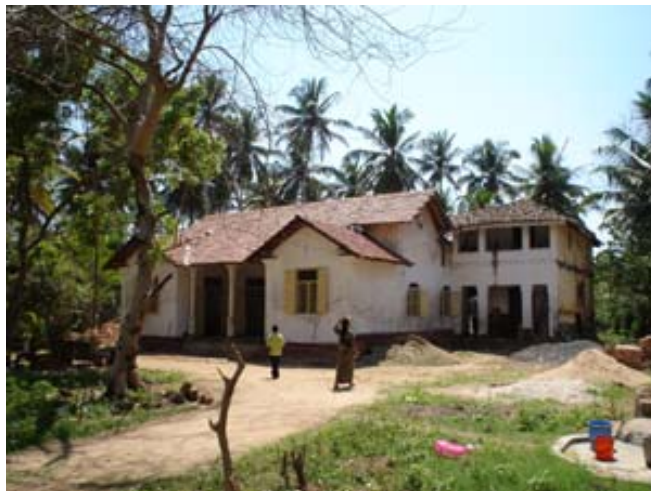
Extent of Damage – **The rear portion is completely destroyed. Doors and windows are damaged. Walls are cracked.**

ELEMENT	MATERIAL	EXTENT OF DAMAGE
ROOF	Half round tiles, timber frame	Rear portion is destroyed.
WALLS	Cabock, Brick	Rear portion is destroyed. Cracked, plaster is damaged.
DOORS	Timber	Rear portion is destroyed. Damaged
WINDOWS	Timber	Rear portion is destroyed. Damaged
FLOOR	Cement rendered	Rear portion is destroyed. Damaged
FOUNDATION	Rubble	No damage
SITE	Coconut cultivation	No damage
OTHER

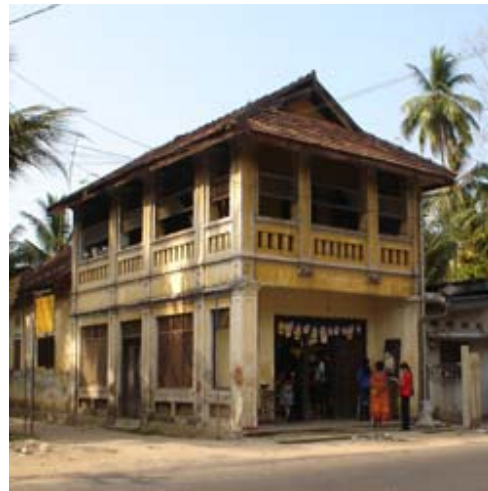
Extent of Damage – Doors have been damaged. Walls are cracked. Part of the roof is damaged.

ELEMENT	MATERIAL	EXTENT OF DAMAGE
ROOF	Calicut tiles, timber frame	Part of the roof is damaged.
WALLS	Bricks	Cracked
DOORS	Timber	Damaged
WINDOWS	Timber	No damage
FLOOR	Cement rendered	No damage
FOUNDATION	Rubble	No damage
SITE		
OTHER

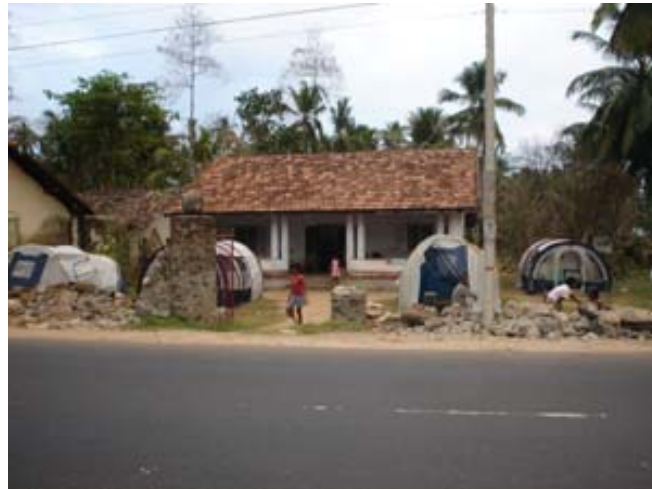
Extent of Damage – **The kitchen is destroyed. Parapet wall is destroyed. Doors and windows are damaged. Walls are cracked and the plaster is damaged.**

ELEMENT	MATERIAL	EXTENT OF DAMAGE
ROOF	Calicut tiles, timber frame	Kitchen is destroyed.
WALLS	Rubble	Kitchen is destroyed. Cracked, plaster is damaged.
DOORS	Timber	Kitchen is destroyed. Damaged
WINDOWS	Timber	Kitchen is destroyed. Damaged
FLOOR	Cement rendered	Kitchen is destroyed. No damage
FOUNDATION	Rubble	No damage
SITE	Sand	No damage
OTHER		Parapet wall is destroyed.

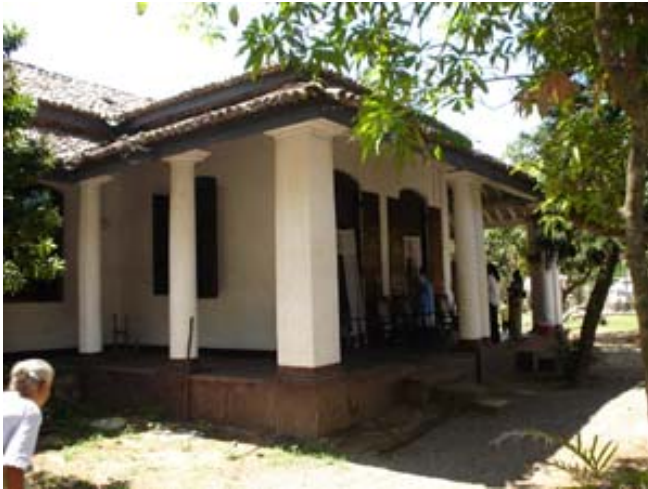
Extent of Damage – The kitchen, a room and the parapet wall are destroyed.

Doors and windows are damaged. Partitioning is damaged.

ELEMENT	MATERIAL	EXTENT OF DAMAGE
ROOF	Half round tiles, timber frame	Kitchen and a room are destroyed.
WALLS	Cabock, Corel Stone , Rubble	Kitchen and a room destroyed. Cracked, plaster is damaged.
DOORS	Timber	Kitchen and a room destroyed. Damaged
WINDOWS	Timber	Kitchen and a room destroyed. Damaged
FLOOR	Stone paved, cement rendered	Kitchen and a room destroyed. No damage
FOUNDATION	Rubble	No damage
SITE	Trees	No damage
OTHER		Parapet wall is destroyed.

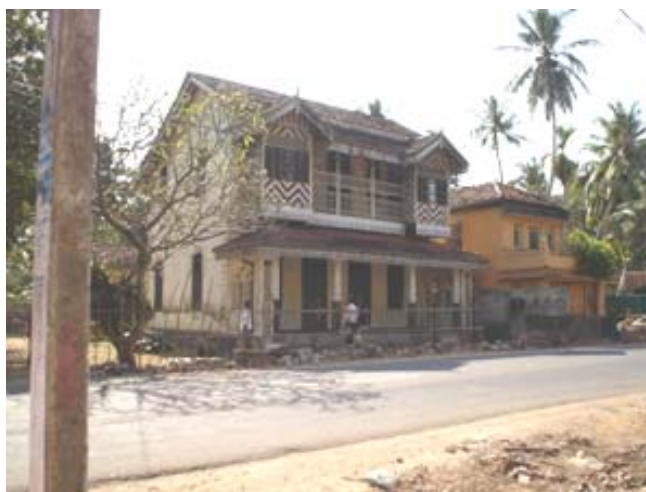
Name – SRIYAVASA
Type – HISTORICAL - RESIDENTIAL
Address – No. 765, Paratharakaya, Galle Road, Kosgoda.
DS Division - Balapitiya
GN Division – Paratharakaya
GPS Coordinates - 06⁰ N 20.414
 - 080⁰ E 01.640
Distance from the Sea – 200 m
Extent of Damage – Doors have been damaged.
Estimated Cost for Restoration
 - Rs. 0.1 million

ELEMENT	MATERIAL	EXTENT OF DAMAGE
ROOF	Calicut tiles, timber frame	No damage
WALLS	Cabock	No damage
DOORS	Timber	Damaged
WINDOWS	Timber	No damage
FLOOR	Cement rendered, timber deck	No damage
FOUNDATION	Rubble	No damage
SITE	Coconut cultivation	No damage
OTHER

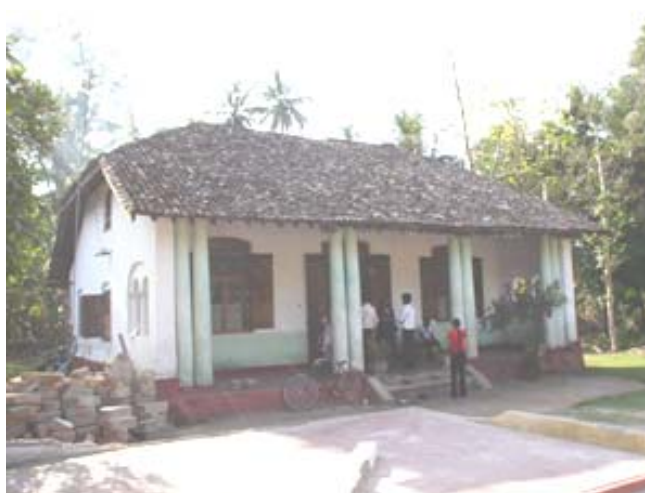
Extent of Damage – **Walls are cracked. Doors and windows are damaged.**

ELEMENT	MATERIAL	EXTENT OF DAMAGE
ROOF	Half round tiles, timber frame	No damage
WALLS	Limestone	No damage
DOORS	Timber	Damaged
WINDOWS	Timber	Damaged
FLOOR	Cement rendered	No damage
FOUNDATION	Rubble	No damage
SITE	Trees	No damage
OTHER

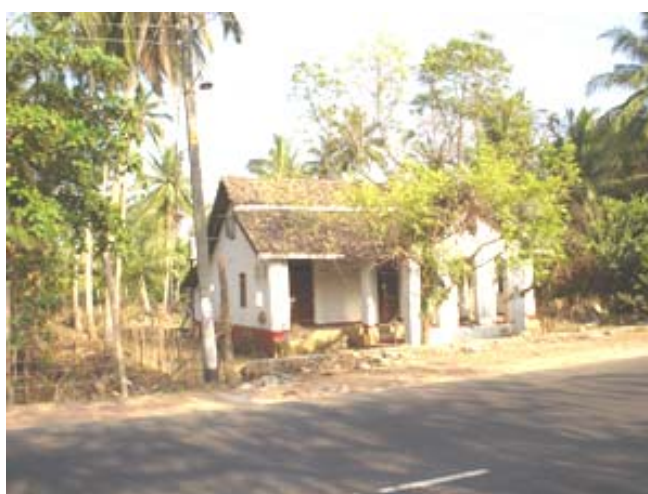
Name – SENANAYAKA NIVASA
Type – HISTORICAL - RESIDENTIAL
Address – Hegalle, Galle Road, Kosgoda
DS Division - Balapitiya
GN Division – Nugathiya
GPS Coordinates - 06⁰ N 19.375
- 080⁰ E 02.066
Distance from the Sea – 400 m
Extent of Damage – Parapet wall is destroyed.
Estimated Cost for Restoration
- Rs. 0.1 million

ELEMENT	MATERIAL	EXTENT OF DAMAGE
ROOF	Half round tiles, timber frame	No damage
WALLS	Cabock	No damage
DOORS	Timber	No damage
WINDOWS	Timber	No damage
FLOOR	Cement rendered	No damage
FOUNDATION	Rubble	No damage
SITE	Trees	No damage
OTHER		Parapet wall is destroyed.

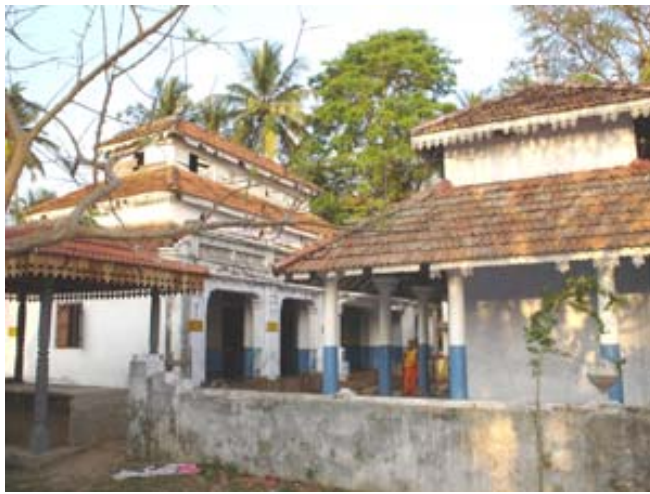
Extent of Damage – No damage. Two parapet walls around the image of Ven. Siri Ghanawimalatissa Nayaka Thero are destroyed.

ELEMENT	MATERIAL	EXTENT OF DAMAGE
ROOF	Calicut tiles, half round tiles, timber frame	No damage
WALLS	Cabock, limestone	No damage
DOORS	Timber	No damage
WINDOWS	Timber, glass	No damage
FLOOR	Cement rendered	No damage
FOUNDATION	Rubble	No damage
SITE	Trees	No damage
OTHER		Parapet wall of the Nayaka statue is damaged.

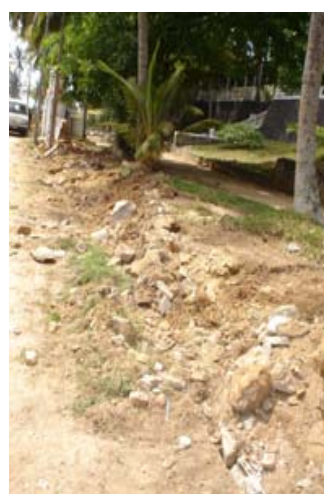
Extent of Damage – The parapet wall is damaged.

ELEMENT	MATERIAL	EXTENT OF DAMAGE
ROOF	Half round tiles, timber frame	No damage
WALLS	Bricks	No damage
DOORS	Timber	No damage
WINDOWS	Timber	No damage
FLOOR	Cement rendered	No damage
FOUNDATION	Rubble	No damage
SITE	Trees	No damage
OTHER		Parapet wall is completely destroyed.

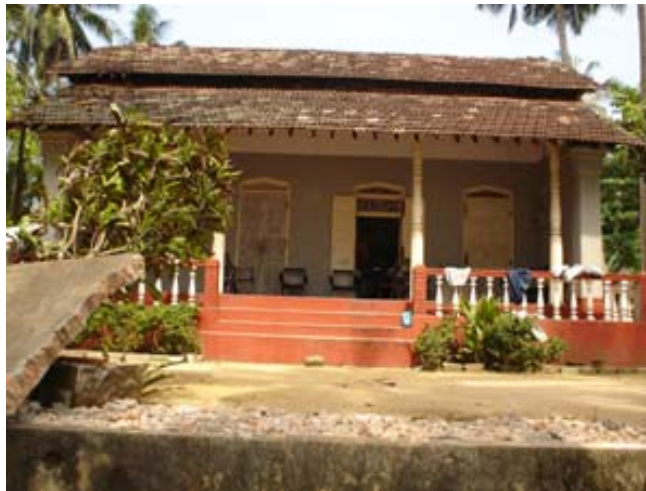
Extent of Damage – Parapet wall is damaged. Walls are cracked. One of the front columns is damaged.

ELEMENT	MATERIAL	EXTENT OF DAMAGE
ROOF	Calicut tiles, timber frame	No damage
WALLS	Rubble	Cracked. One column is damaged.
DOORS	Timber	No damage
WINDOWS	Timber	No damage
FLOOR	Cement rendered	No damage
FOUNDATION	Rubble	No damage
SITE	Coconut cultivation	No damage
OTHER		Parapet wall is completely destroyed.

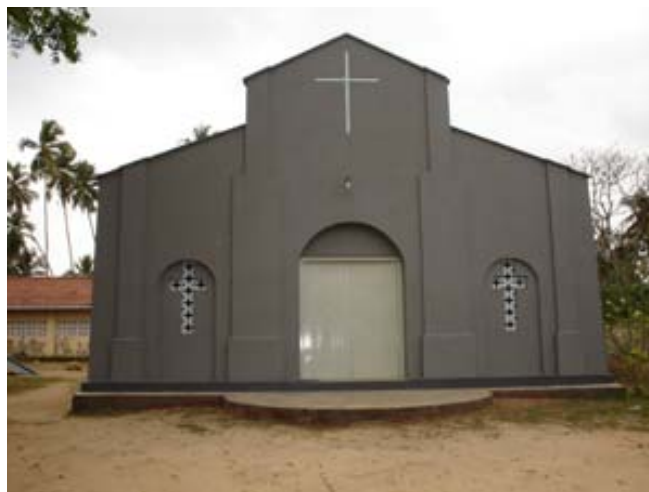
Name – ST. MARY’S CHURCH
Type – RELIGIOUS - CULTURAL
Address – St. Mary’s Church, Balapitiya
DS Division - Balapitiya
GN Division – Balapitiya
GPS Coordinates - 06⁰ N 16.445
- 080⁰ E 02.240
Distance from the Sea – 300 m
Extent of Damage – Parapet wall has been destroyed.
Estimated Cost for Restoration
- Rs. 0.5 million

ELEMENT	MATERIAL	EXTENT OF DAMAGE
ROOF	Calicut tiles, timber frame	No damage
WALLS	Bricks	Plaster is damaged.
DOORS	Timber	No damage
WINDOWS	Timber	No damage
FLOOR	Cement rendered	No damage
FOUNDATION	Rubble	No damage
SITE	Coconut cultivation	Washed away.
OTHER

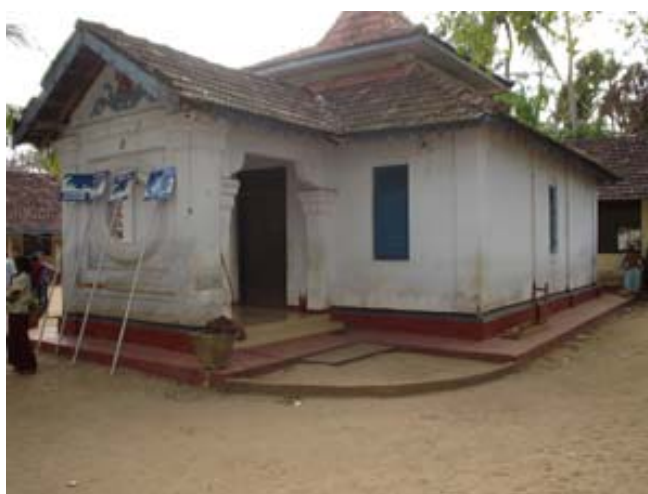
Name – ABINAVARAMAYA
Type – RELIGIOUS - CULTURAL
Address – Abinavarama Road, Balapitiya
DS Division - Balapitiya
GN Division – Bhramanawatta
GPS Coordinates - 06⁰ N 16.553
- 080⁰ E 02.308
Distance from the Sea – 300 m
Extent of Damage – Plaster of the walls has been damaged.
Estimated Cost for Restoration
- Rs. 0.2 million

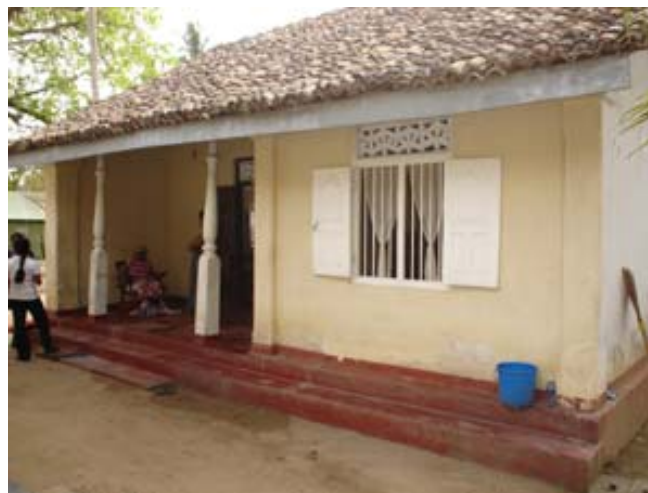
Extent of Damage – Walls are cracked.

ELEMENT	MATERIAL	EXTENT OF DAMAGE
ROOF	Half round tiles Timber frame	No damage
WALLS	Lime	Cracked
DOORS	Timber	No damage
WINDOWS	Timber	No damage
FLOOR	Cement rendered	No damage
FOUNDATION	Cabock	No damage
SITE	Coconut cultivation	No damage
OTHER

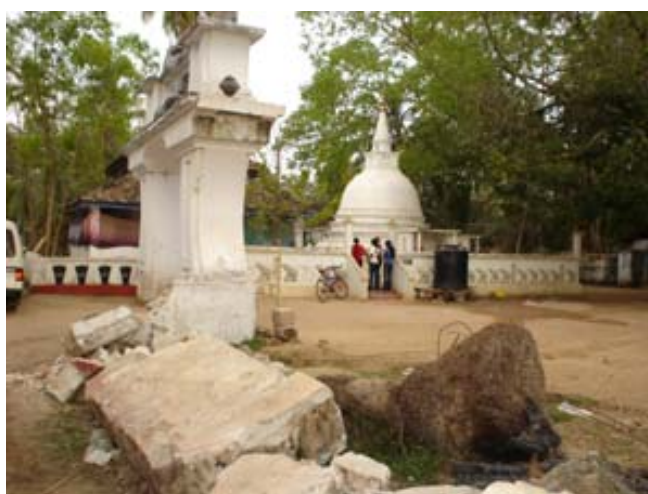
Extent of Damage – Parapet wall is destroyed. *Bodhighara* is damaged. Cracks have appeared in the *devalaya*.

ELEMENT	MATERIAL	EXTENT OF DAMAGE
ROOF	Half round tiles, calicut tiles, timber frame	No damage
WALLS	Brick	Cracked and damaged.
DOORS	Timber	No damage
WINDOWS	Timber	No damage
FLOOR	Cement rendered	No damage
FOUNDATION	Rubble	No damage
SITE	Trees	No damage
OTHER		Parapet wall is completely destroyed.

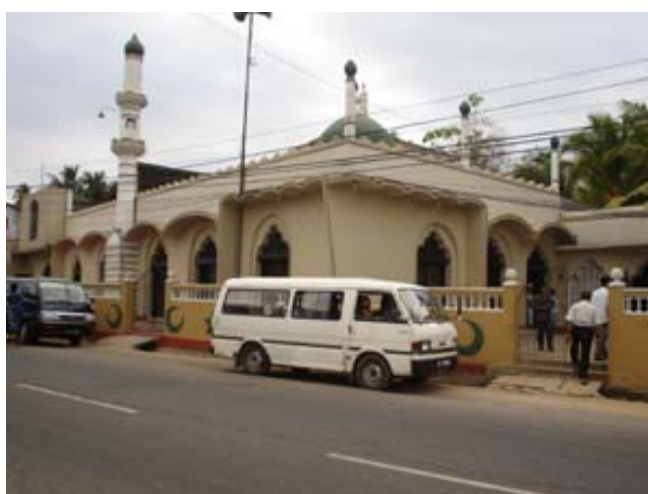
Name – WELITARA MUSLIM JUMMA MOSQUE
Type – RELIGIOUS - HISTORICAL - CULTURAL
Address – Colombo Road, Balapitiya
DS Division - Balapitiya
GN Division – Welitara
GPS Coordinates - 06⁰ N 16.962
- 080⁰ E 02.449
Distance from the Sea – 800 m
Extent of Damage – Parapet wall has been destroyed.
Estimated Cost for Restoration
- Rs. 0.5 million

ELEMENT	MATERIAL	EXTENT OF DAMAGE
ROOF	Asbestos, timber frame	No damage
WALLS	Rubble	No damage
DOORS	Timber	No damage
WINDOWS	Timber	No damage
FLOOR	Tiled	No damage
FOUNDATION	Rubble	No damage
SITE	Trees	No damage
OTHER		Parapet wall is completely destroyed.

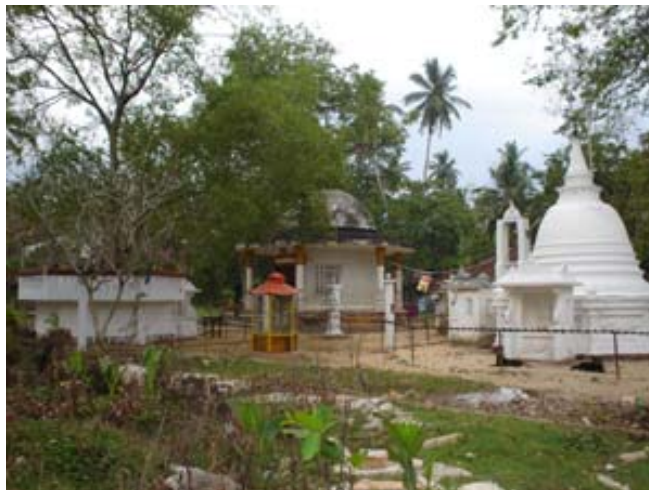
Name – SRI SUGATHARAMAYA
Type – RELIGIOUS - HISTORICAL - CULTURAL
Address – Devala Mawatha, Balapitiya
DS Division - Balapitiya
GN Division – Bhramanawatta South
GPS Coordinates - 06⁰ N 16.855
- 080⁰ E 02.333
Distance from the Sea – 250 m
Extent of Damage – The parapet wall is destroyed. Doors and windows are damaged.
Estimated Cost for Restoration
- Rs. 0.5 million

ELEMENT	MATERIAL	EXTENT OF DAMAGE
ROOF	Calicut tiles, timber frame	No damage
WALLS	Rubble	No damage
DOORS	Timber	Damaged
WINDOWS	Timber	No damage
FLOOR	Cement rendered	No damage
FOUNDATION	Rubble	No damage
SITE	Trees	No damage
OTHER		Parapet wall is completely destroyed.

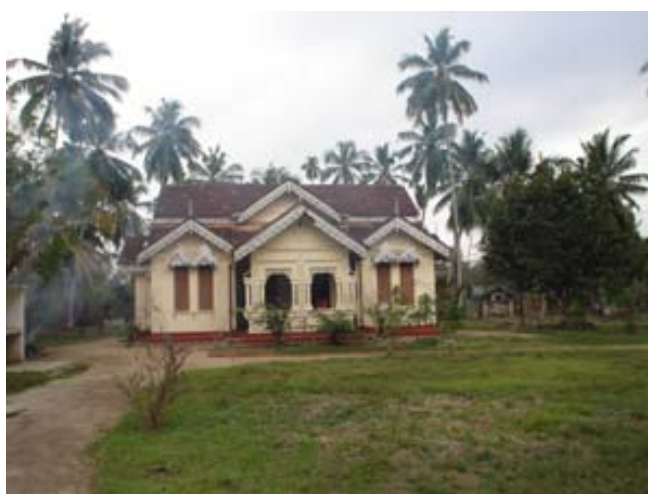
95

Name – MALINI
Type – HISTORICAL - RESIDENTIAL
Address – Welitara, Balapitiya
DS Division - Balapitiya
GN Division –Weliwatugoda
GPS Coordinates - 060 N 17.267
- 0800 E 02.578
Distance from the Sea – 300 m
Extent of Damage – Parapet wall is destroyed.
Estimated Cost for Restoration
- Rs. 0.1 million

ELEMENT	MATERIAL	EXTENT OF DAMAGE
ROOF	Calicut tiles, timber frame	No damage
WALLS	Limestone	No damage
DOORS	Timber	Damaged
WINDOWS	Timber	No damage
FLOOR	Cement rendered	No damage
FOUNDATION	Rubble	No damage
SITE	Trees	No damage
OTHER		Parapet wall is completely destroyed.

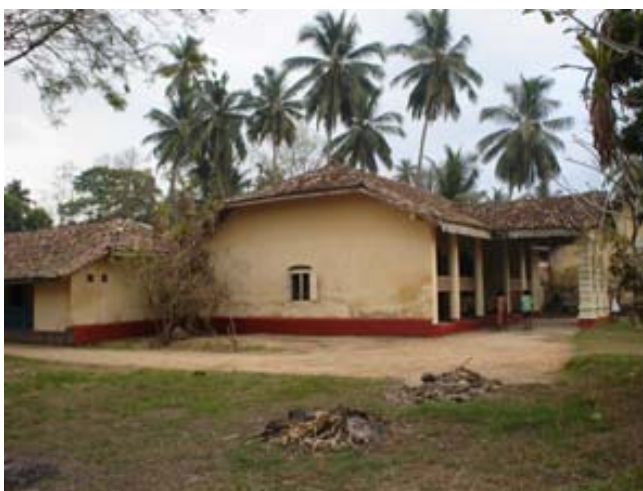
Extent of Damage – Parapet wall is destroyed.

- Rs. 0.1 million

ELEMENT	MATERIAL	EXTENT OF DAMAGE
ROOF	Half round tiles, timber frame	No damage
WALLS	Limestone	No damage
DOORS	Timber	Damaged
WINDOWS	Timber	No damage
FLOOR	Cement rendered	No damage
FOUNDATION	Rubble	No damage
SITE	Coconut cultivation	No damage
OTHER		Parapet wall is completely destroyed.

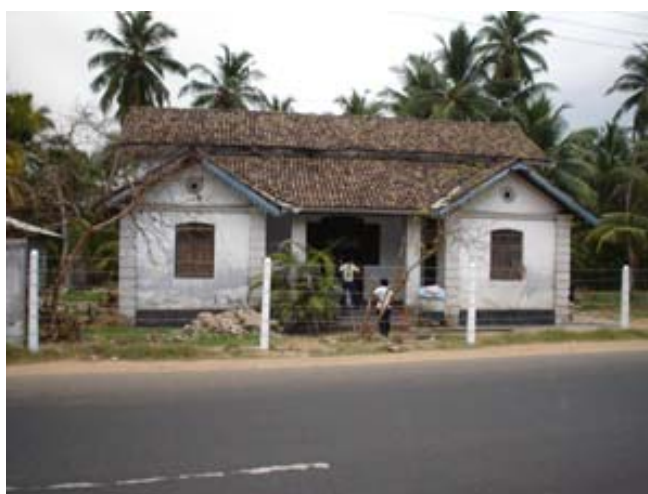
Extent of Damage – Doors are damaged. Walls are cracked. One room is damaged.

- Rs. 0.2 million

ELEMENT	MATERIAL	EXTENT OF DAMAGE
ROOF	Calicut tiles, timber frame	No damage
WALLS	Rubble, cabock	Cracked
DOORS	Timber	Damaged
WINDOWS	Timber	No damage
FLOOR	Cement rendered	No damage
FOUNDATION	Rubble	No damage
SITE	Turf	No damage
OTHER		One room is damaged.

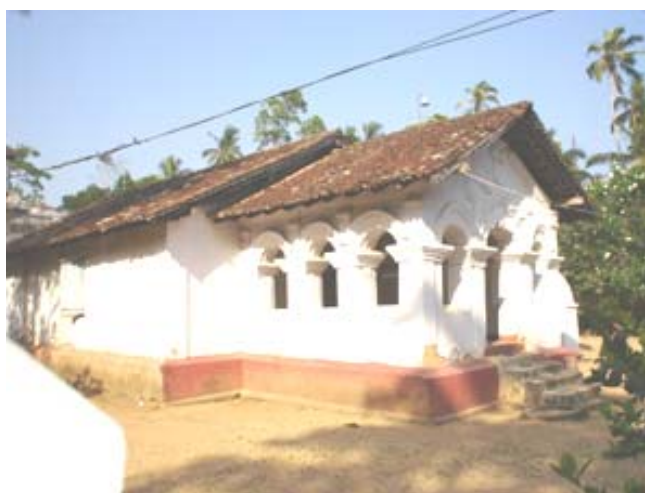
99

Name – KOSGODA RAJA MAHA VIHARAYA
Type – RELIGIOUS - CULTURAL - HISTORICAL
Address – Ganegodella Raja Maha Viharaya, Kosgoda
DS Division - Balapitiya
GN Division – Nape
GPS Coordinates - 06⁰ N 20.186
- 080⁰ E 01.934
Distance from the Sea – 850 m
Extent of Damage – Not affected.
Estimated Cost for Restoration
- Rs. 000 million

ELEMENT	MATERIAL	EXTENT OF DAMAGE
ROOF	Calicut tiles, timber frame	No damage
WALLS	Cabock	No damage
DOORS	Timber	No damage
WINDOWS	Timber	No damage
FLOOR	Cement rendered	No damage
FOUNDATION	Rubble	No damage
SITE	Trees	No damage
OTHER

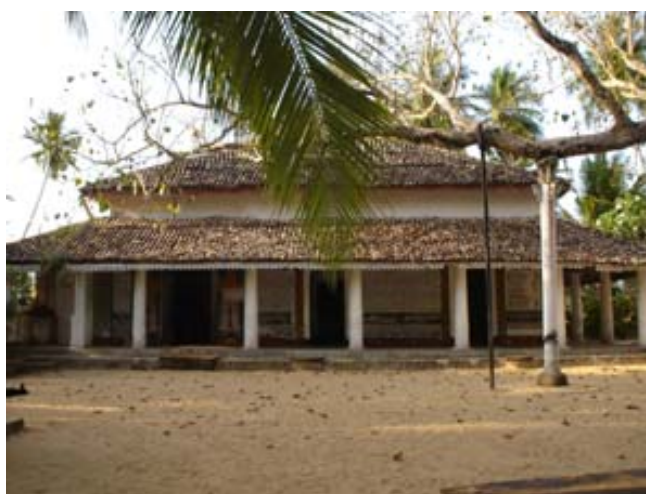
100

Name – SAMUDRARAMA PURANA VIHARAYA
Type – RELIGIOUS - CULTURAL - HISTORICAL
Address – Dammakusala Mawatha, Godamulla, Kosgoda
DS Division - Balapitiya
GN Division – Ahungalla
GPS Coordinates - 06⁰ N 19.215
- 080⁰ E 01.824
Distance from the Sea – 25 m
Extent of Damage – Not affected.
Estimated Cost for Restoration
- Rs. 000 million

ELEMENT	MATERIAL	EXTENT OF DAMAGE
ROOF	Half round tiles, timber frame	No damage
WALLS	Cabock	No damage
DOORS	Timber	No damage
WINDOWS	Timber, glass	No damage
FLOOR	Cement rendered	No damage
FOUNDATION	Rubble	No damage
SITE	Trees	No damage
OTHER

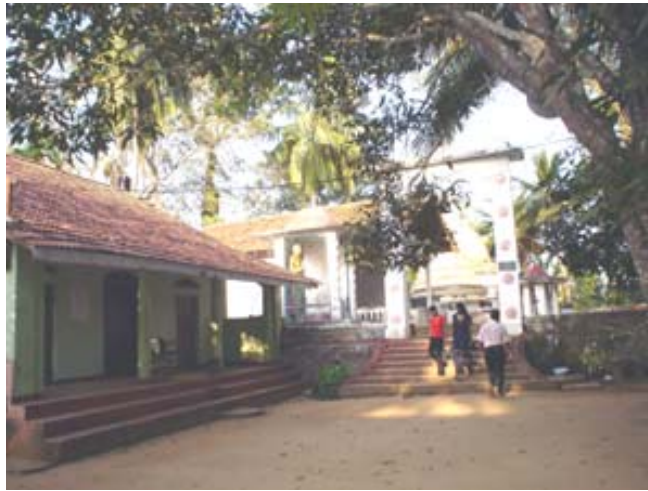
101

Name – SRI WIJAYARAMAYA
Type – RELIGIOUS - CULTURAL
Address – Galkanda, Kosgoda
DS Division - Balapitiya
GN Division – Ahungalla
GPS Coordinates - 06⁰ N 19.323
- 080⁰ E 01.973
Distance from the Sea – 50 m
Extent of Damage – Not affected.
Estimated Cost for Restoration
- Rs. 000 million

ELEMENT	MATERIAL	EXTENT OF DAMAGE
ROOF	Calicut tiles, timber frame	No damage
WALLS	Cabock	No damage
DOORS	Timber	No damage
WINDOWS	Timber, glass	No damage
FLOOR	Cement rendered	No damage
FOUNDATION	Rubble	No damage
SITE	Trees	No damage
OTHER

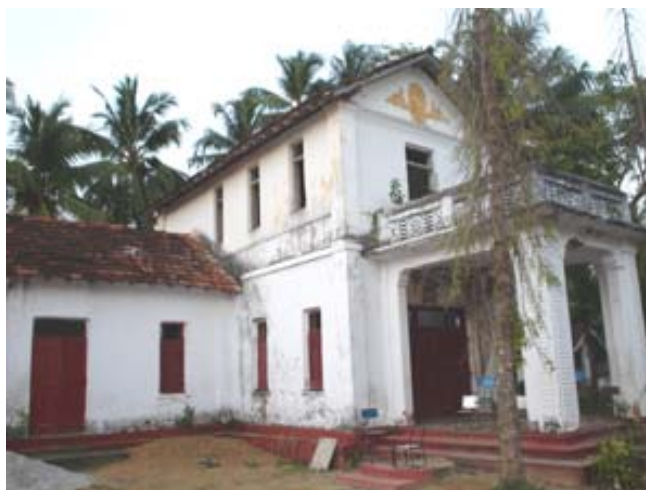
102

Name – KSHETRARAMAYA
Type – RELIGIOUS - CULTURAL
Address – Asabha Mawatha, Ahungalla
DS Division - Balapitiya
GN Division – Middaramulla
GPS Coordinates - 06⁰ N 18.665
- 080⁰ E 02.209
Distance from the Sea – 500 m
Extent of Damage – No damage.
Estimated Cost for Restoration
- Rs. 000 million

ELEMENT	MATERIAL	EXTENT OF DAMAGE
ROOF	Calicut tiles, timber frame	No damage
WALLS	Cabock	No damage
DOORS	Timber	No damage
WINDOWS	Timber, glass	No damage
FLOOR	Cement rendered	No damage
FOUNDATION	Rubble	No damage
SITE	Trees	No damage
OTHER

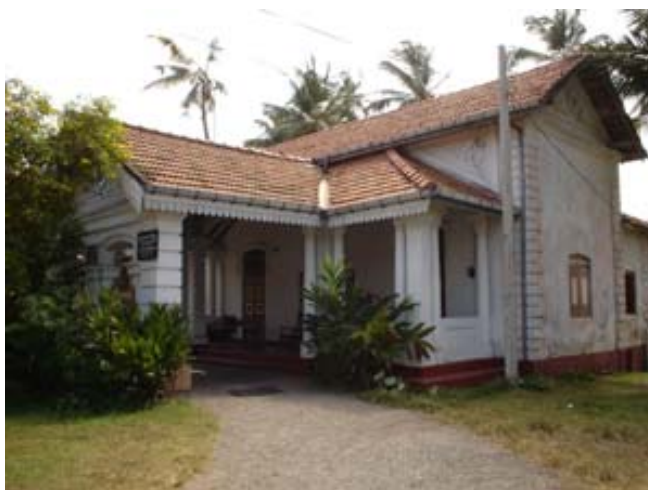
103

Name – SIRIDARA NIVASA
Type – HISTORICAL - RESIDENTIAL
Address – No. 738, Galle Road, Randombe, Ambalangoda.
DS Division - Balapitiya
GN Division – Randombe North
GPS Coordinates - 06⁰ N 15.150
- 080⁰ E 02.480
Distance from the Sea – 20 m
Extent of Damage – No damage.
Estimated Cost for Restoration
- Rs. 000 million

ELEMENT	MATERIAL	EXTENT OF DAMAGE
ROOF	Calicut tiles, timber frame	No damage
WALLS	Rubble	No damage
DOORS	Timber	No damage
WINDOWS	Timber	No damage
FLOOR	Cement rendered	No damage
FOUNDATION	Rubble	No damage
SITE	Coconut cultivation	No damage
OTHER

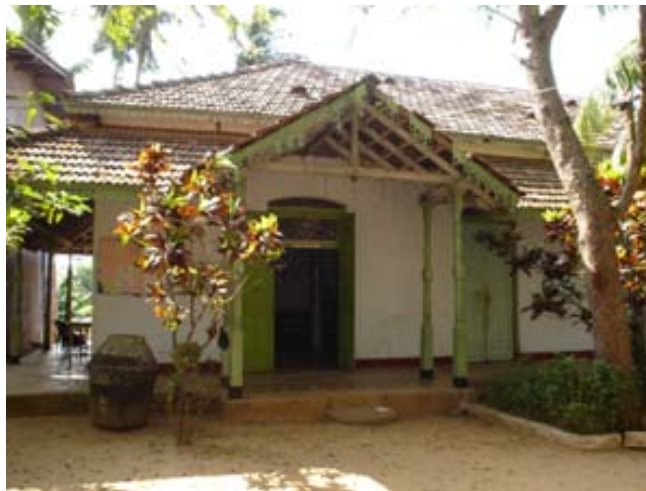
104

Name – SRI SUBADRARAMAYA
Type – RELIGIOUS - HISTORICAL - CULTURAL
Address – Sri Subadrarama Ancient Temple, Balapitiya
DS Division - Balapitiya
GN Division – Balapitiya
GPS Coordinates - 06⁰ N 16.043
- 080⁰ E 02.301
Distance from the Sea – 500 m
Extent of Damage – Not affected.
Estimated Cost for Restoration
- Rs. 000 million

ELEMENT	MATERIAL	EXTENT OF DAMAGE
ROOF	Half round tiles, Calicut tiles, timber frame	Not affected
WALLS	Cabock, rubble	Not affected
DOORS	Timber	Not affected
WINDOWS	Timber	Not affected
FLOOR	Cement rendered	Not affected
FOUNDATION	Rubble	Not affected
SITE	Trees	Not affected
OTHER

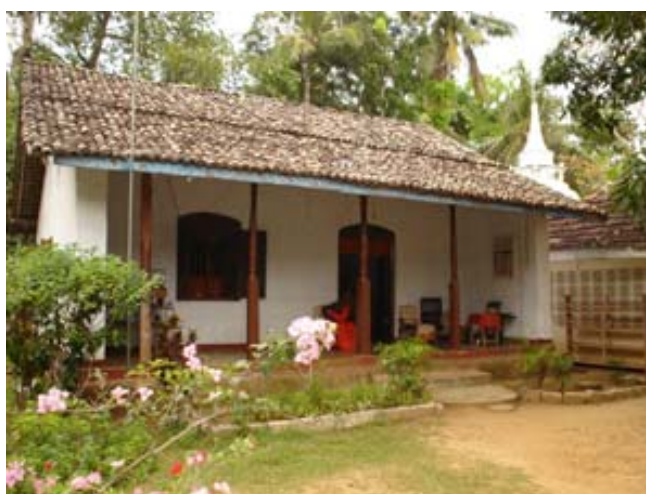
105

Name – SIRI SUMANARAMAYA
Type – RELIGIOUS - HISTORICAL - CULTURAL
Address – Mohottiwatta, Balapitiya
DS Division - Balapitiya
GN Division – Balapitiya
GPS Coordinates - 06⁰ N 16.201
- 080⁰ E 02.206
Distance from the Sea – 100 m
Extent of Damage – Not affected.
Estimated Cost for Restoration
- Rs. 000 million

ELEMENT	MATERIAL	EXTENT OF DAMAGE
ROOF	Half round tiles, timber frame	No damage
WALLS	Bricks	No damage
DOORS	Timber	No damage
WINDOWS	Timber	No damage
FLOOR	Cement rendered	No damage
FOUNDATION	Rubble	No damage
SITE	Coconut cultivation	No damage
OTHER

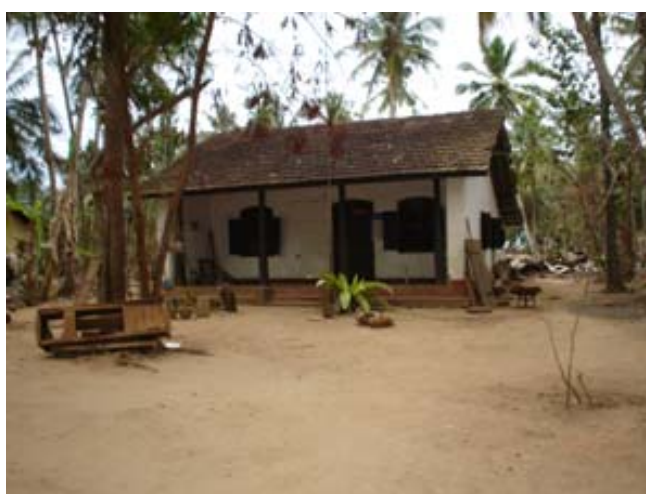
106

Name – ROHANA NIVASA
Type – HISTORICAL - RESIDENTIAL
Address – Wellaboda, Balapitiya
DS Division - Balapitiya
GN Division –Wellaboda
GPS Coordinates - 06⁰ N 17.662
- 080⁰ E 02.420
Distance from the Sea – 200 m
Extent of Damage – No damage.
Estimated Cost for Restoration
- Rs. 000 million

ELEMENT	MATERIAL	EXTENT OF DAMAGE
ROOF	Half round tiles, timber frame	No damage
WALLS	Bricks	No damage
DOORS	Timber	No damage
WINDOWS	Timber	No damage
FLOOR	Cement rendered	No damage
FOUNDATION	Rubble	No damage
SITE	Coconut cultivation	No damage
OTHER

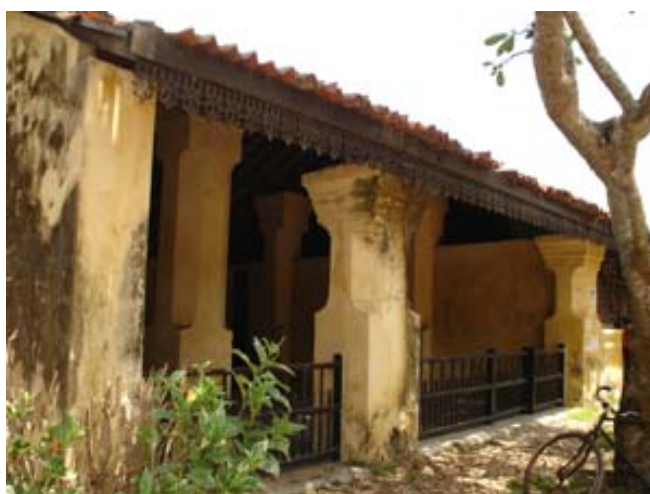
108

Name – DUTCH CHURCH SCHOOL
Type – HISTORICAL - CULTURAL
Address – Rest House Premises, Ambalangoda.
DS Division - Ambalangoda
GN Division – Hiriwatta
GPS Coordinates - 06⁰ N 13.945
- 080⁰ E 03.184
Distance from the Sea – 15 m
Extent of Damage – Not affected.
Estimated Cost for Restoration
- Rs. 000 million

ELEMENT	MATERIAL	EXTENT OF DAMAGE
ROOF	Half round tiles, timber frame	No damage
WALLS	Bricks	No damage
DOORS	Timber	No damage
WINDOWS	Timber	No damage
FLOOR	Cement rendered	No damage
FOUNDATION	Rubble	No damage
SITE	Trees	No damage
OTHER

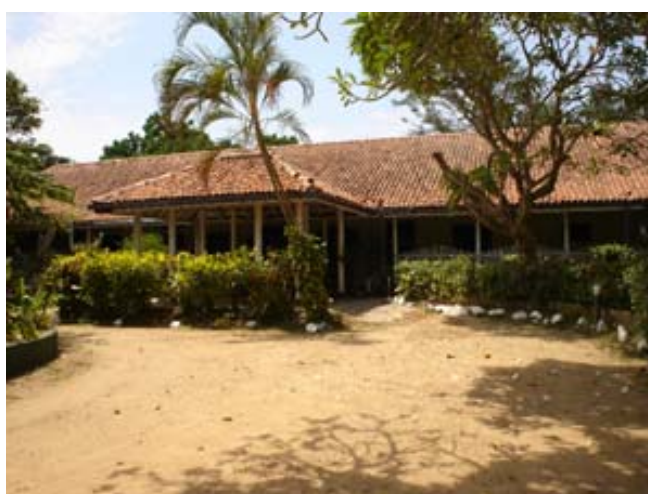
Extent of Damage – Not Affected.

ELEMENT	MATERIAL	EXTENT OF DAMAGE
ROOF	Half round tiles, timber frame	No damage
WALLS	Bricks	No damage
DOORS	Timber	No damage
WINDOWS	Timber	No damage
FLOOR	Cement rendered	No damage
FOUNDATION	Rubble	No damage
SITE	Trees	No damage
OTHER

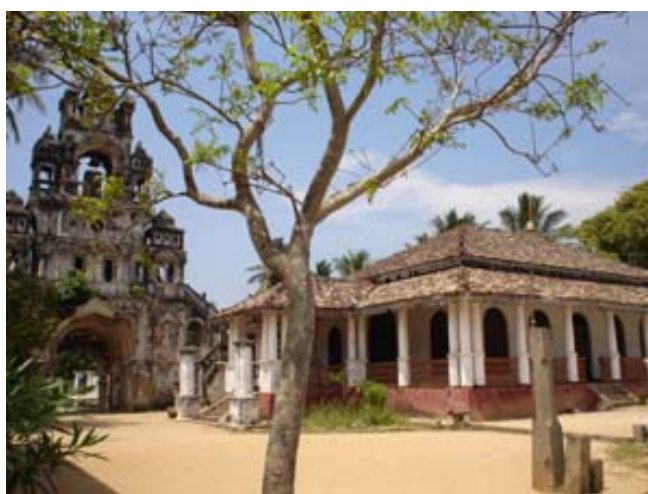
110

Name – SRI SUNANDARAMA MAHA VIHARAYA
Type – RELIGIOUS - HISTORICAL - CULTURAL
Address – Sunandarama MahaViharaya, Ambalangoda.
DS Division - Ambalangoda
GN Division –Peniyanduwa (Wilegoda)
GPS Coordinates - 06⁰ N 14.028
- 080⁰ E 03.416
Distance from the Sea – 300 m
Extent of Damage – Not affected.
Estimated Cost for Restoration
- Rs. 000 million

ELEMENT	MATERIAL	EXTENT OF DAMAGE
ROOF	Half round tiles, timber frame	No damage
WALLS	Bricks	No damage
DOORS	Timber	No damage
WINDOWS	Timber	No damage
FLOOR	Cement rendered	No damage
FOUNDATION	Rubble	No damage
SITE	Trees	No damage
OTHER

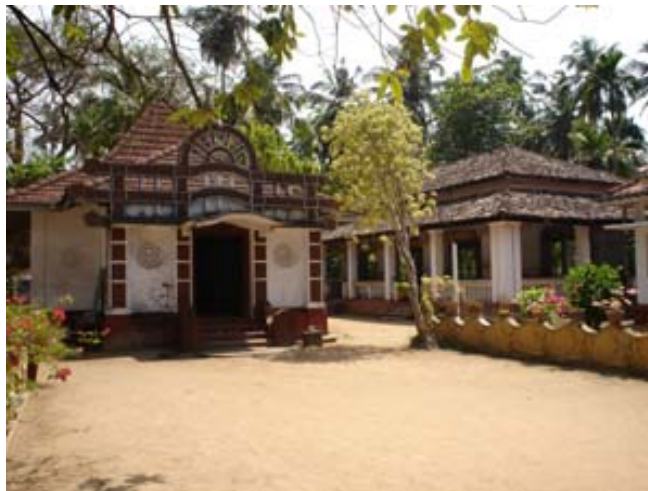
111

Name – SIRI WIJAYARAMAYA
Type – RELIGIOUS – CULTURAL
Address – Hiriwatta, Ambalangoda.
DS Division - Ambalangoda
GN Division – Hiriwatta
GPS Coordinates - 06⁰ N 13.869
- 080⁰ E 03.322
Distance from the Sea – 300 m
Extent of Damage – No damage.
Estimated Cost for Restoration
- Rs. 000 million

ELEMENT	MATERIAL	EXTENT OF DAMAGE
ROOF	Half round tiles, timber frame	No damage
WALLS	Bricks	No damage
DOORS	Timber	No damage
WINDOWS	Timber	No damage
FLOOR	Cement rendered	No damage
FOUNDATION	Rubble	No damage
SITE	Trees	No damage
OTHER

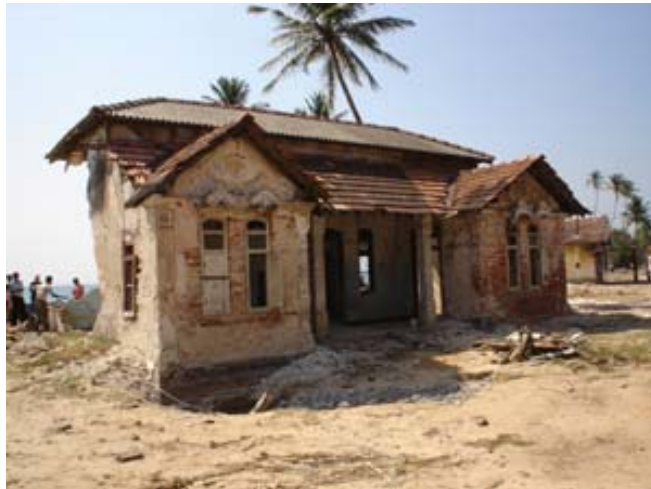
Extent of Damage – Completely destroyed.

- Rs. 2.6 million

ELEMENT	MATERIAL	EXTENT OF DAMAGE
ROOF	Calicut tiles, asbestos, timber frame	Rear is completely destroyed.
WALLS	Rubble, bricks lime mortar	Rear is completely destroyed.
DOORS	Decorated timber	Completely destroyed
WINDOWS	Decorated timber	Completely destroyed
FLOOR	Cement rendered	Completely destroyed
FOUNDATION	Rubble	Damaged
SITE		
OTHER

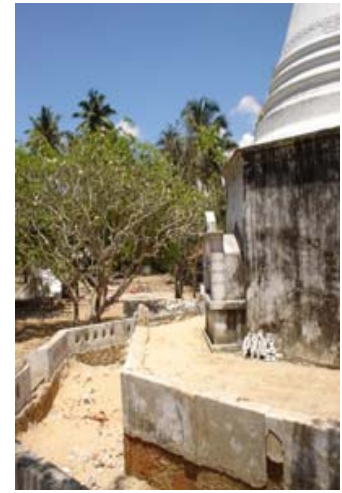
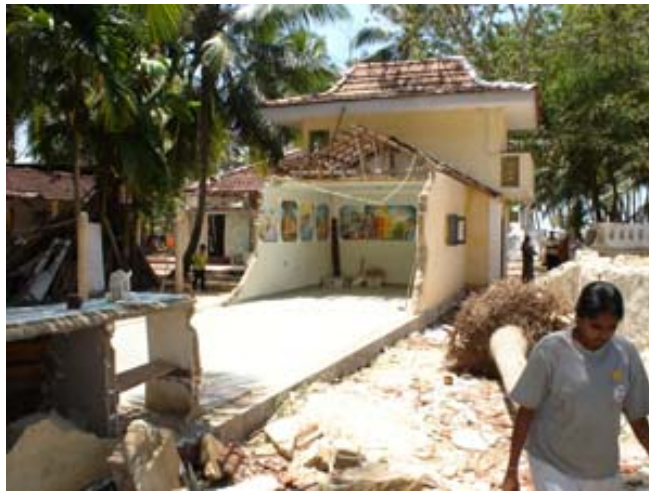
Extent of Damage – *Dharmasalava* and *danasalava* are completely destroyed. The *prakara* of the *stupa* is destroyed. The walls of the *avasage* are cracked and the front and left side is damaged. The ceiling is damaged. Doors and windows are destroyed. Parapet wall is destroyed. Toilets are destroyed.

Estimated Cost for Restoration – Rs. 18.0 million

ELEMENT	MATERIAL	EXTENT OF DAMAGE
ROOF	Calicut tiles, timber frame	<i>Dharmasalava</i> and <i>danasalava</i> are completely destroyed.
WALLS	Bricks	<i>Dharmasalava</i> and <i>danasalava</i> are completely destroyed. Walls in the other buildings are cracked. The <i>Stupa prakara</i> is completely destroyed.
DOORS	Timber	Completely destroyed and some are damaged.
WINDOWS	Timber	Completely destroyed and some are damaged.
FLOOR	Cement rendered	Completely destroyed. The floor of the <i>stupa maluwa</i> is washed away.
FOUNDATION	Rubble	Damaged
SITE	Coconut cultivation	Washed away
OTHER		Parapet wall is destroyed.

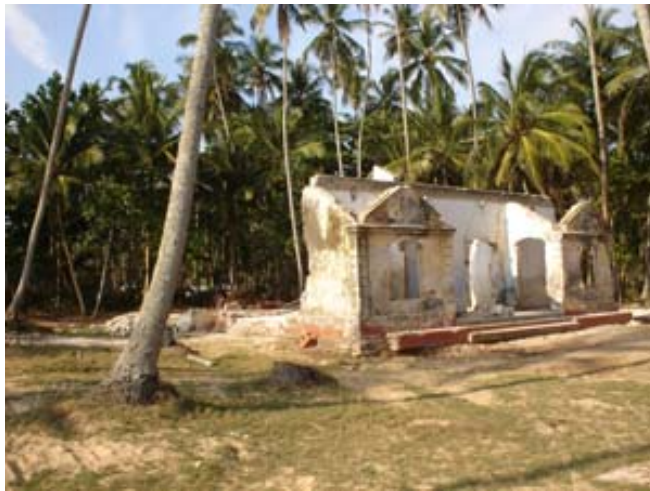
Extent of Damage – **Completely destroyed.**

- **Rs. 8.1 million**

ELEMENT	MATERIAL	EXTENT OF DAMAGE
ROOF		Completely destroyed
WALLS	Corel stones	Completely destroyed
DOORS		Completely destroyed
WINDOWS		Completely destroyed
FLOOR	Cement rendered	Completely destroyed
FOUNDATION	Rubble	Completely destroyed
SITE	Coconut cultivation	Washed away
OTHER		Parapet wall is destroyed.

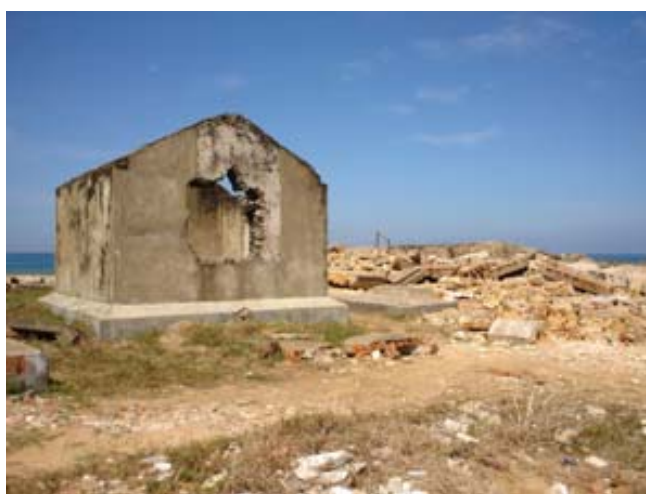
117

Name – CUSTOMS BUILDING
Type – HISTORICAL - CULTURAL
Address – Customs Road, Dodanduwa
DS Division - Hikkaduwa
GN Division – Godabedda
GPS Coordinates - 06⁰ N 06.225
- 080⁰ E 0.509
Distance from the Sea – 10 m
Extent of Damage – Completely destroyed.
Estimated Cost for Restoration
- Rs. 000 million – not worth

ELEMENT	MATERIAL	EXTENT OF DAMAGE
ROOF		Completely destroyed
WALLS	Mud, rubble	Completely destroyed
DOORS		Completely destroyed
WINDOWS		Completely destroyed
FLOOR		Completely destroyed
FOUNDATION	Rubble	Completely destroyed
SITE		Washed away
OTHER

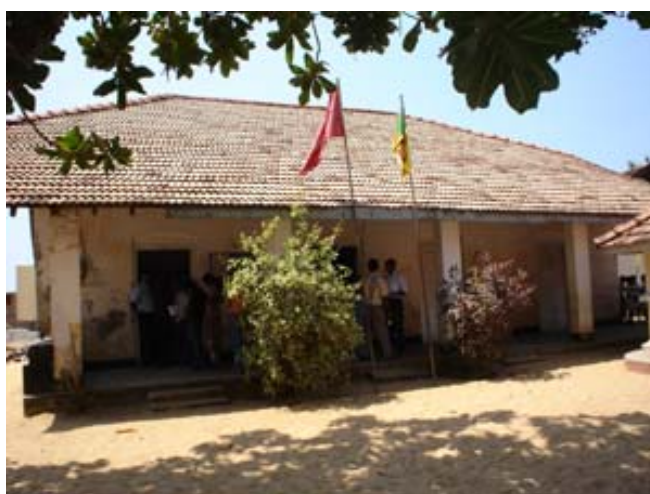
Extent of Damage – Old building has been damaged. Parapet walls are destroyed. Doors and windows are damaged. Toilets are destroyed.

- Rs. 2.1 million

ELEMENT	MATERIAL	EXTENT OF DAMAGE
ROOF	Calicut tiles, timber frame	Rear is damaged.
WALLS	Rubble	Rear is damaged.
DOORS	Timber	Rear is damaged.
WINDOWS	Timber	Rear is damaged.
FLOOR	Cement rendered	Rear is damaged.
FOUNDATION	Rubble	No damage
SITE	Sand	Washed away
OTHER		Parapet wall and toilets are destroyed.

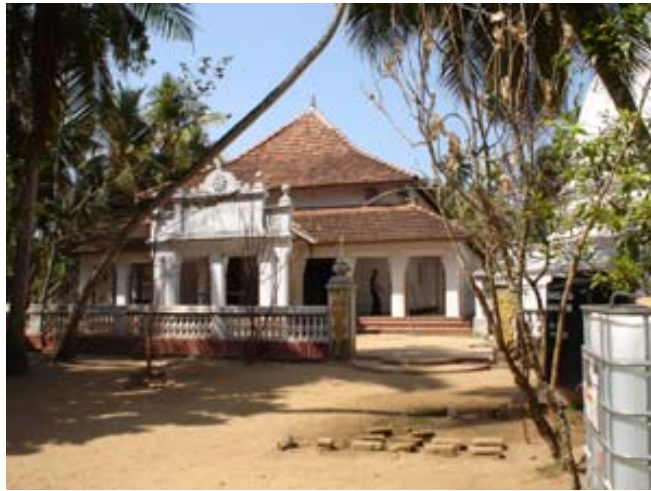
Extent of Damage – The painted ceiling panels of the image house which had been removed have been washed away by the water. The walls are cracked.

- Rs. 1.0 million

ELEMENT	MATERIAL	EXTENT OF DAMAGE
ROOF	Calicut tiles, timber frame	No damage
WALLS	Rubble, lime mortar	Cracked
DOORS	Timber	No damage
WINDOWS	Timber	No damage
FLOOR	Tiled	No damage
FOUNDATION	Rubble	No damage
SITE	Coconut cultivation	No damage
OTHER		The painted timber ceiling panels were washed away.

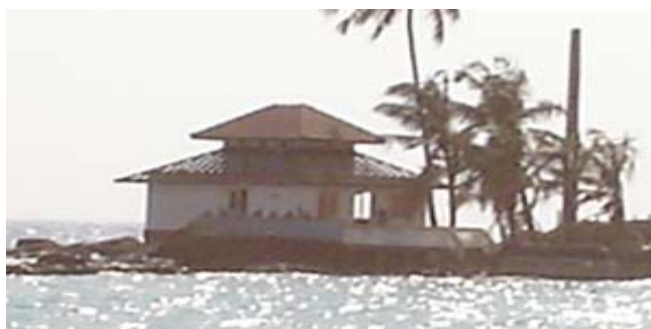
Extent of Damage – The tiles on the roof of the old *devalaya* are destroyed. The image house, Bo-tree, *bodi-prakara* and parapet wall were destroyed. All the doors and windows are destroyed.

- Rs. 2.0 million

ELEMENT	MATERIAL	EXTENT OF DAMAGE
ROOF	Flat tiles, timber frame	Tiles washed away.
WALLS	Bricks	Image house, Bo-tree and <i>pakara</i> were completely destroyed.
DOORS	Timber	Completely destroyed
WINDOWS	Timber	Completely destroyed
FLOOR	Tiled	Completely destroyed
FOUNDATION	Rubble	Damaged
SITE	Sand	Washed away
OTHER

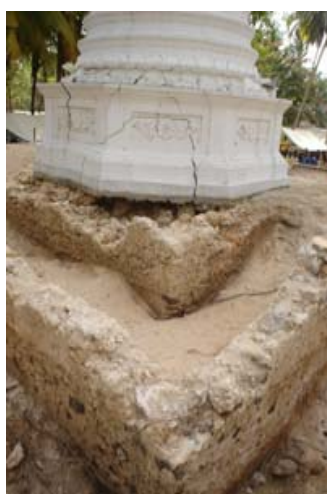
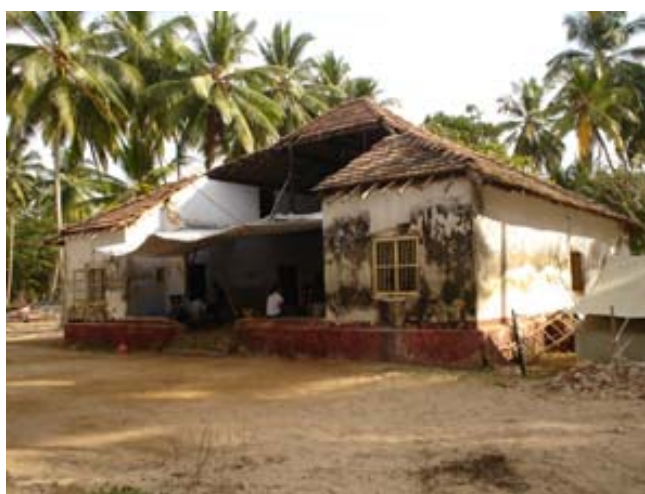
Extent of Damage – Refectory, *Dharmasalava*, *parakara* walls and parapet wall have been completely destroyed. The *avasage* has been badly damaged. The *stupa* is cracked. Services have been completely destroyed. Images and *bodhigara* have been damaged.

Estimated Cost for Restoration – Rs. 3.0 million

ELEMENT	MATERIAL	EXTENT OF DAMAGE
ROOF	Calicut tiles, timber frame	Refectory, <i>dharmasalava</i> and part of the <i>avasage</i> has been completely destroyed.
WALLS	Corel Stone	Refectory, <i>dharmasalava</i> and part of the <i>avasage</i> has been completely destroyed. <i>Prakara bemma</i> has been completely destroyed. Image house and <i>bodhigara</i> has been damaged.
DOORS	Timber	Some are destroyed and others are damaged.
WINDOWS	Timber	Some are destroyed and others are damaged.
FLOOR	Cement rendered	Refectory, <i>Dharmasalawa</i> and part of the <i>avasage</i> has been damaged.
FOUNDATION	Corel stone, rubble	Damaged.
SITE	Coconut cultivation	Washed away.
OTHER		Parapet wall has been destroyed.

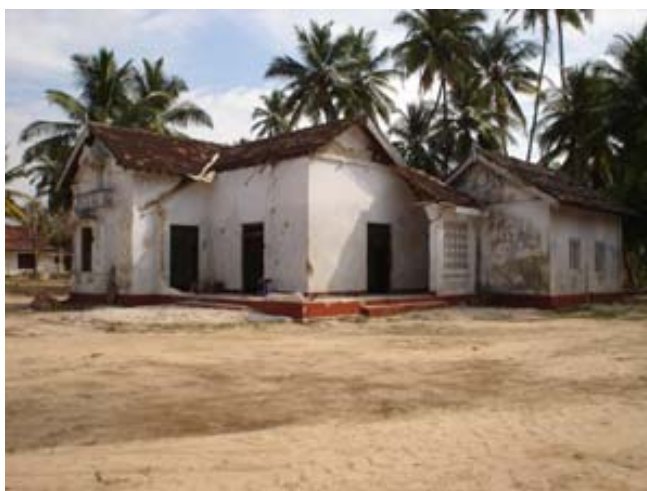
Extent of Damage – Parapet wall has been completely destroyed. The front verandah has been destroyed. Doors and windows have been damaged.

- Rs. 2.5 million

ELEMENT	MATERIAL	EXTENT OF DAMAGE
ROOF	Half round tiles, calicut tiles, timber frame	Front verandah is destroyed.
WALLS	Corel stone, lime stone	Plaster is damaged.
DOORS	Timber	Damaged
WINDOWS	Timber	Damaged
FLOOR	Cement rendered	No damage
FOUNDATION	Corel stone, Rubble	No damage
SITE	Coconut cultivation	No damage
OTHER		Parapet wall is destroyed.

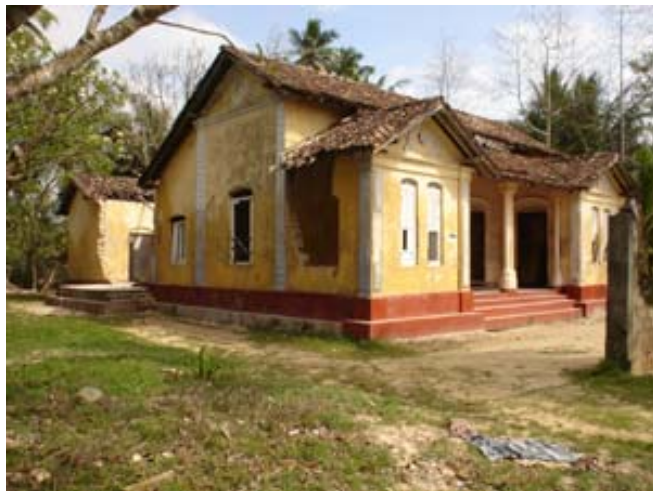
126

Extent of Damage – Walls in the courtyard and in the house have been destroyed. Doors and windows have been destroyed. Roof is damaged.

ELEMENT	MATERIAL	EXTENT OF DAMAGE
ROOF	Calicut tiles, timber frame	Part is damaged.
WALLS	Corel stone	Walls in the courtyard have been completely destroyed.
DOORS	Timber	Damaged
WINDOWS	Timber	Damaged
FLOOR	Cement rendered	Damaged
FOUNDATION	Corel stone, rubble	No damage
SITE	Coconut cultivation	No damage
OTHER
