ICOMOS Sri Lanka

**Preliminary Survey of Tsunami-affected Monuments
and Sites in the Maritime Region of Sri Lanka**

PART THREE
The Western Maritime Region:
from the Gin Ganga to the Kalu Ganga

March 2005

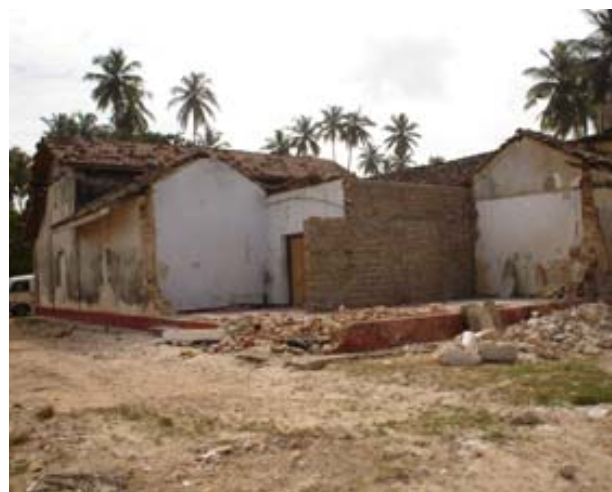
127

Extent of Damage – Rear portion of the house has been destroyed. Doors and windows are destroyed. The roof is damaged.

ELEMENT	MATERIAL	EXTENT OF DAMAGE
ROOF	Calicut tiles, timber frame	Partly damaged.
WALLS	Corel stone	Walls in the back have been completely destroyed.
DOORS	Timber	Damaged
WINDOWS	Timber	Damaged
FLOOR	Cement rendered	Damaged
FOUNDATION	Corel stone, rubble	No damage
SITE	Coconut cultivation	No damage
OTHER

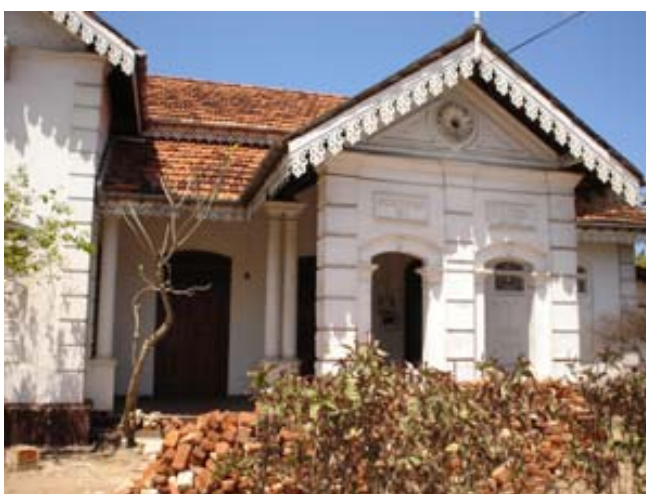
128

Extent of Damage – The rear portion of the house has been destroyed. Doors and windows have been destroyed. Roof is damaged.

ELEMENT	MATERIAL	EXTENT OF DAMAGE
ROOF	Calicut tiles, timber frame	Part is damaged
WALLS	Corel stone	Walls in the back have been completely destroyed.
DOORS	Timber	Damaged
WINDOWS	Timber	Damaged
FLOOR	Cement rendered	Damaged
FOUNDATION	Corel stone, rubble	No damage
SITE	Coconut cultivation	No damage
OTHER

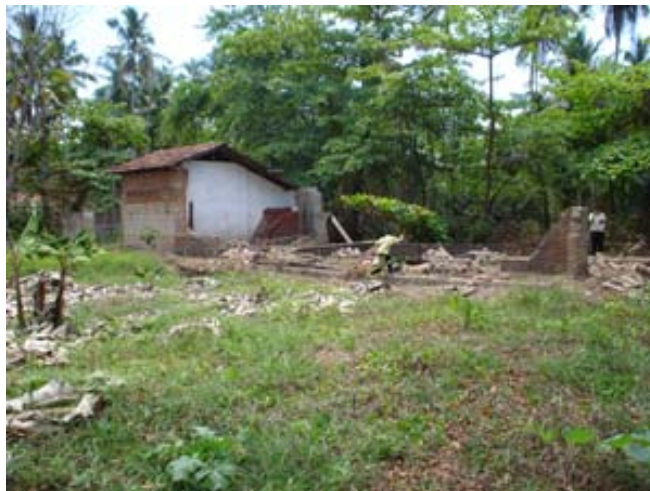
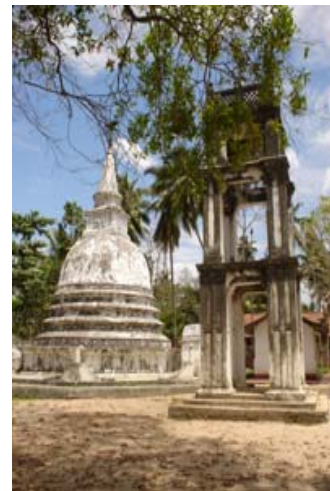
Extent of Damage – *Dharmasalava* is completely destroyed. The parapet wall is destroyed. The *avasa* walls are badly cracked and the floor has settled.

ELEMENT	MATERIAL	EXTENT OF DAMAGE
ROOF	Calicut tiles, timber frame	<i>Dharmasalava</i> is completely destroyed
WALLS	Bricks	<i>Dharmasalava</i> is completely destroyed
DOORS	Timber	<i>Dharmasalava</i> is completely destroyed
WINDOWS	Timber	<i>Dharmasalava</i> is completely destroyed
FLOOR	Cement rendered	<i>Dharmasalava</i> is completely destroyed
FOUNDATION	Rubble	<i>Dharmasalava</i> is completely destroyed
SITE	Coconut cultivation	Washed away.
OTHER		Parapet wall is destroyed.

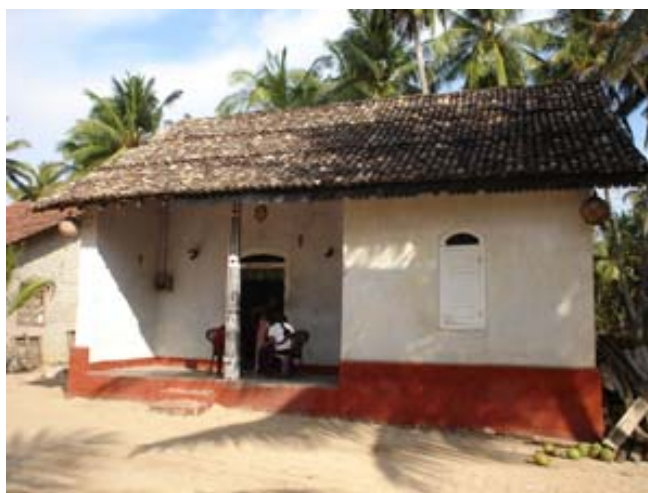
133

Extent of Damage – The doors and windows are damaged. Plaster on the walls has been damaged. The new kitchen is destroyed.

ELEMENT	MATERIAL	EXTENT OF DAMAGE
ROOF	Half round tiles, timber frame	Not affected.
WALLS	Corel stone	Plaster is damaged.
DOORS	Timber	Damaged
WINDOWS	Timber	Damaged
FLOOR	Cement rendered	Not affected.
FOUNDATION	Corel stone, rubble	Not affected.
SITE	Coconut cultivation	Washed away
OTHER		Newly build kitchen is completely destroyed.

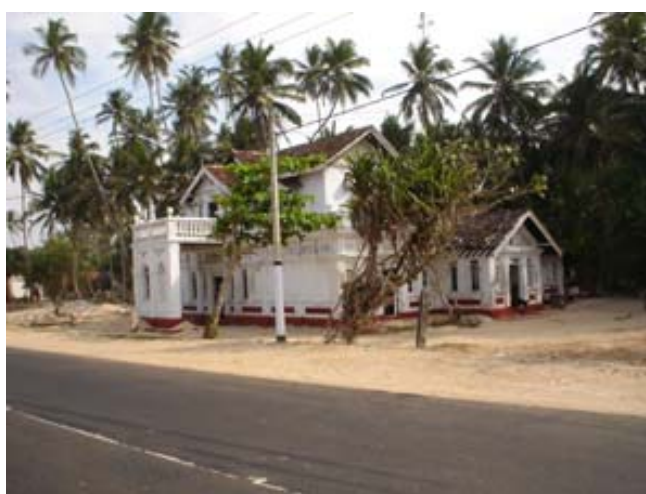
135

Extent of Damage – The parapet wall has been completely destroyed. Plaster has been damaged. A small part of the roof has collapsed.

ELEMENT	MATERIAL	EXTENT OF DAMAGE
ROOF	Half round tiles, Calicut tiles, timber frame	A part has collapsed.
WALLS	Corel stone, limestone	Plaster is damaged.
DOORS	Timber	No damage
WINDOWS	Timber	No damage
FLOOR	Cement rendered	No damage
FOUNDATION	Corel stone, rubble	No damage
SITE	Coconut cultivation	No damage
OTHER		Parapet wall is destroyed.

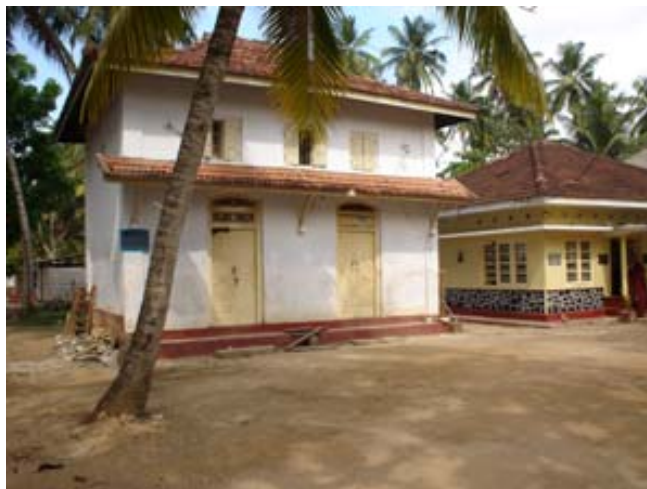
136

Name – SUMANARAMAYA
Type – RELIGIOUS - HISTORICAL - CULTURAL
Address – Wenamulla, Keliyagoda, Ambalangoda.
DS Division - Hikkaduwa
GN Division - Wenamulla
GPS Coordinates - 06⁰ N 12.671
- 080⁰ E 03.778
Distance from the Sea – 200 m
Extent of Damage – Refectory has been partly destroyed.
Estimated Cost for Restoration
- Rs. 2.0 million

ELEMENT	MATERIAL	EXTENT OF DAMAGE
ROOF	Calicut tiles, timber frame	Part of the refectory has been completely destroyed.
WALLS	Corel stone	Part of the refectory has been completely destroyed.
DOORS	Timber	Part of the refectory has been completely destroyed.
WINDOWS	Timber	Part of the refectory has been completely destroyed.
FLOOR	Cement rendered	Damaged
FOUNDATION	Corel stone, rubble	No damage
SITE	Coconut cultivation	No damage
OTHER		Parapet wall is destroyed.

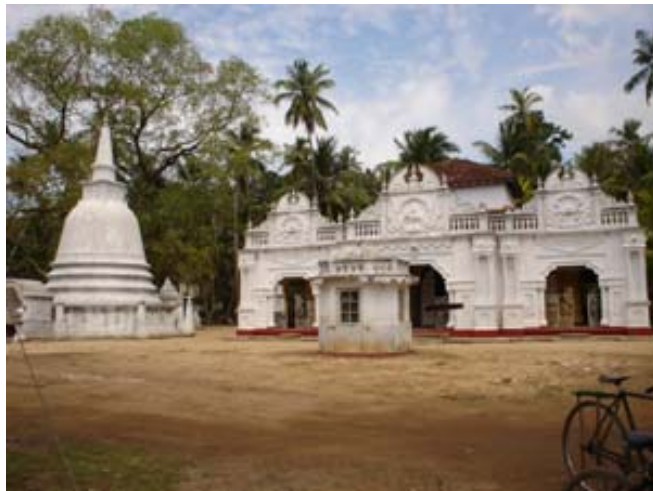
Extent of Damage – Doors and windows are damaged. The parapet wall has been destroyed. The *prakara* of the Bo-tree has cracked.

ELEMENT	MATERIAL	EXTENT OF DAMAGE
ROOF	Calicut tiles, timber frame	No damage
WALLS	Bricks	Refectory walls are damaged. The <i>prakara</i> wall is cracked
DOORS	Timber	Damaged
WINDOWS	Timber	Damaged
FLOOR	Cement rendered	No damage
FOUNDATION	Corel stone, rubble	No damage
SITE	Coconut cultivation	No damage
OTHER		Parapet walls are destroyed.

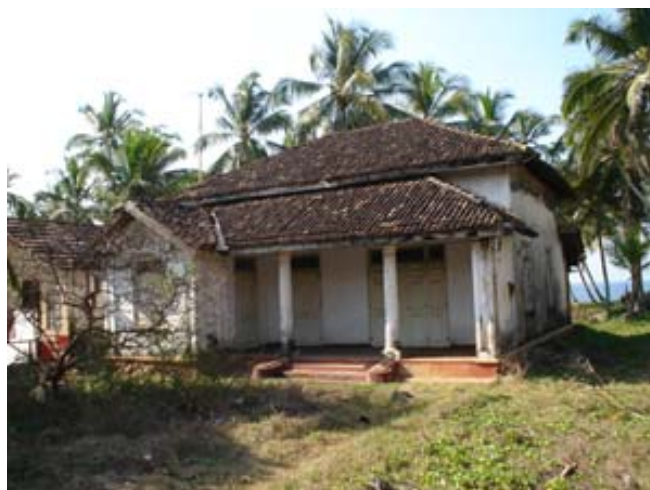
138

Extent of Damage – The floor of two rooms has been damaged. The parapet wall is damaged.

ELEMENT	MATERIAL	EXTENT OF DAMAGE
ROOF	Half round tiles, timber frame	No damage
WALLS	Bricks	No damage
DOORS	Timber	No damage
WINDOWS	Timber, glass	No damage
FLOOR	Cement rendered	Damaged
FOUNDATION	Rubble	No damage
SITE	Coconut cultivation	No damage
OTHER		Parapet wall is destroyed.

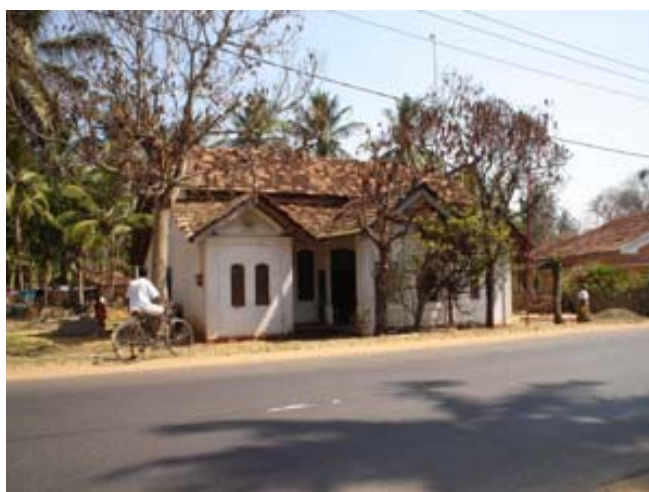
140

Extent of Damage – Walls are cracked. Floor has settled. Doors cannot be closed.

ELEMENT	MATERIAL	EXTENT OF DAMAGE
ROOF	Half round tiles, timber frame	No damage
WALLS	Bricks	Cracked
DOORS	Decorated timber	Cannot be closed.
WINDOWS	Timber	No damage
FLOOR	Cement rendered	Settled
FOUNDATION	Rubble	No damage
SITE	Coconut cultivation	No damage
OTHER

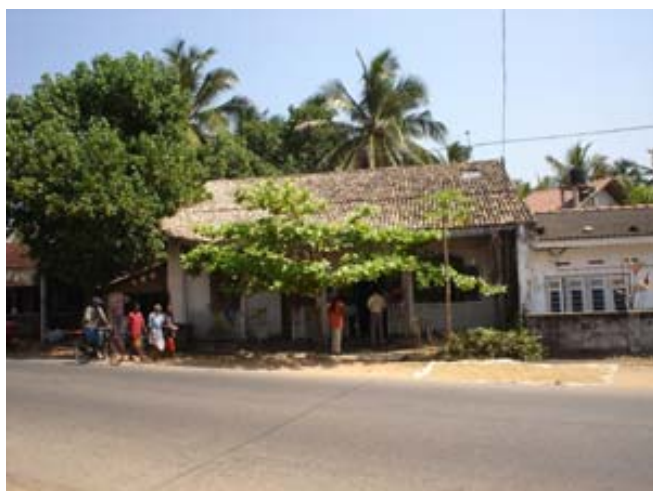
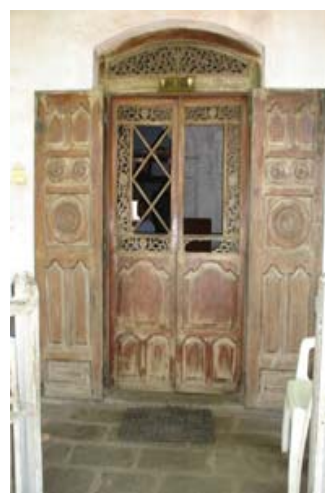
141

Extent of Damage – **The door has been damaged. Walls are cracked. The fence in the front is destroyed.**

ELEMENT	MATERIAL	EXTENT OF DAMAGE
ROOF	Half round tiles, timber frame	No damage
WALLS	Rubble	Cracked
DOORS	Decorated timber	Damaged
WINDOWS	Decorated timber	No damage
FLOOR	Rubble, cement rendered	No damage
FOUNDATION	Rubble	No damage
SITE	Trees, sandy soil	No damage
OTHER		The front timber railing is destroyed.

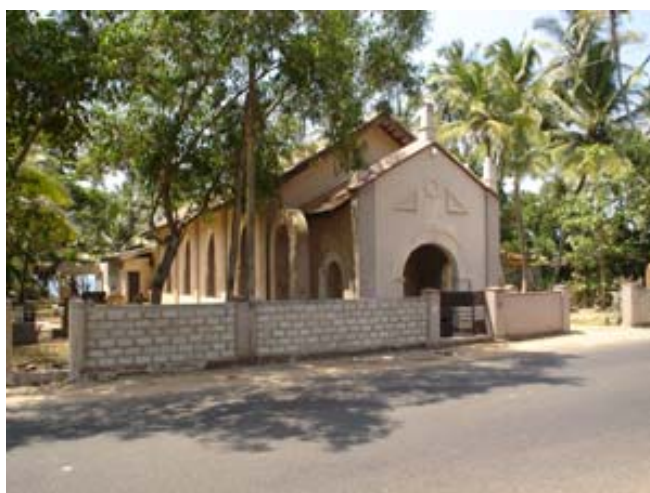
142

Extent of Damage – Six rooms have been destroyed. The parapet walls are destroyed.

ELEMENT	MATERIAL	EXTENT OF DAMAGE
ROOF	Asbestos, timber frame	Six rooms have been destroyed.
WALLS	Rubble	Six rooms have been destroyed.
DOORS	Timber	Six rooms have been destroyed.
WINDOWS	Timber, glass	Six rooms have been destroyed.
FLOOR	Cement rendered	Six rooms have been destroyed.
FOUNDATION	Rubble	No damage
SITE	Coconut cultivation	Washed away
OTHER		Parapet wall is destroyed.

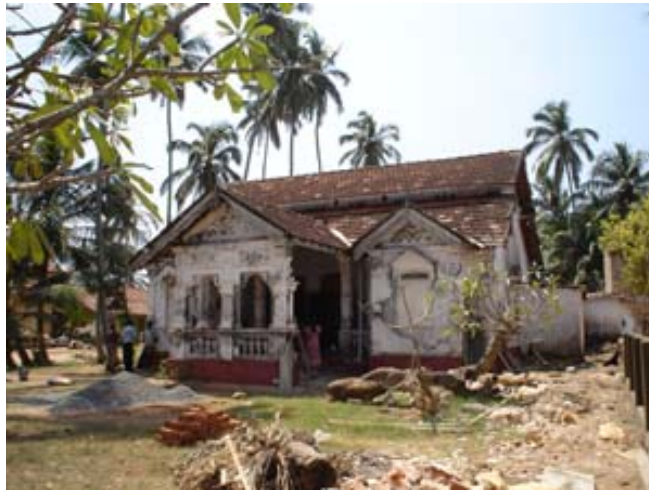
143

Extent of Damage – The walls are cracked and the plaster has fallen. The parapet wall is destroyed.

ELEMENT	MATERIAL	EXTENT OF DAMAGE
ROOF	Calicut tiles, timber frame	No damage
WALLS	Bricks	Cracked. Plaster is damaged.
DOORS	Timber	No damage
WINDOWS	Timber, glass	No damage
FLOOR	Cement rendered	No damage
FOUNDATION	Rubble	No damage
SITE	Coconut cultivation	No damage
OTHER		Parapet wall is destroyed.

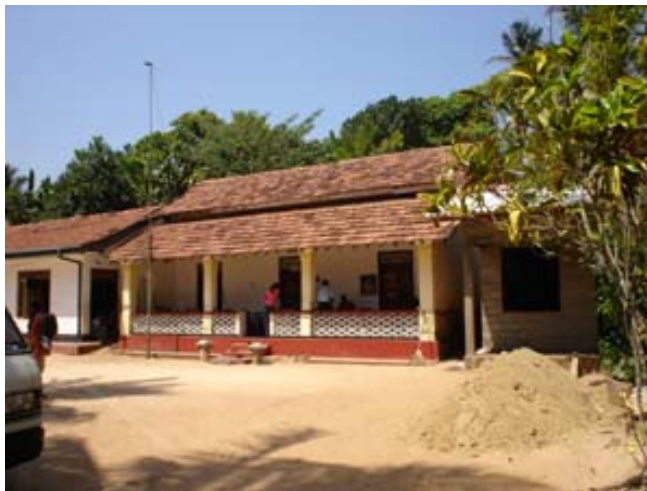
144

Extent of Damage – Parapet wall is damaged. The *dharmasalava* is damaged.

ELEMENT	MATERIAL	EXTENT OF DAMAGE
ROOF	Calicut tiles, timber frame	No damage
WALLS	Corel stone, Cabock	Cracked
DOORS	Timber	Damaged
WINDOWS	Timber	Damaged
FLOOR	Cement rendered	No damage
FOUNDATION	Rubble	No damage
SITE	Coconut cultivation	No damage
OTHER		Parapet wall is damaged.

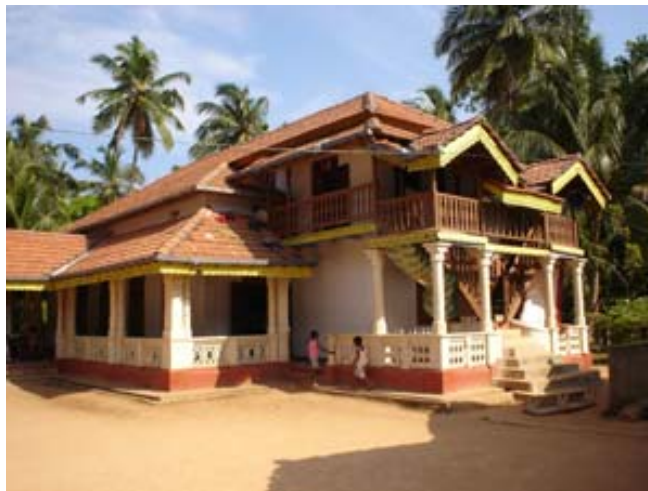
145

Name – KUSUMAEAMA VIHARAYA
Type – RELIGIOUS – HISTORICAL - CULTURAL
Address – No. 64A, Sinigama, Hikkaduwa
DS Division - Hikkaduwa
GN Division – Sinigama North
GPS Coordinates - 06⁰ N 09.565
- 080⁰ E 05.844
Distance from the Sea – 550 m
Extent of Damage – The stone stairway and parapet wall are destroyed.
Estimated Cost for Restoration
- Rs. 0.2 million

ELEMENT	MATERIAL	EXTENT OF DAMAGE
ROOF	Half round tiles, Calicut tiles, Timber frame.	No damage
WALLS	Rubble	No damage
DOORS	Timber	No damage
WINDOWS	Timber	No damage
FLOOR	Tiled	No damage
FOUNDATION	Rubble	No damage
SITE	Trees	No damage
OTHER		Stone stairway and parapet walls are damaged.

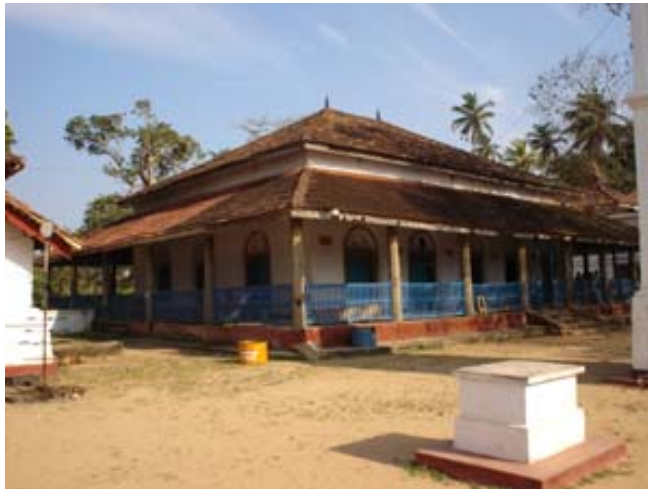
146

Name – TOTAGAMUWA VIJAYABA PARIVENA
Type – RELIGIOUS - HISTORICAL - CULTURAL
Address – Parana Totagamuwa Viharaya, Telwatta
DS Division - Hikkaduwa
GN Division – Telwatta
GPS Coordinates - 06⁰ N 10.213
- 080⁰ E 05.487
Distance from the Sea – 350 m
Extent of Damage – Parapet wall has been completely destroyed.
Estimated Cost for Restoration
- Rs. 0.2 million

ELEMENT	MATERIAL	EXTENT OF DAMAGE
ROOF	Half round tiles, Calicut tiles, timber frame	No damage
WALLS	Corel stones	No damage
DOORS	Timber	No damage
WINDOWS	Timber	No damage
FLOOR	Cement rendered	No damage
FOUNDATION	Rubble	No damage
SITE	Coconut cultivation	No damage
OTHER		Parapet wall is destroyed.

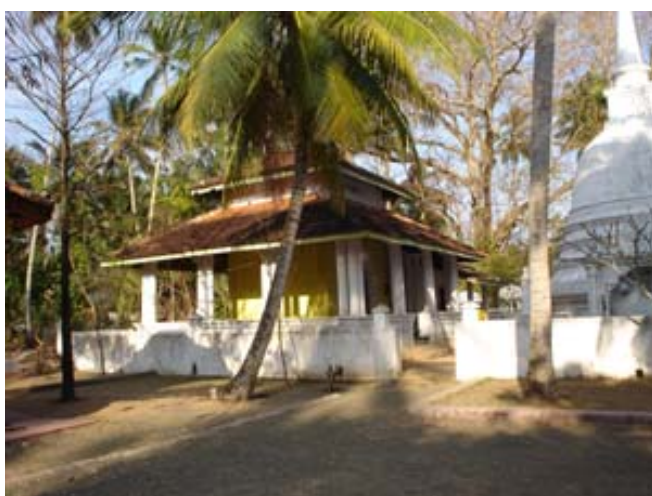
147

Extent of Damage – Parapet wall was completely destroyed. Doors are destroyed.

ELEMENT	MATERIAL	EXTENT OF DAMAGE
ROOF	Calicut tiles, timber frame	Not affected.
WALLS	Bricks	Not affected.
DOORS	Timber	Damaged
WINDOWS	Timber, glass	Not affected.
FLOOR	Cement rendered	Not affected.
FOUNDATION	Rubble	Not affected.
SITE	Coconut cultivation	Not affected.
OTHER		Parapet wall has been destroyed.

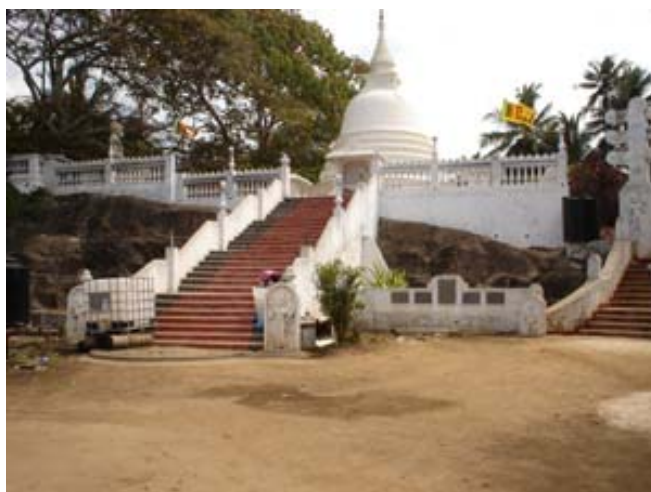
148

Extent of Damage – Doors and windows are damaged. Walls in the refectory have been damaged.

ELEMENT	MATERIAL	EXTENT OF DAMAGE
ROOF	Calicut tiles, timber frame	No damage
WALLS	Bricks	Refectory walls are damaged
DOORS	Timber	Damaged
WINDOWS	Timber	Damaged
FLOOR	Cement rendered	No damage
FOUNDATION	Rubble	No damage
SITE	Coconut cultivation	No damage
OTHER

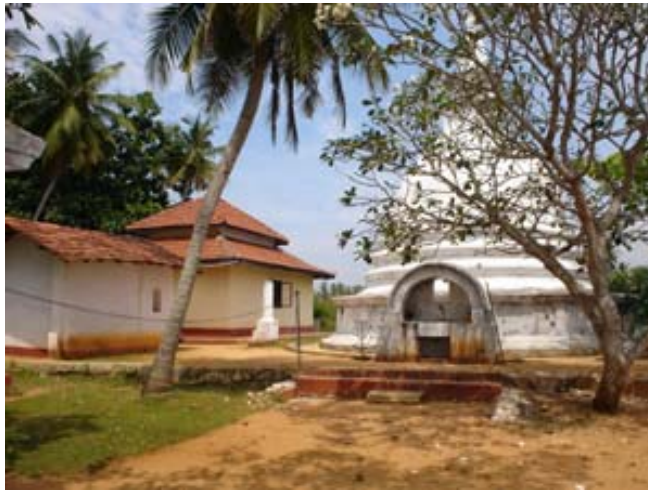
149

Extent of Damage – Parapet wall has been destroyed. The *prakara* of the Bo-tree has been cracked.

ELEMENT	MATERIAL	EXTENT OF DAMAGE
ROOF	Calicut tiles, timber frame	No damage
WALLS	Bricks	<i>Prakara</i> walls are cracked
DOORS	Timber	No damage
WINDOWS	Timber	No damage
FLOOR	Cement rendered	No damage
FOUNDATION	Rubble	No damage
SITE	Coconut cultivation	No damage
OTHER		Parapet walls are destroyed.

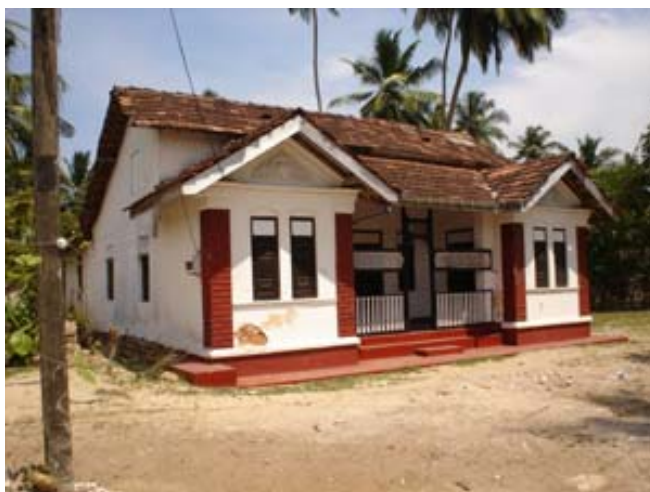
150

Extent of Damage – **Plaster of the wall is damaged.**

ELEMENT	MATERIAL	EXTENT OF DAMAGE
ROOF	Calicut tiles, timber frame	No damage
WALLS	Bricks	Plaster is damaged
DOORS	Timber	No damage
WINDOWS	Timber	No damage
FLOOR	Cement rendered	No damage
FOUNDATION	Rubble	No damage
SITE	Coconut cultivation	No damage
OTHER

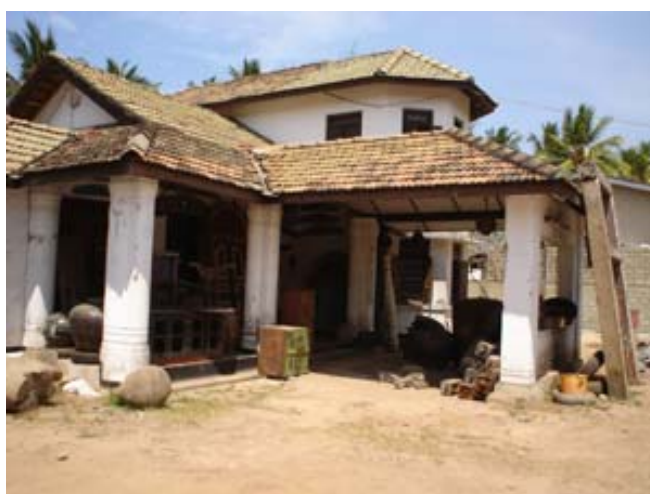
151

Extent of Damage – **Part of the wall including the roof has been damaged.**

ELEMENT	MATERIAL	EXTENT OF DAMAGE
ROOF	Calicut tiles, timber frame	Part is collapsed.
WALLS	Bricks	Part is collapsed.
DOORS	Timber	Damaged
WINDOWS	Timber	No damage
FLOOR	Cement rendered	No damage
FOUNDATION	Rubble	No damage
SITE		
OTHER

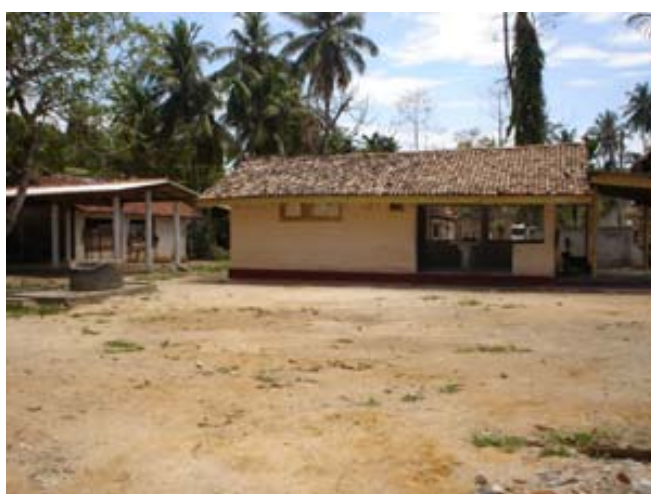
Extent of Damage – Part of the wall has been damaged.

ELEMENT	MATERIAL	EXTENT OF DAMAGE
ROOF	Half round tiles, timber frame	Part has collapsed.
WALLS	Bricks	Part has collapsed.
DOORS	Timber	Damaged
WINDOWS	Timber, glass	No damage
FLOOR	Tiled	No damage
FOUNDATION	Rubble	No damage
SITE	Coconut cultivation	No damage
OTHER

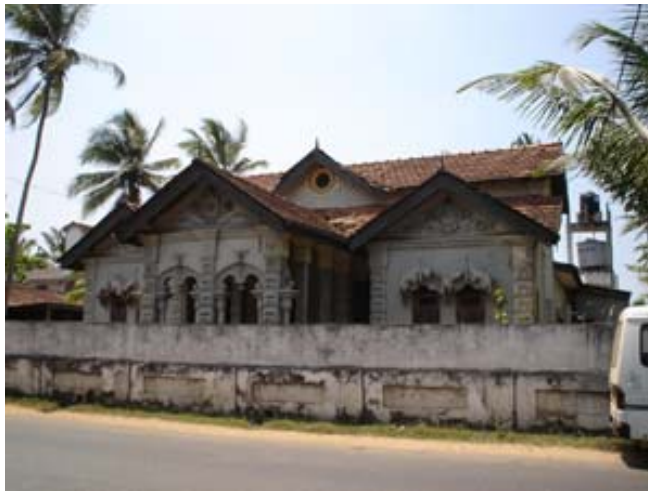
158

Name – SKUBA VILA
Type – HISTORICAL - RESIDENTIAL
Address – No. 864, Thiranagama, Hikkaduwa
DS Division - Hikkaduwa
GN Division – Thiranagama
GPS Coordinates - 06⁰ N 07.218
- 080⁰ E 06.920
Distance from the Sea – 50 m
Extent of Damage – Newly constructed part has been destroyed.
Estimated Cost for Restoration
- Rs. 000 million

ELEMENT	MATERIAL	EXTENT OF DAMAGE
ROOF	Calicut tiles, Asbestos, timber frame	No damage
WALLS	Bricks	No damage
DOORS	Timber	No damage
WINDOWS	Timber, glass	No damage
FLOOR	Cement rendered	No damage
FOUNDATION	Rubble	No damage
SITE	Trees	No damage
OTHER		Newly constructed part is destroyed.

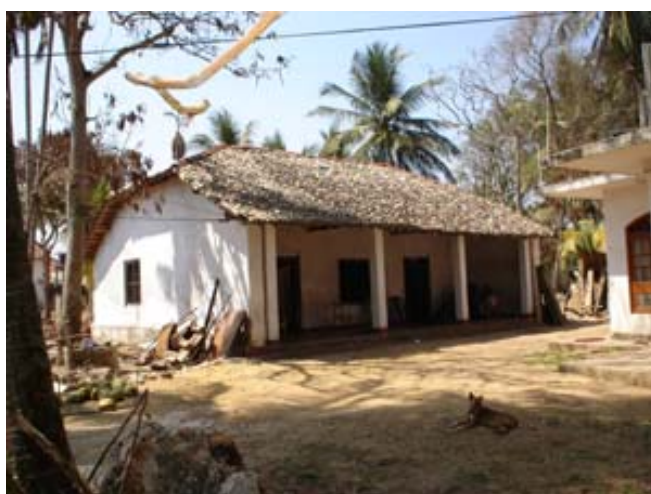
Extent of Damage – **No damage.**

ELEMENT	MATERIAL	EXTENT OF DAMAGE
ROOF	Calicut tiles, timber frame	No damage
WALLS	Corel stone	No damage
DOORS	Timber	No damage
WINDOWS	Timber	No damage
FLOOR	Cement rendered	No damage
FOUNDATION	Rubble	No damage
SITE	Coconut cultivation	No damage
OTHER

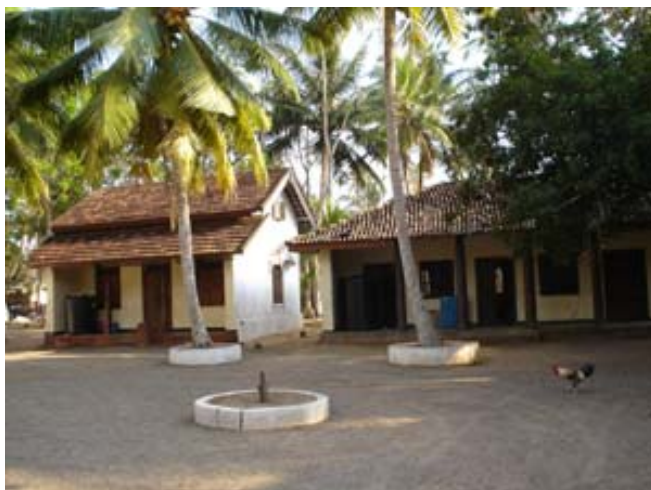
Name – SRI VIVEKARAMAYA
Type – RELIGIOUS - HISTORICAL - CULTURAL
Address – Kuruppu Kanda, Godagama, Kahawa
DS Division - Hikkaduwa
GN Division – Kahawa
GPS Coordinates - 06⁰ N 10.862
- 080⁰ E 04.756
Distance from the Sea – 350 m
Extent of Damage – Not affected.
Estimated Cost for Restoration
- Rs. 000 million

ELEMENT	MATERIAL	EXTENT OF DAMAGE
ROOF	Calicut tiles, timber frame	Not affected.
WALLS	Bricks	Not affected.
DOORS	Timber	Not affected.
WINDOWS	Timber	Not affected.
FLOOR	Cement rendered	Not affected.
FOUNDATION	Rubble	Not affected.
SITE	Coconut cultivation	Not affected.
OTHER

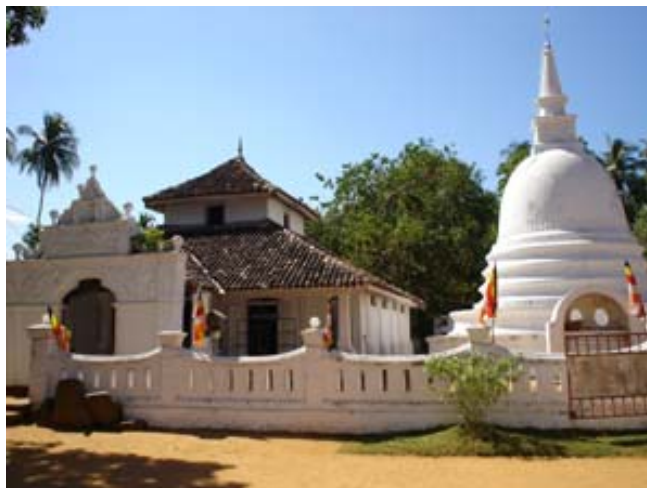
Extent of Damage – Not affected.

ELEMENT	MATERIAL	EXTENT OF DAMAGE
ROOF	Half round tiles, Calicut tiles, timber frame	Not affected.
WALLS	Lime, rubble	Not affected.
DOORS	Timber	Not affected.
WINDOWS	Timber	Not affected.
FLOOR	Stone paved, cement rendered	Not affected.
FOUNDATION	Rubble, lime	Not affected.
SITE	Coconut cultivation	Not affected.
OTHER

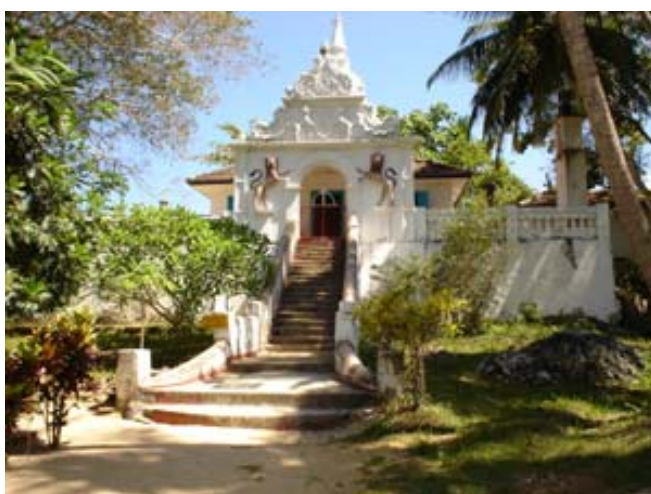
Name – SUMANARAMAYA
Type – RELIGIOUS - CULTURAL
Address – Thiranagama, Hikkaduwa
DS Division - Hikkaduwa
GN Division – Wallabada
GPS Coordinates - 06⁰ N 07.411
- 080⁰ E 06.892
Distance from the Sea – 300 m
Extent of Damage – Not affected.
Estimated Cost for Restoration
- Rs. 000 million

ELEMENT	MATERIAL	EXTENT OF DAMAGE
ROOF	Calicut tiles, timber frame	Not affected.
WALLS	Lime, rubble	Not affected.
DOORS	Timber	Not affected.
WINDOWS	Timber	Not affected.
FLOOR	Tiled	Not affected.
FOUNDATION	Rubble, lime	Not affected.
SITE	Coconut cultivation	Not affected.
OTHER

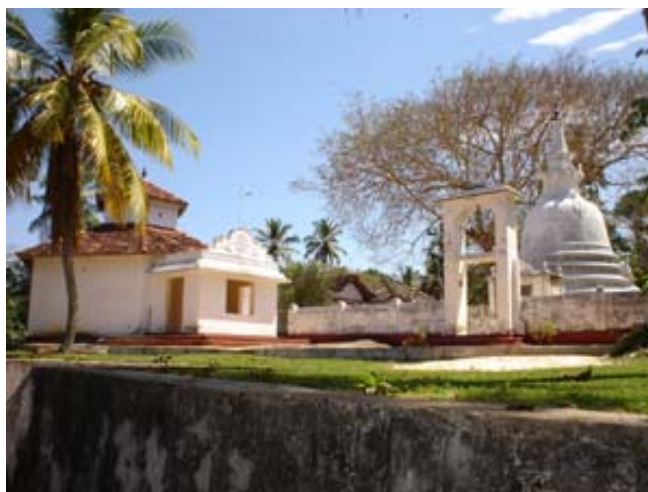
Name – SHALILATHARAMAYA
Type – RELIGIOUS - CULTURAL
Address – Narigama, Hikkaduwa
DS Division - Hikkaduwa
GN Division – Narigama
GPS Coordinates - 06⁰ N 08.276
- 080⁰ E 05.978
Distance from the Sea – 300 m
Extent of Damage – Not affected.
Estimated Cost for Restoration
- Rs. 000 million

ELEMENT	MATERIAL	EXTENT OF DAMAGE
ROOF	Calicut tiles, timber frame	Not affected.
WALLS	Lime, rubble	Not affected.
DOORS	Timber	Not affected.
WINDOWS	Timber	Not affected.
FLOOR	Cement rendered	Not affected.
FOUNDATION	Rubble, lime	Not affected.
SITE	Coconut cultivation	Not affected.
OTHER

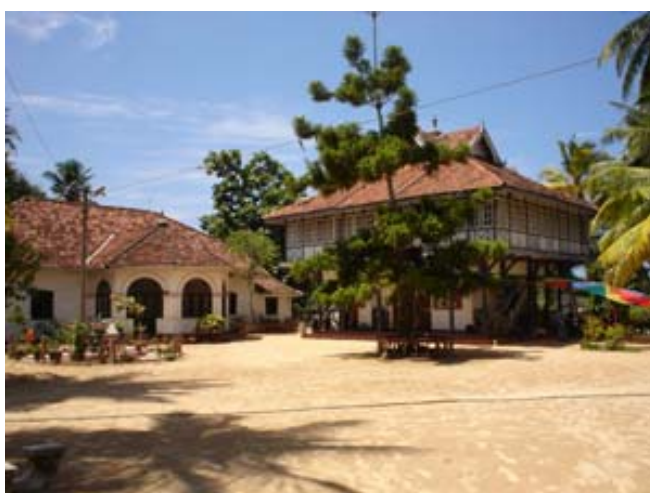
Name – JANANANDARAMAYA
Type – RELIGIOUS - HISTORICAL - CULTURAL
Address – Baddegama Road, Hikkaduwa
DS Division - Hikkaduwa
GN Division - Hikkaduwa
GPS Coordinates - 06⁰ N 08.314
- 080⁰ E 06.266
Distance from the Sea – 900 m
Extent of Damage – Not affected.
Estimated Cost for Restoration
- Rs. 000 million

ELEMENT	MATERIAL	EXTENT OF DAMAGE
ROOF	Calicut tiles, timber frame	Not affected.
WALLS	Timber, lime, rubble	Not affected.
DOORS	Timber	Not affected.
WINDOWS	Timber	Not affected.
FLOOR	Cement rendered	Not affected.
FOUNDATION	Rubble	Not affected.
SITE	Coconut cultivation	Not affected.
OTHER

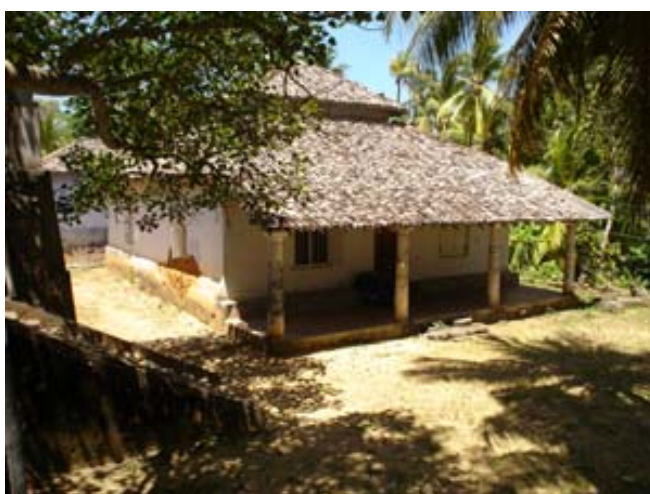
Name – THILAKARAMAYA
Type – RELIGIOUS - HISTORICAL - CULTURAL
Address – Hettigoda, Hikkaduwa
DS Division - Hikkaduwa
GN Division - Hettigoda
GPS Coordinates - 060 N 08.887
- 0800 E 06.336
Distance from the Sea – 900 m
Extent of Damage – Not affected.
Estimated Cost for Restoration
- Rs. 000 million

ELEMENT	MATERIAL	EXTENT OF DAMAGE
ROOF	Half round tiles, Calicut tiles, timber frame	Not affected.
WALLS	Mud, rubble	Not affected.
DOORS	Timber	Not affected.
WINDOWS	Timber	Not affected.
FLOOR	Cement rendered	Not affected.
FOUNDATION	Mud, rubble	Not affected.
SITE	Coconut cultivation	Not affected.
OTHER
