The Deterioration of Wood in Heritage Structures in Canada

An illustrated lecture

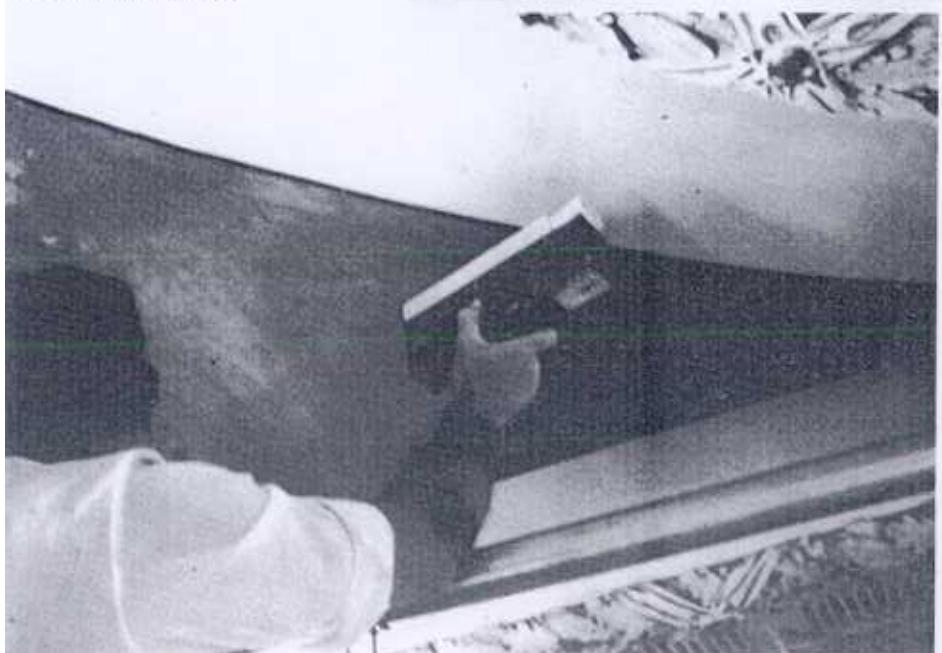
5. Taking relative humidity readings at ceiling level in Quebec's National Assembly building during research on effects of dessication.
Photo: Martin Weaver.

Excessive dessication of wood is also a major problem in Canadian interiors, where forced hot-air heating may lower R.H. to around 20% or less. (fig. 4). Not only does wood dry out, cracking and twisting, but the glue joints also fail. (fig.5).

- fig. 3 La thermographie infra-rouge montre la perte de chaleur d'une toiture. Bâtiment est du Parlement, Ottawa.
- fig. 4 Mesuration du taux d'humidité au niveau du plafond à l'Assemblée Nationale, Québec.

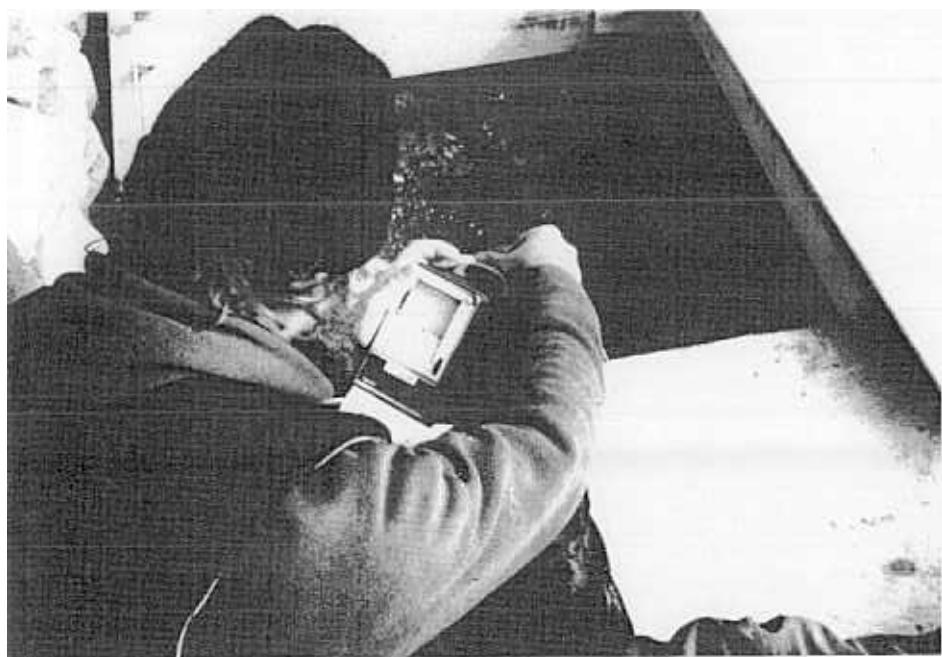
6 - 7. Installing a monitoring thermohydrograph under the floor covering protecting frozen artifacts in an 1853 explorer's supply cache, Dealeys Island, High Arctic.
Photo: Martin Weaver.

An increasing number of conservation projects involve continuing programmes of monitoring of temperature and R.H. (fig. 6&7).

- fig. 6 & 7 Installation d'un thermohydrographe sous le plancher d'une cabane d'explorateurs datant de 1853, Dealey Island, Arctique. La détérioration causée par les insectes (ou les pivers) est également un résultat du climat environnant, du taux d'humidité et de la qualité du bois.

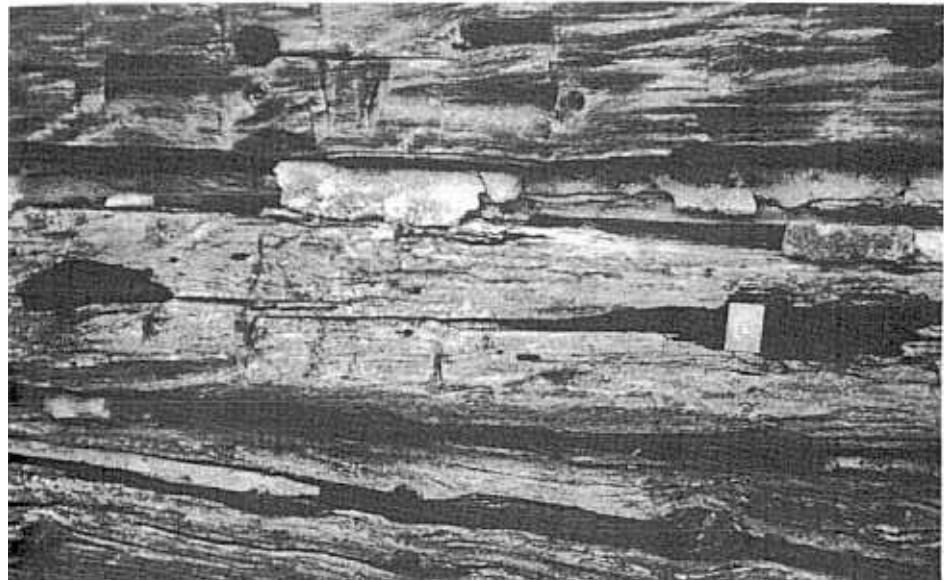
8. Heavy attack by carpenter ants (*Camponotus Pennsylvanicus*) in Eastern White Cedar logs in a nineteenth century log farm building, Ottawa, Ontario. Photo: Martin Weaver.

Insect attacks and related problems such as woodpecker damage are clearly related to environmental criteria i.e. wood species, sufficient warmth, optimum humidity and wood moisture contents. (fig. 8) Monochamus- pine sawyer beetle damage mainly in forest or recently felled timber. Anobiid damage larger boreholes than European counterpart (fig. 9). Death watch beetle attack together with rot, not uncommon in Maritimes. Subterranean termite attacks are common in Southern Ontario and southern British Columbia (fig. 10). Dry wood termites are not to found in Canada but in attacked wood imported in furniture and wooden siding (fig. 11). Nacerdes melanura – the Wharf Borer commonly attacks wood in wharves, docks and wet basements in Ontario, the Maritimes and British Columbia (fig. 12). Marine borers attack wood in salt water on both east and west coasts. They include both teredo borers and lomoria (fig. 13).

- fig. 8 Exemple de rondin de cèdre provenant d'une ferme de l'Ontario, attaqué par les termites (*camponotus Pensylvanicus*).
- fig. 9 Dommages causés par un coléoptère attaquant les meubles anciens (*annobivium punctatum*). Les trous sont plus grands que dans les exemples européens.
