UKRAINE

ICOMOS Ukraine

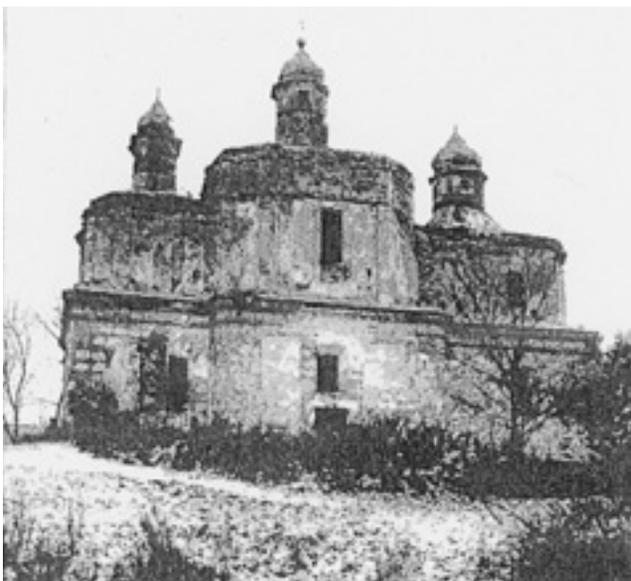
Church of the Transfiguration of the Saviour, village of Polichyntsi

The Church is situated at the end of the village, on a hill above a small river. This place of worship is tripartite, two-tiered, with three cupolas. The first storey is built of stone, the second tier and the drums are of brick.

The heritage place is in a critical state. It is in urgent need of help to prevent its collapse and begin conservation works, but lack of funds prevents an immediate start.

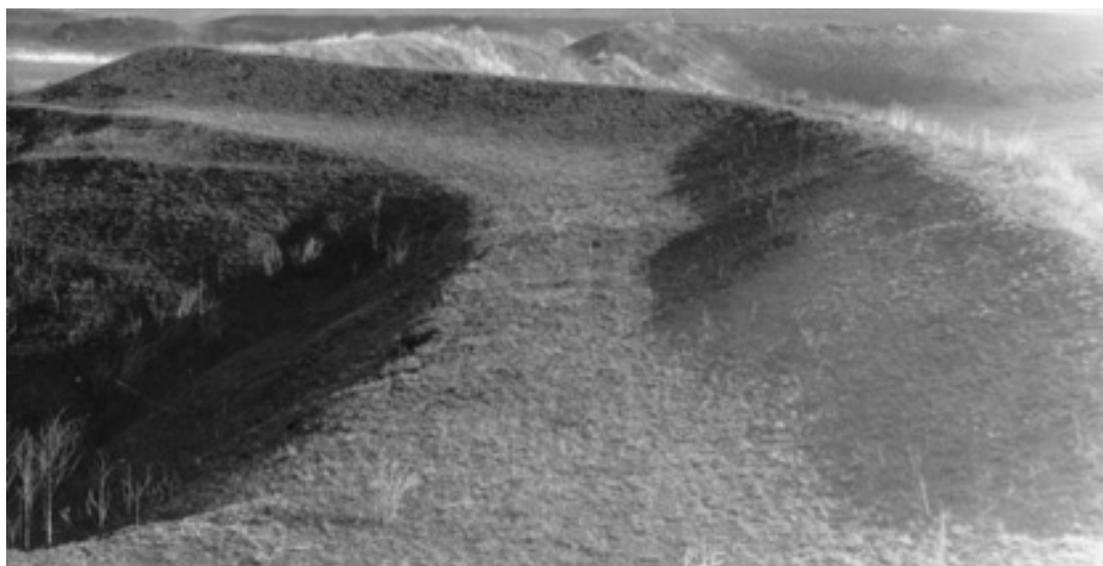
The extension of the Ukrainian frontier spanning the watershed between the Dnipro and Siversky Donets rivers is some 285 km long. This border represents a continuous moated rampart with 16 fortresses and two hundred redoubts and blockhouses mounted along it. The area of each fortress' inner court is about 1.2 ha, the perimeter of its ramparts 980 m. The fortifications were designed and their construction supervised by French fortification engineers G M de Brigny and D I de Bosquet, under the guidance of Kyiv Governor General A I Tarakanov. In building the borderline, 20,000 Cossacks and 10,000 peasants were employed under Cossack Colonel Halahan.

Today this line of border is in critical state. Saving this unique monument to the art of fortification and town-planning is one of the most urgent tasks, and presents serious organisational as well as methodological problems.

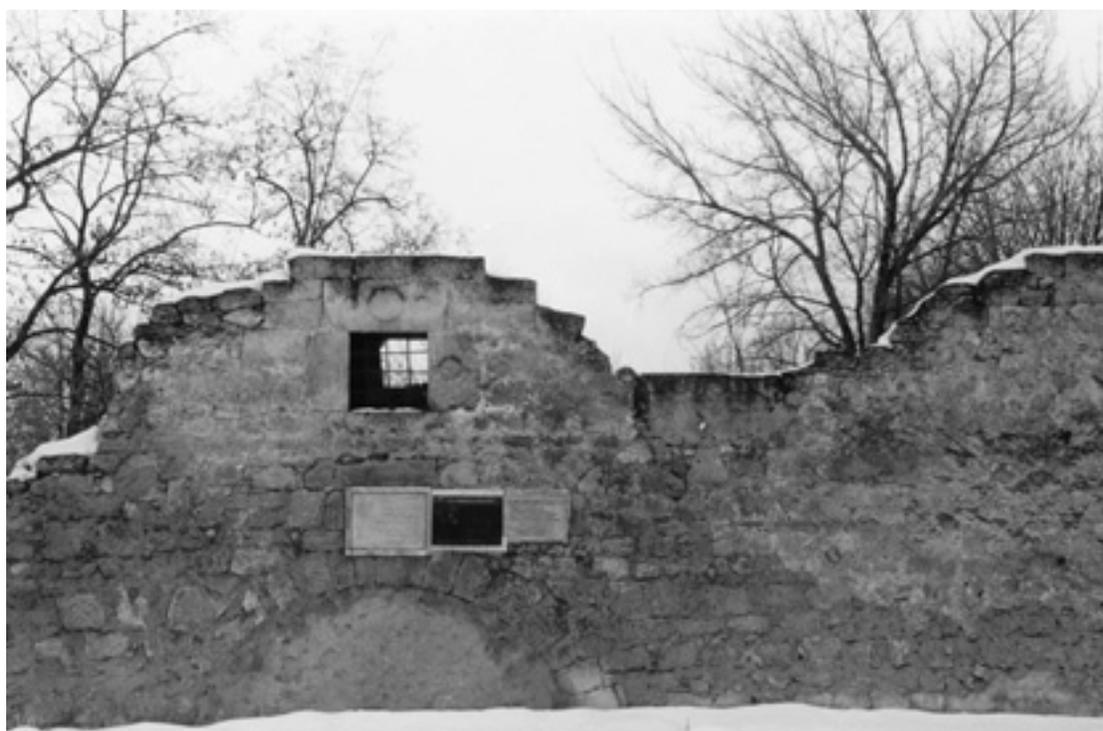
Caravanserai in Bilogorsk,
Independent Republic of Crimea

Until the mid-1950s, the western wall survived relatively well-preserved with its inner buildings (about 42 m lengthwise, 1.5 m in thickness). Now less than 18 m of the wall survives, with a maximum height of 4.7 m. To the left of its façade there is a semicircular arch of the gateway, above which there is a rectangular window with metal grating. There are two embrasures to the right on the second level. On the side of the courtyard, three semicircular tunnel vaults have survived – a gateway and two rooms (about 4 m x 4 m), one room with a fireplace. The gateway and entrances to the rooms have been conserved, walled-up with cut Inkerman stone. A layer of deposit at the walls is no less than 1.5 m deep.
