# The Urbieto Wreck

## (Gernika) Basque Country

**Manuel Izaguirre**

Center for Underwater Investigations INSUB

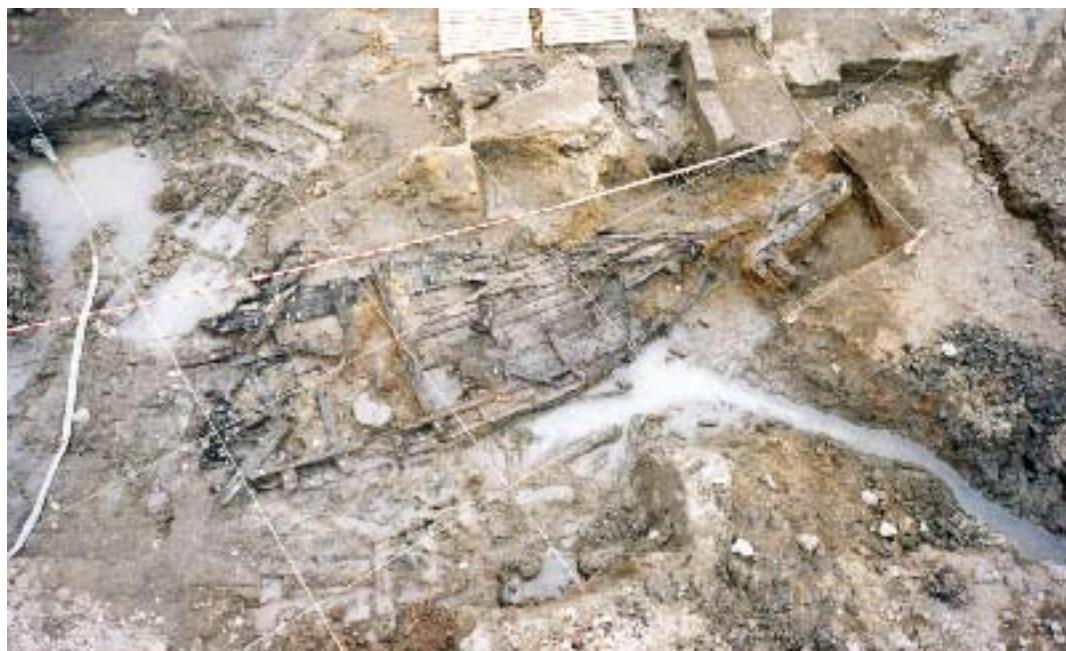
**Figure 1:** Aerial view of the dig; at the extreme right of the wreck is the stern and at the left is seen the transverse gap caused by the excavation equipment during the dredging of the Oka river

Through the excavations it was possible to observe that the vessel had run aground on its port side which, despite its destruction, had kept all its strakes from its keel to its gunnel. On the starboard side only remains of the garboard strake and of some other strakes were found pushed inwards towards the port side.

The central part of the vessel, along about one-third of its length had been destroyed by the backhoe excavator. While most of the solid pieces could be salvaged, many of the construction details of this part were lost such as the keelson and the

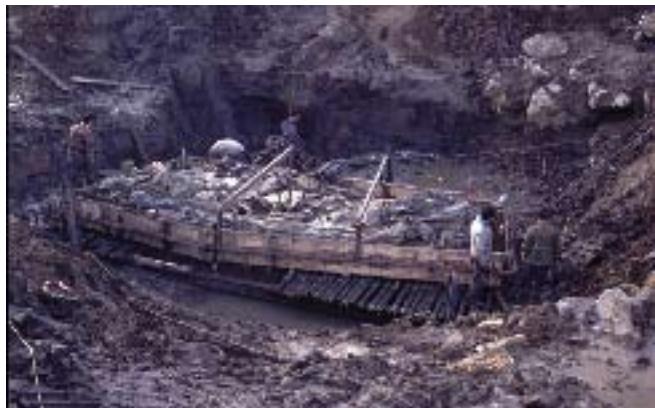
**Figure 2:** In order to extract the wreck from the silt of the river, it was required to detach it from the ground by creating a platform of horizontal tubes

To raise the vessel, the surroundings of the vessel were excavated up to a depth of 1.6m over a sufficiently wide area to obtain a horizontal plane that allowed the boring of transversal tunnelling holes and placement of a series of parallel horizontal tubes under the vessel. Taking into account the irregularity of the mud and sand under the boat, a blocking fence was built around the structure using wooden boards and a metal structure to a height of 60 cm.

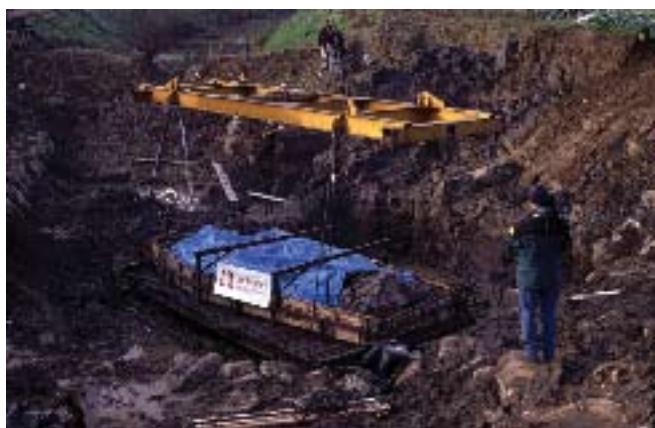
**Figure 3:** Once detached from the silt, it required a large crane to lift the block of the wreck onto the bed of a special truck of adjustable height

The horizontal layer of tubes thus created also served as a base for the earthen block on which the vessel was resting. Once this was reinforced by the metal structure, it was extracted using a heavy-duty crane and placed onto a truck/lorry of adjustable height, which transported the whole block to a temporary storehouse near the location of the find.

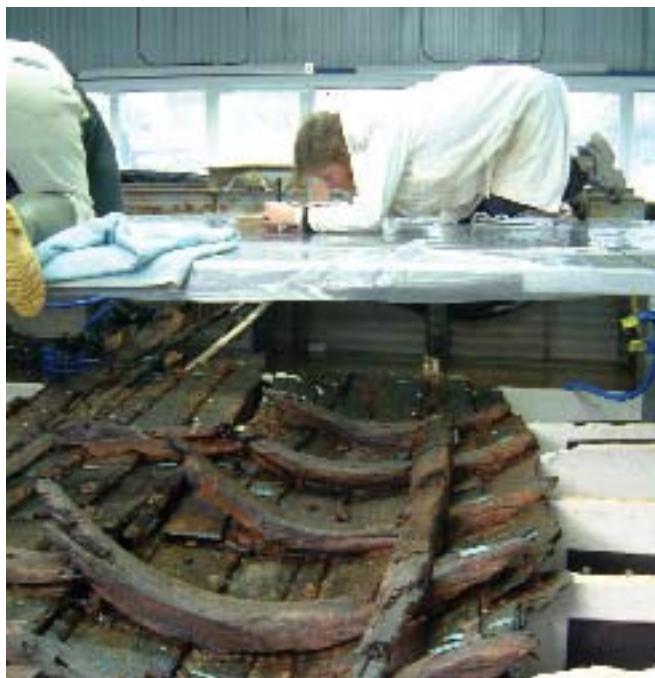
**Figure 4:** After a careful cleaning of the wreck, the details and design of the archaeological remains were recorded, indispensable for the recreation and elaboration of the real and hypothetical forms of the architecture of the boat
